“Development of a technology to investigate inside the Reactor Primary Containment Vessel (PCV)”

- Results of follow up check after the site test -

[For April 18 and 19, 2015]

Tokyo Electric Power Company

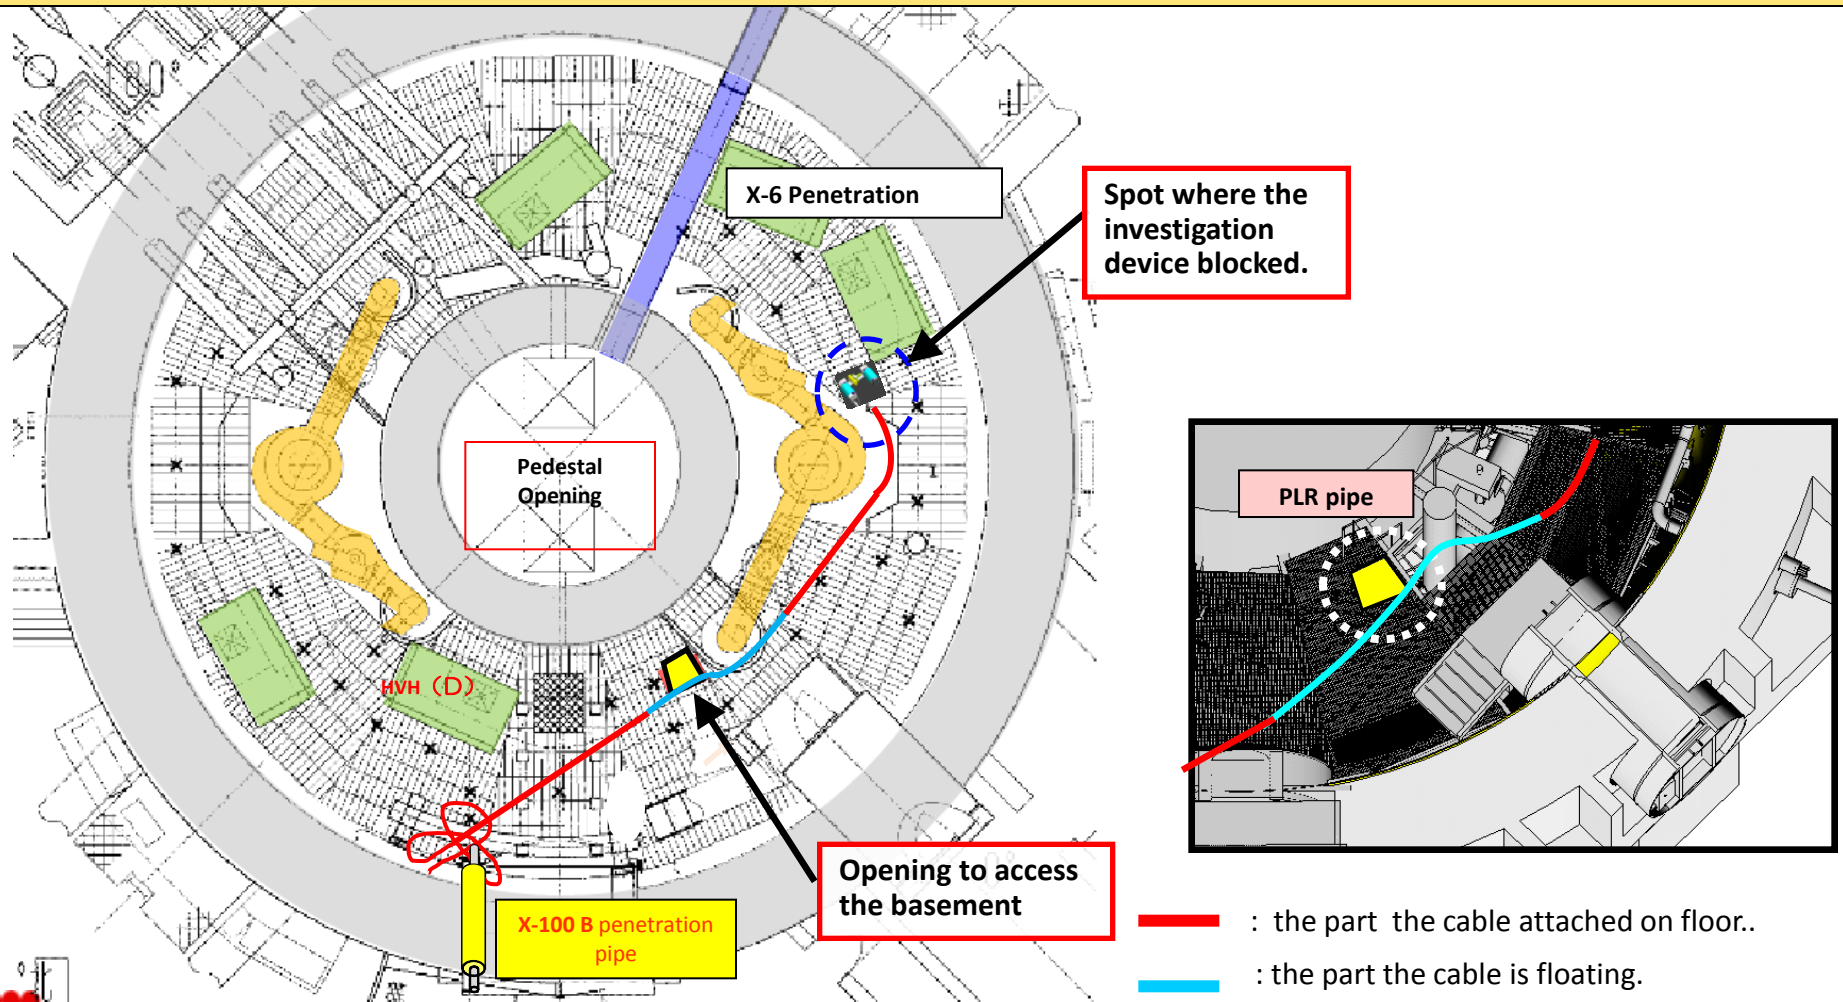
2. Status of the cable remained

- The route of remaining cables is shown as below.
- **It was confirmed that** the remaining cable around the opening to access the basement **will be no obstacle to B2 investigation.**

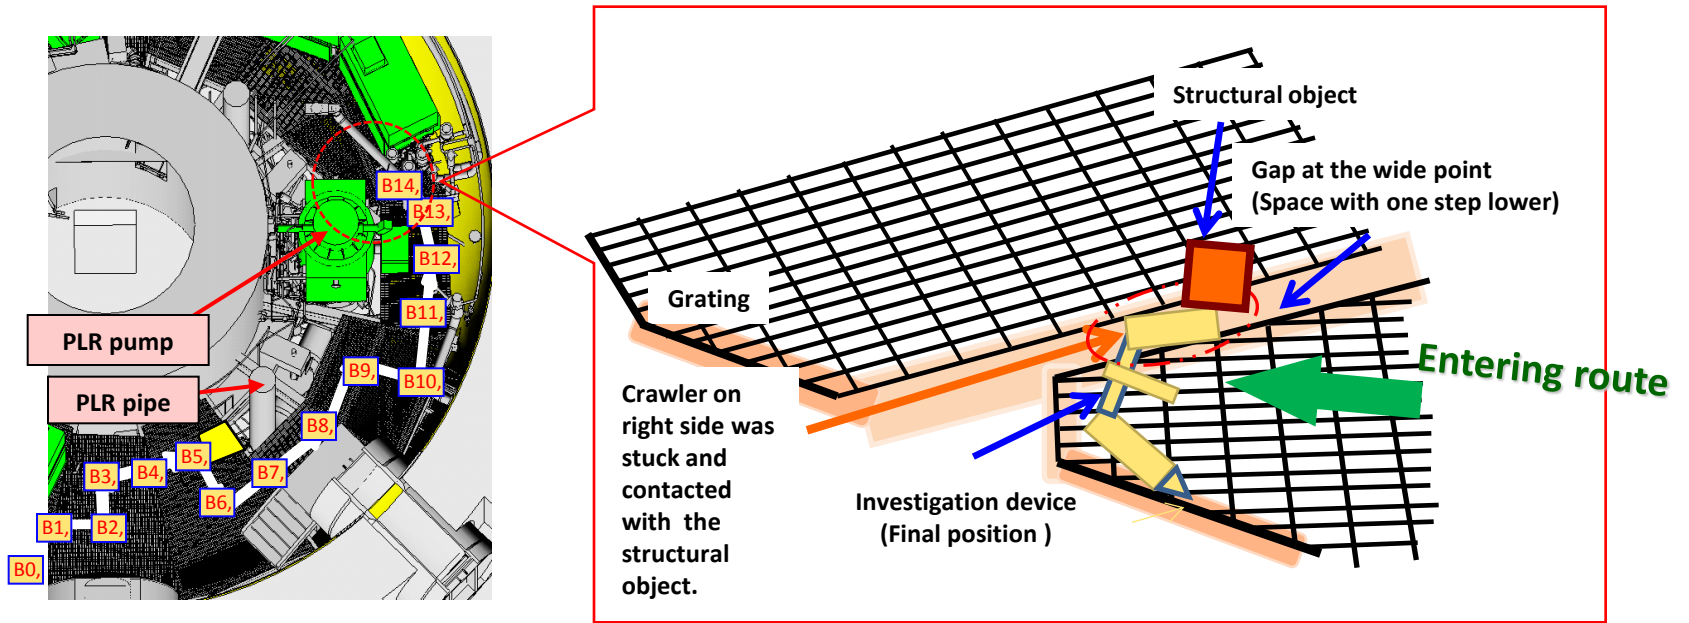
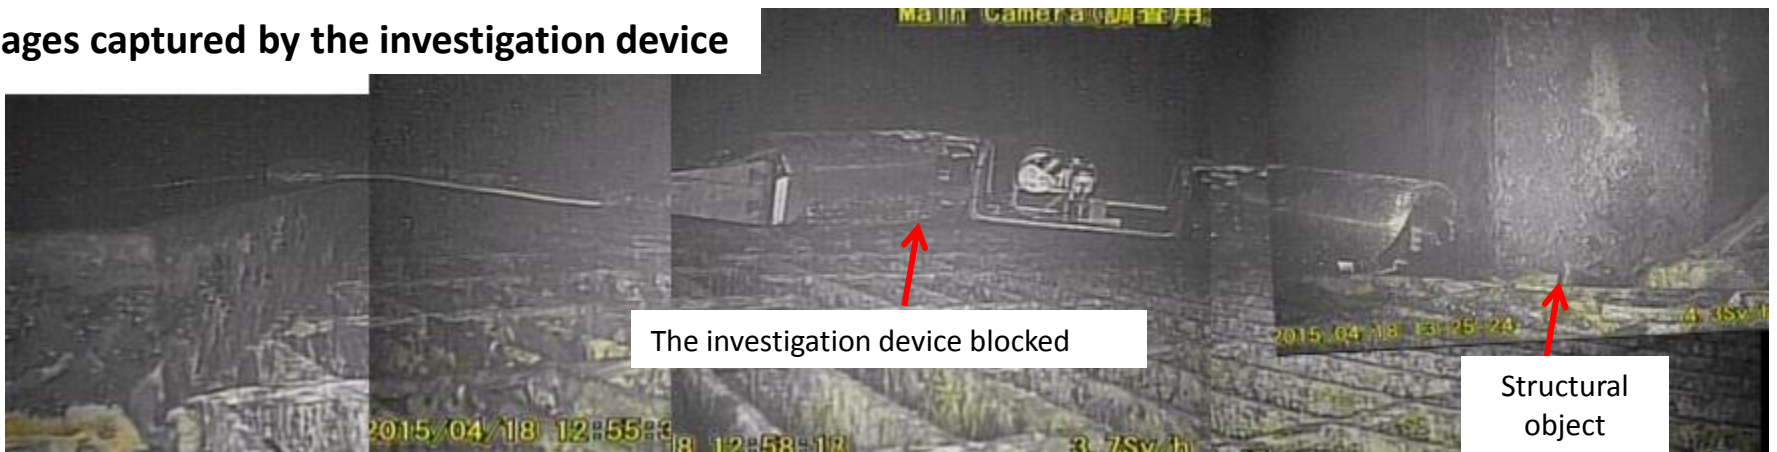
3. Status of the investigation device blocked

The situation of the investigation device blocked is shown as below, which is almost compatible with what has been assumed.

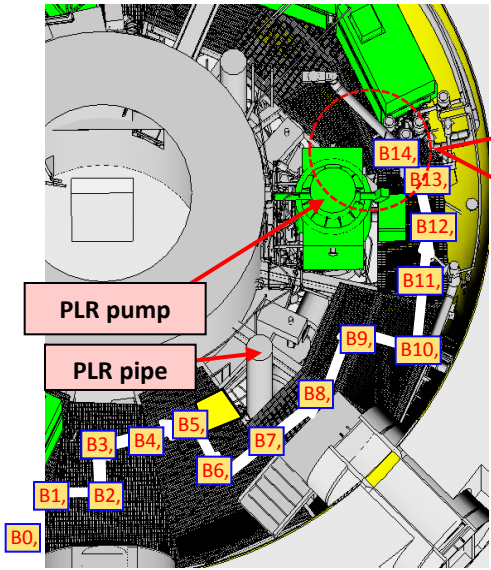
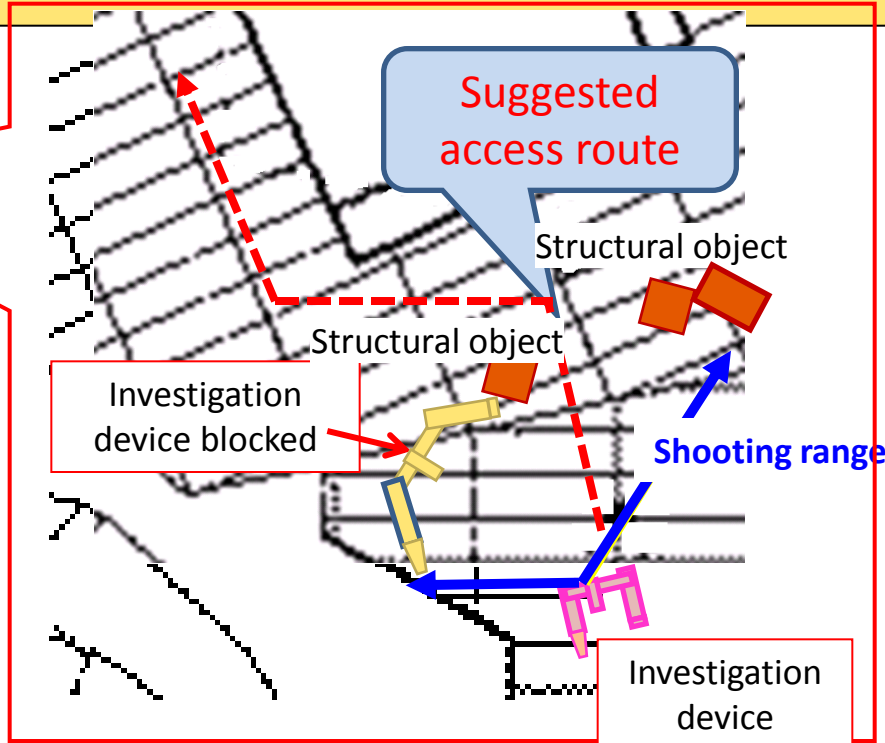
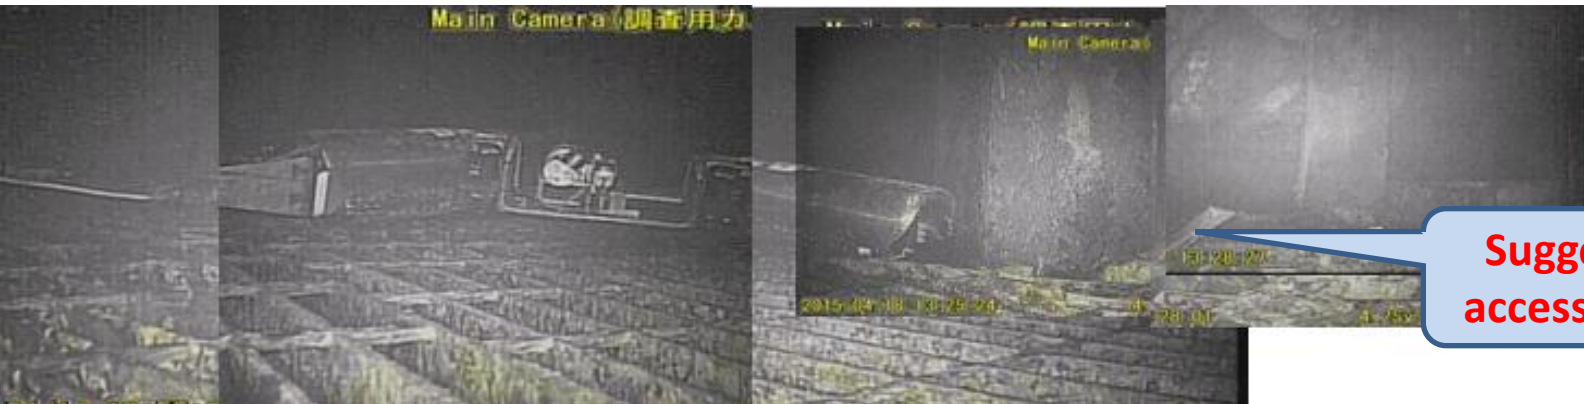
4. Check on the access route to CRD rail

It was judged that the suggested access route to CRD rail would be **too narrow to get the device pass through between the two structural objects.**

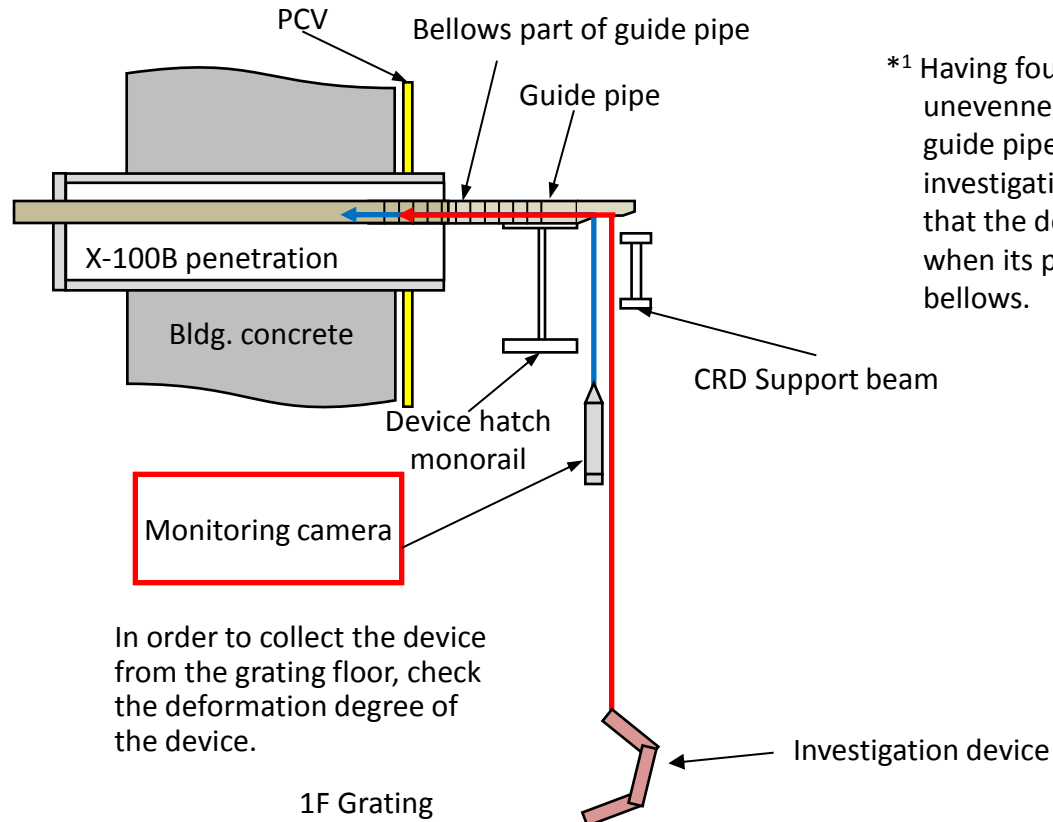
5. Collection of the investigation device

- Earning information inside the reactor primary containment vessel, which is the main purpose of this investigation, has been achieved.
- Due to the deterioration of the monitoring camera with radiation, it became disabled to perform a deformation check on the device. Accordingly, the collection of the device to outside the reactor primary containment vessel has been judged as risky. (*1)

*1 Having found that there is a slight unevenness at the bellows part of guide pipe when inserting the investigation device, there is a risk that the device might get stuck when its passing through the bellows.

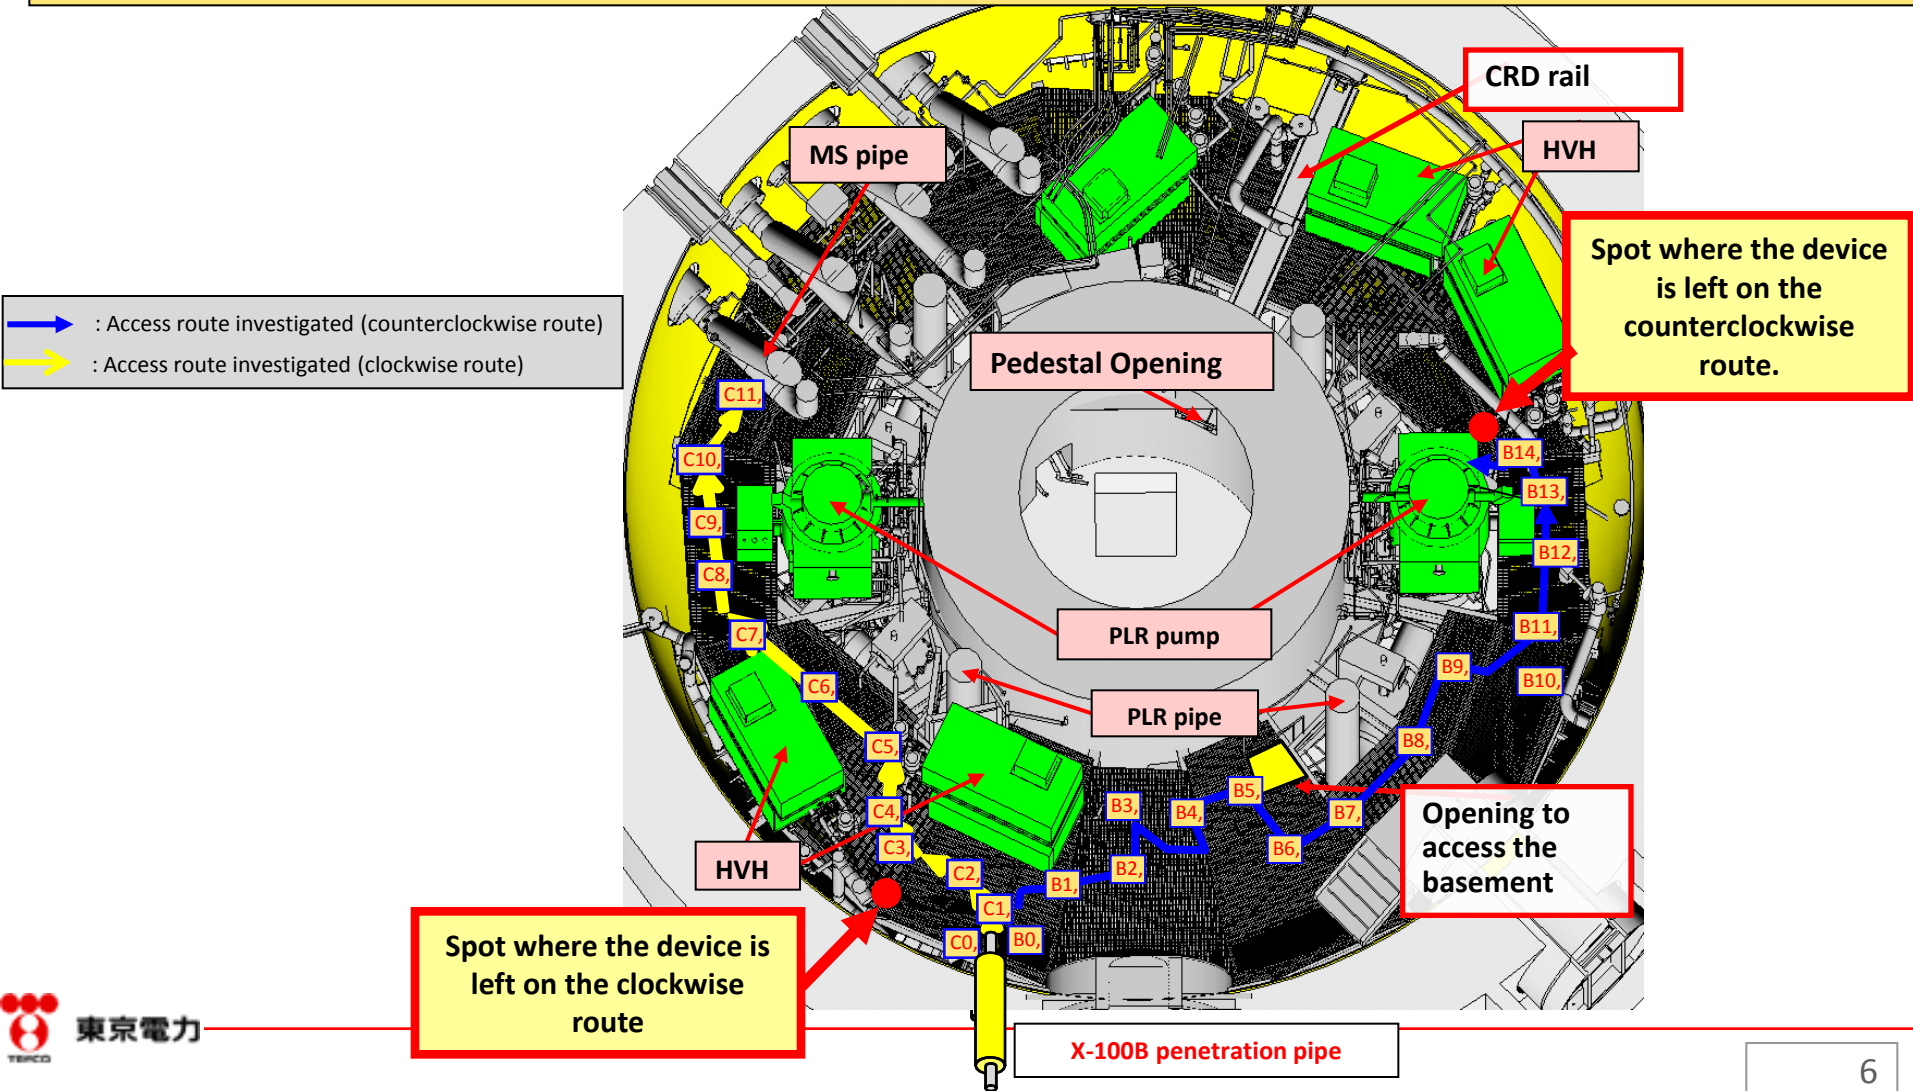
6. Leaving the investigation device

- Locations where the devices are left are shown as below. Those are places that are able to retain the devices in a stable state.
- The remaining devices will be no obstacle to B2 investigation.

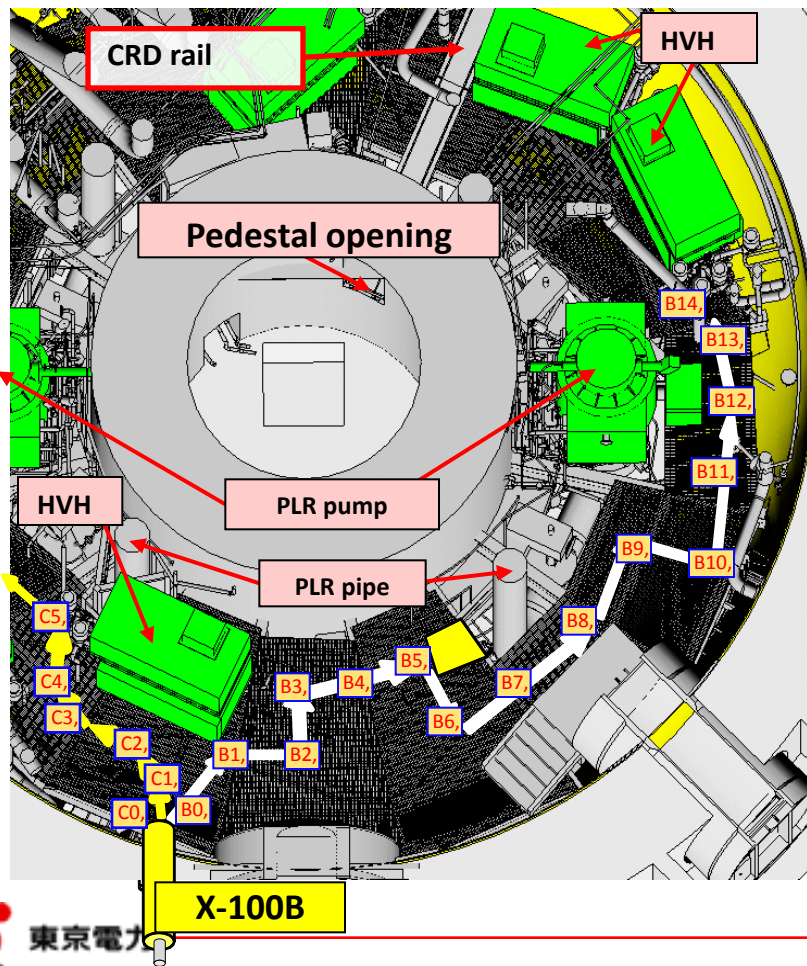
(Reference) Measurement on temperature/ dose rate

Temperature and dose rate were measured at the following points.

| | Dose rate (Sv/h) | Temperature (°C) |
|---|---|---|
| Around B14 | 4.4 | 17.9 |
| Around B11 | 5.7 | 18.7 |
| Around B7 | 5.9 | 19.1 |
| Final point (around C3) | 4.1 | 20.4 |
