IRID In-house Project

Development of Technology for Detailed Investigation inside Primary Containment Vessel (PCV) (On-site Demonstration of Technology for Detailed Investigation Considering Deposit Measures)

FY2021 Accomplishment Report

International Research Institute for Nuclear Decommissioning
(IRID)

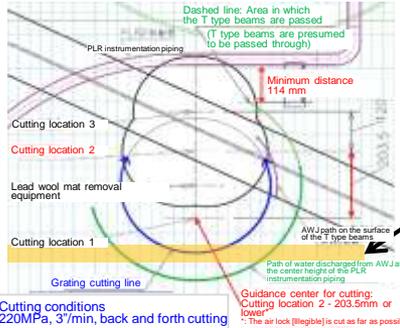
The distance from the nozzle to Conduit E-1 is approx. 1.1m, and hence it is presumed that a part of the conduit would get cut and cut off due to passage of the water discharged from AWJ.

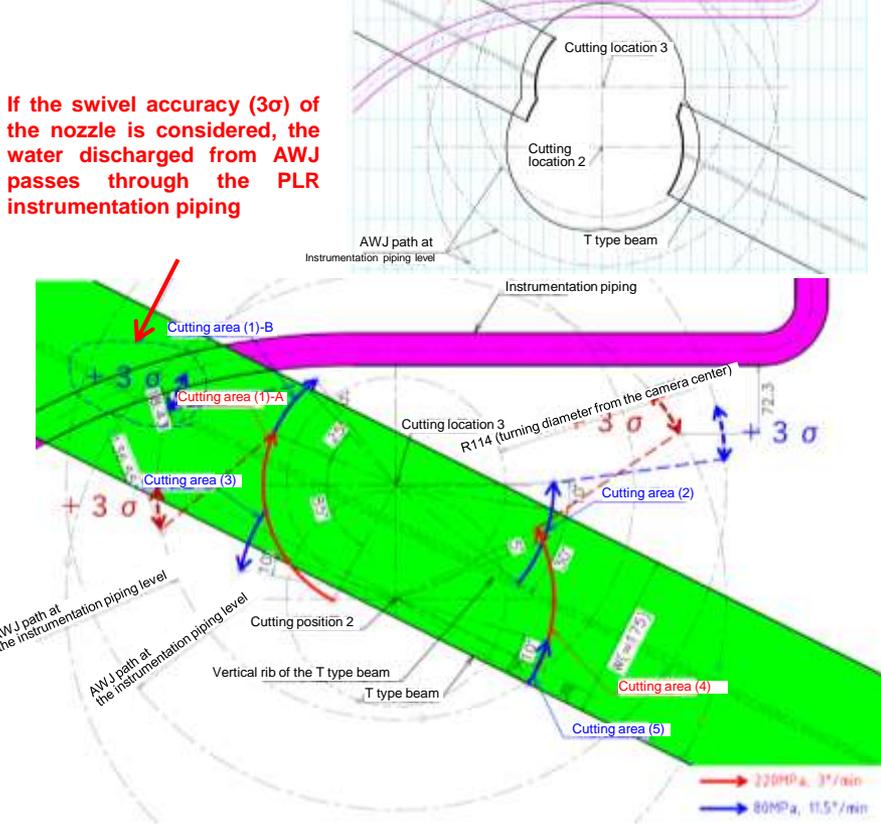
- It was verified that the water discharged from AWJ while cutting the T type beam is likely to pass through the PLR instrumentation piping.
- The impact can be reduced (minor thinning) by using a discharge pressure of 80MPa.

If the swivel accuracy (3σ) of the nozzle is considered, the water discharged from AWJ passes through the PLR instrumentation piping

- Avoiding any impact of cutting on the PLR instrumentation piping was given priority and the ROV insertion route was narrowed down to Plan 1 and Plan 2-1.

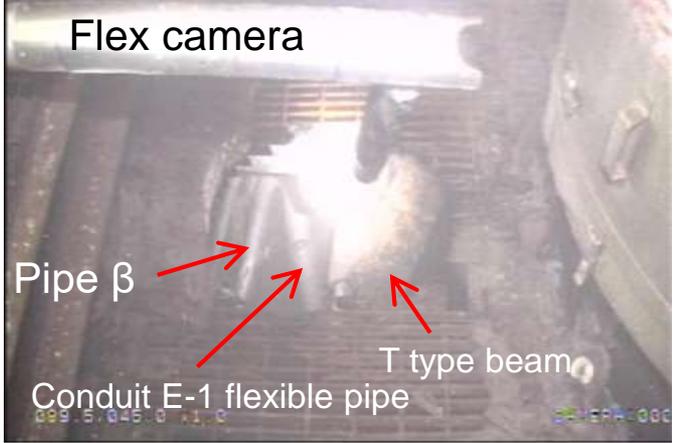
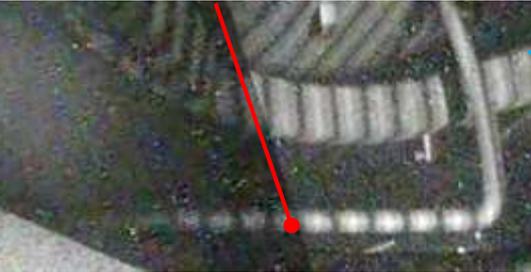
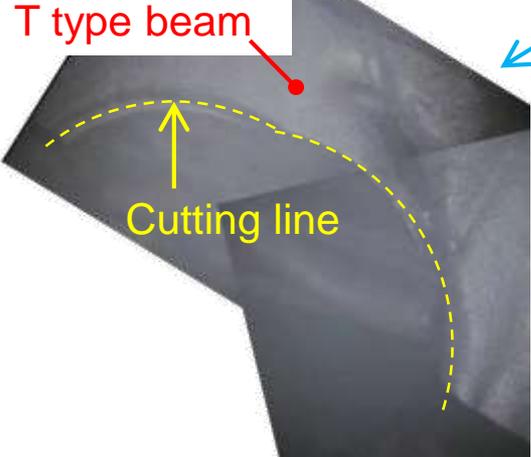
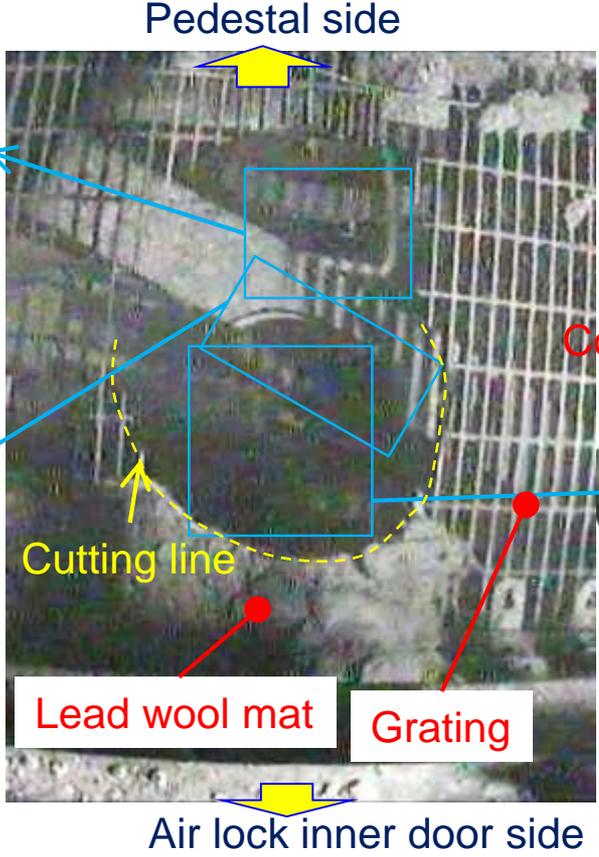
- The situation of Conduit E-1 was confirmed after cutting the lead wool mat and grating and the T type beam.
- It was found that the flexible side conduit had been cut and was hanging down.

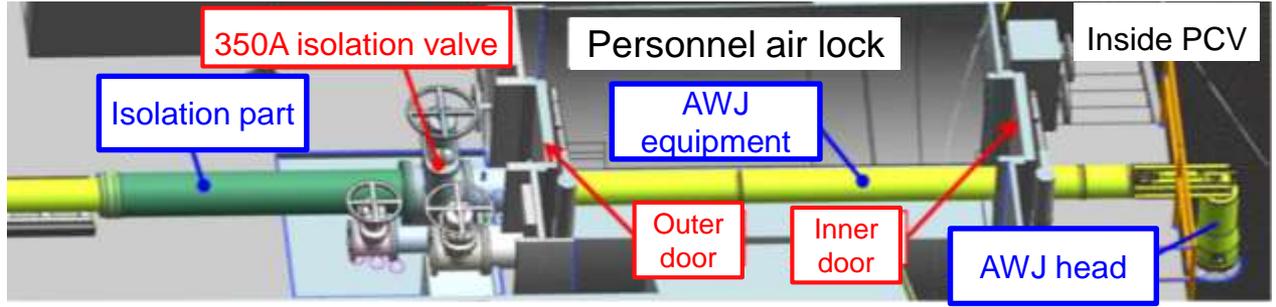
Figure 4.1.2 (1) (ii)-1 Status at the time of removal of lead wool mat / cutting of grating

Removal of lead wool mat, and cleaning and cutting of the grating were completed as planned.

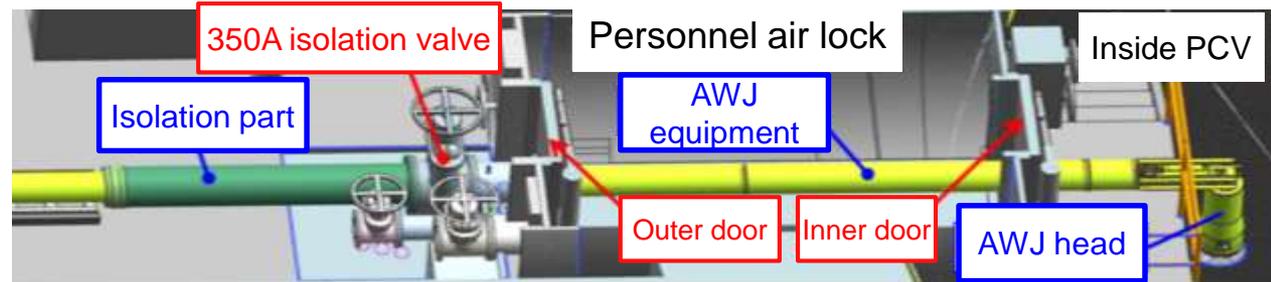
Figure 4.1.2 (iii)-1 Cutting the T type beam

- The 0° cut (first time) was too close to the longitudinal rib and the cut could not be made. Hence the position was moved 5mm and the cut was performed again (second time).
- Cutting was completed at positions by and large as per the plan.

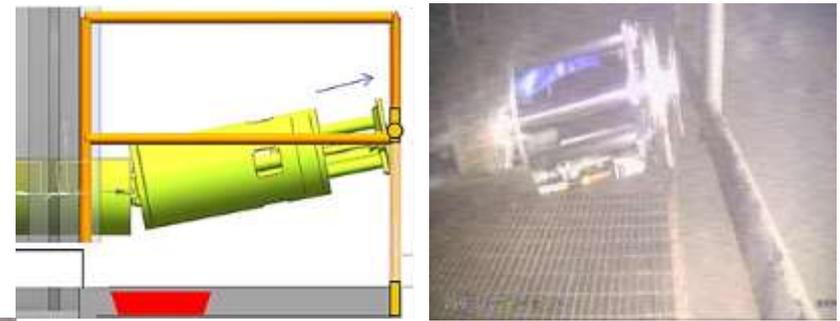
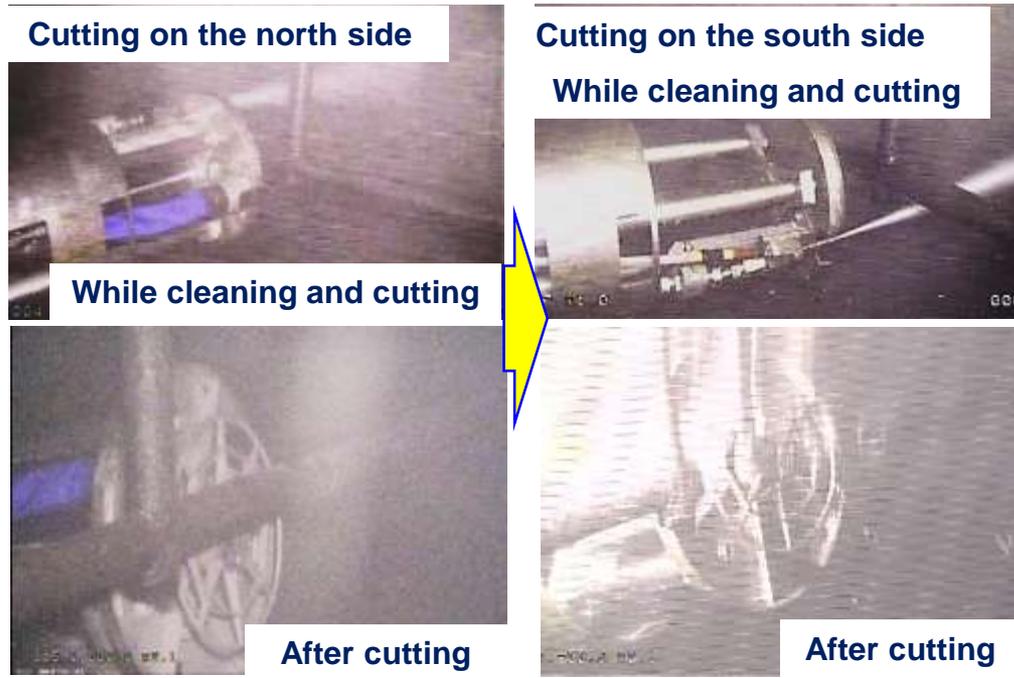
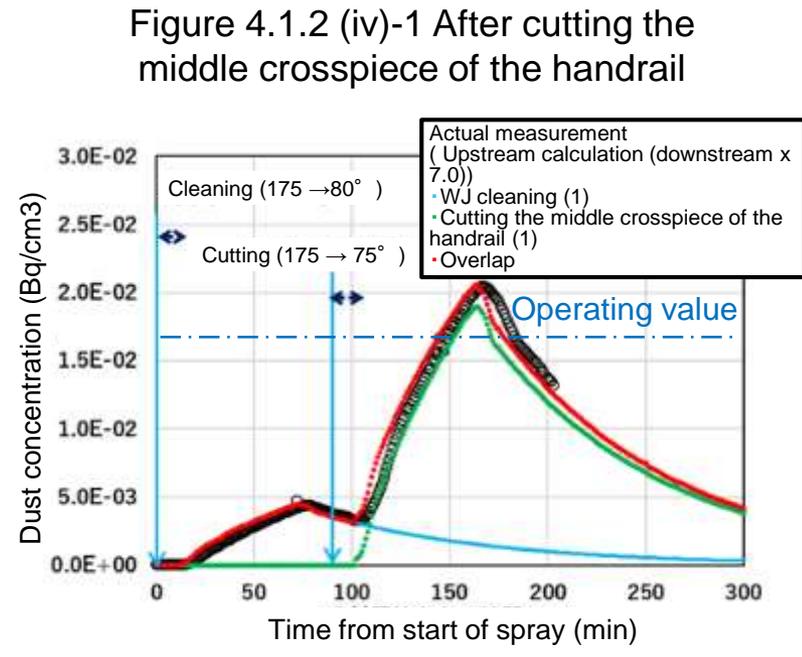
Figure 4.1.2 (iv)-1 Status while cleaning / cutting the middle crosspiece of the handrail and after cutting

- Cutting was completed at positions as per the plan.
- At the time of cutting on the north side, dust inside PCV increased beyond the operating value ($1.7 \times 10^{-2} \text{Bq/cm}^3$), but it was lower than the maximum dust recorded in the past and there was no impact on the outside.

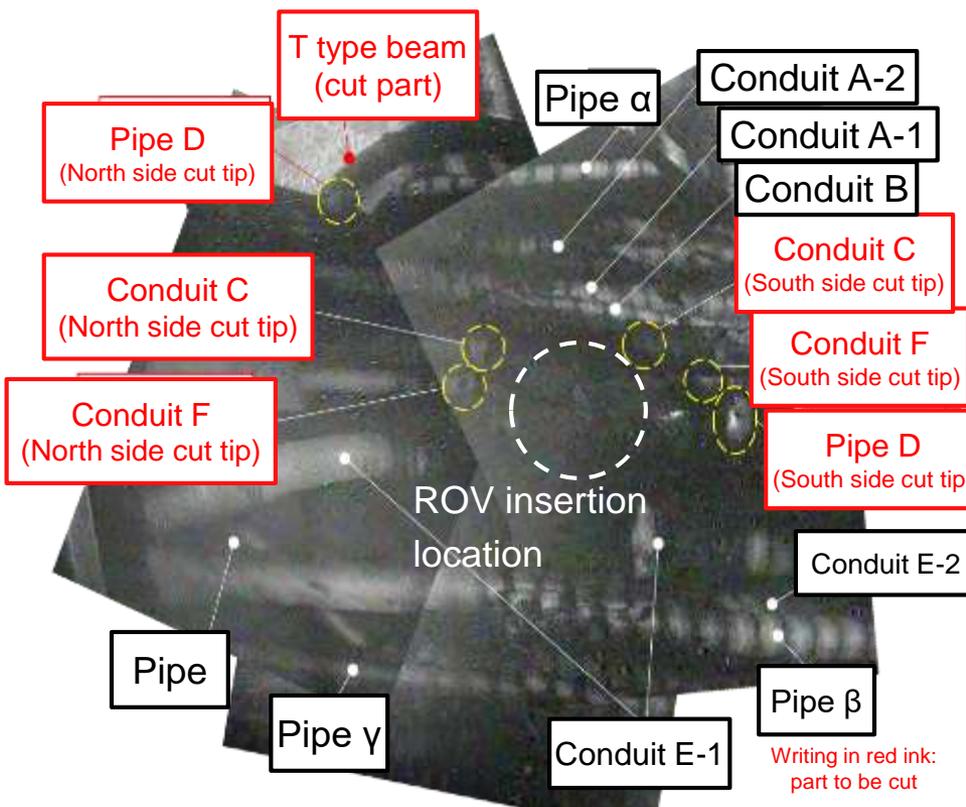
Figure 4.1.1 (v)-2 After cutting the conduits

- Cutting of Pipe D, Conduit F and Conduit C was completed as per the plan.
- The conduits were cut continuously for a maximum of approx. 60 minutes, but the dust level inside PCV was low on the whole.

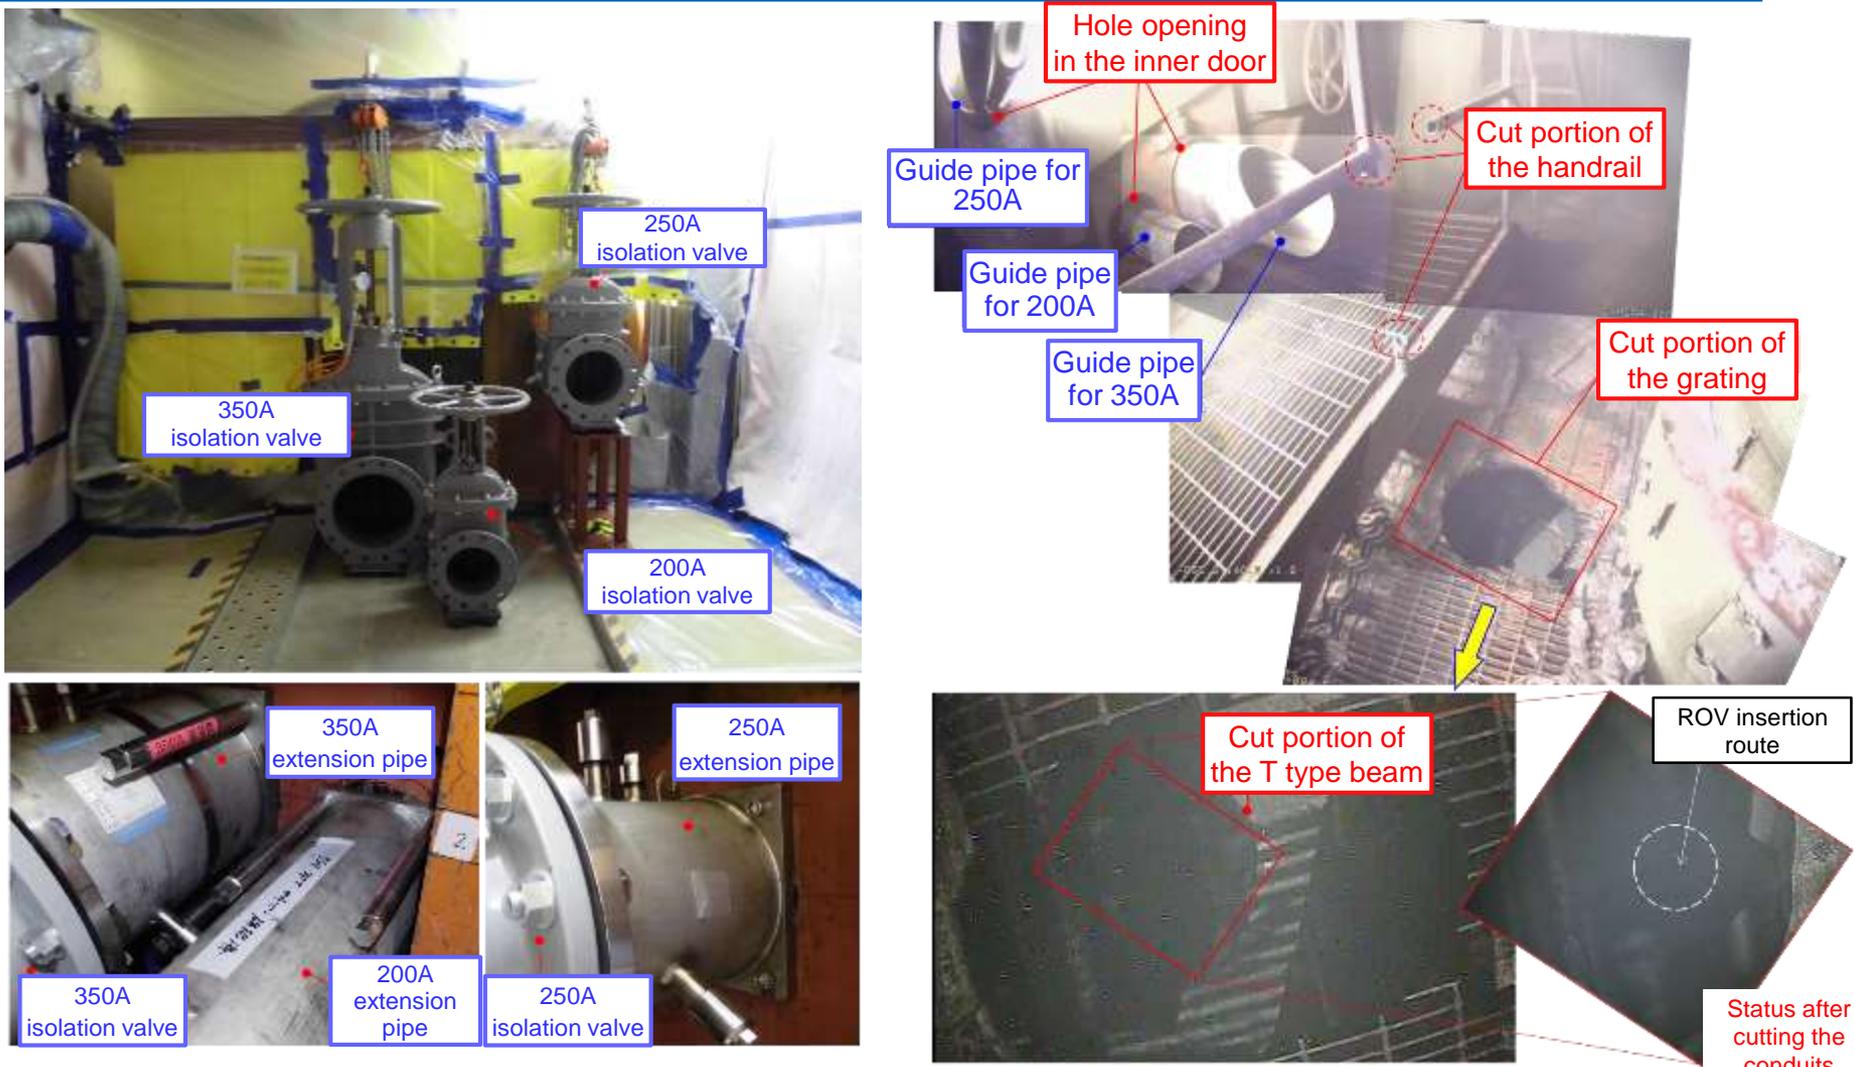
Figure 4.1.2(2)-2 External appearance after completion

- Three guide pipes were installed as scheduled.
