Overview of IRID R&D Focusing on Debris Retrieval

16th October 2017

**International Research Institute for Nuclear Decommissioning
(IRID)**

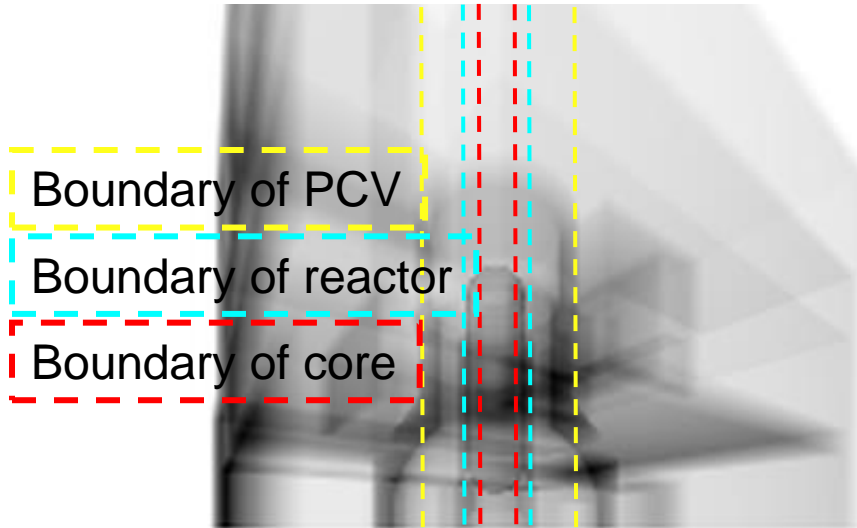
Detection of Fuel Debris using Cosmic Ray MUON at Unit 1

High density material (fuel) is not detected at the area where the reactor core was originally located.

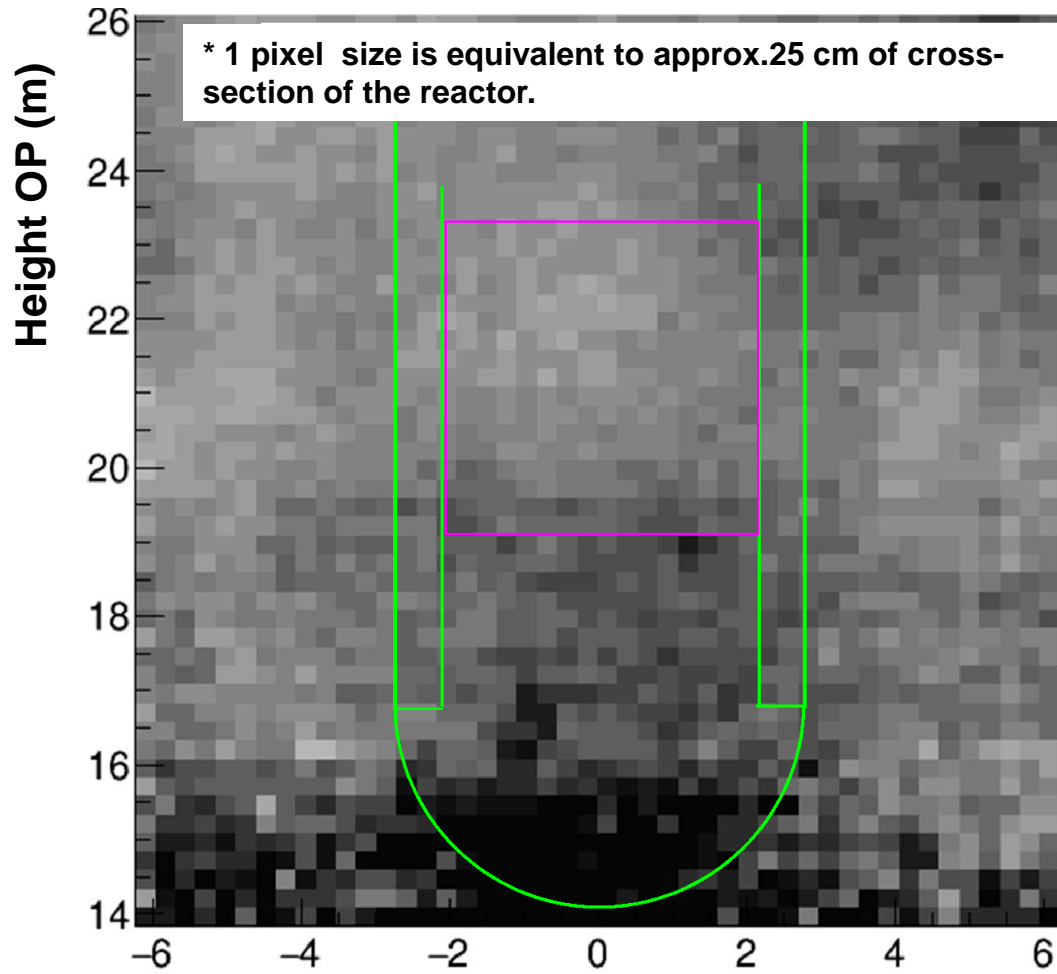
Investigation using MUON at Unit 2

■ Confirming the high density material shadow that is assumed to be fuel debris at the bottom of RPV.

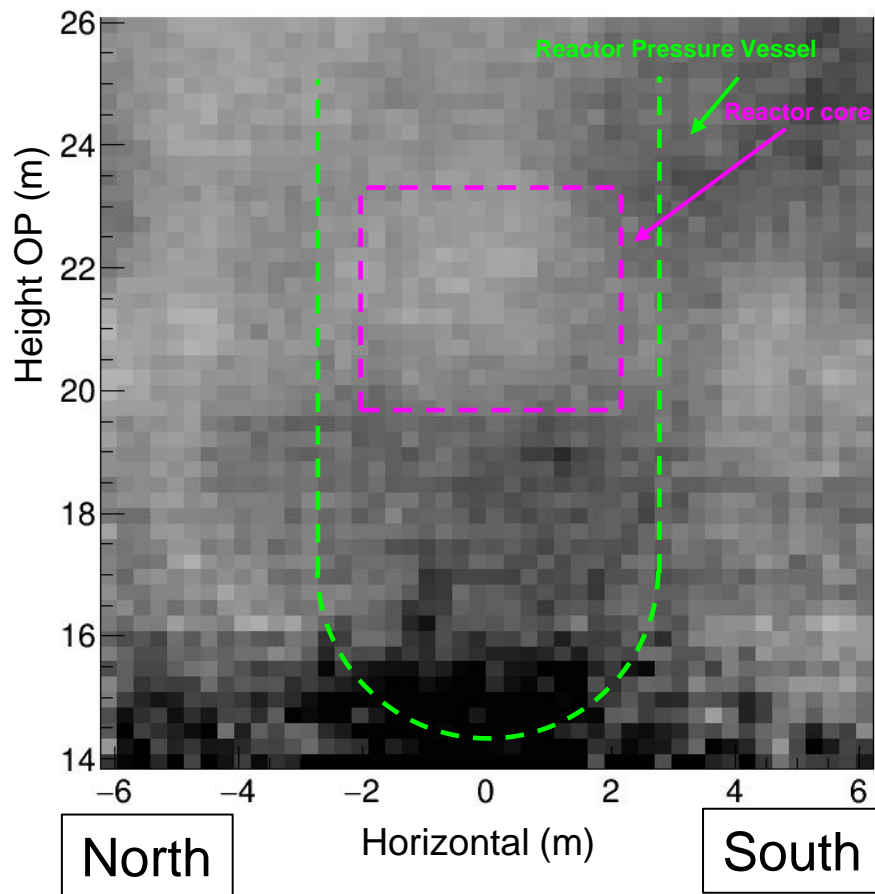
- Assuming the high density material that exists at the bottom of Unit 2 RPV.
- Not confirming the high density material at Unit 3 RPV that is assumed to exist at the Unit 2 RPV.

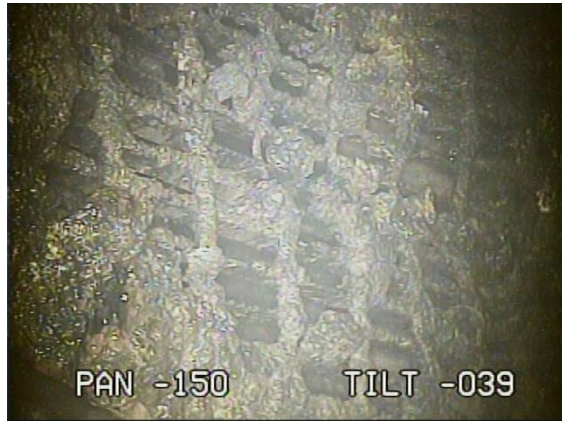
Accretion of the grating

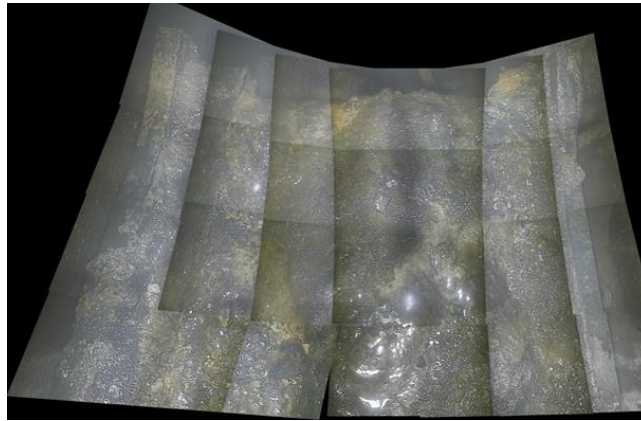
Sediments on CRD rail

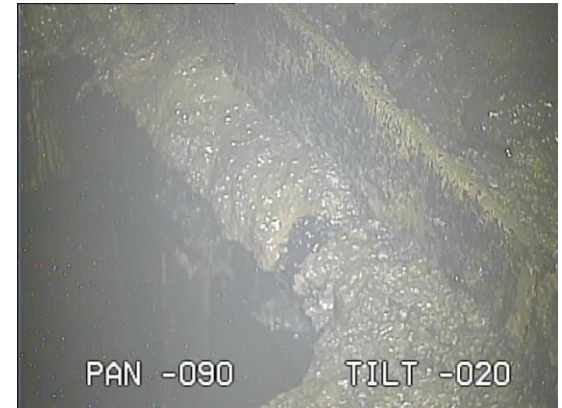
Crack of platform grating

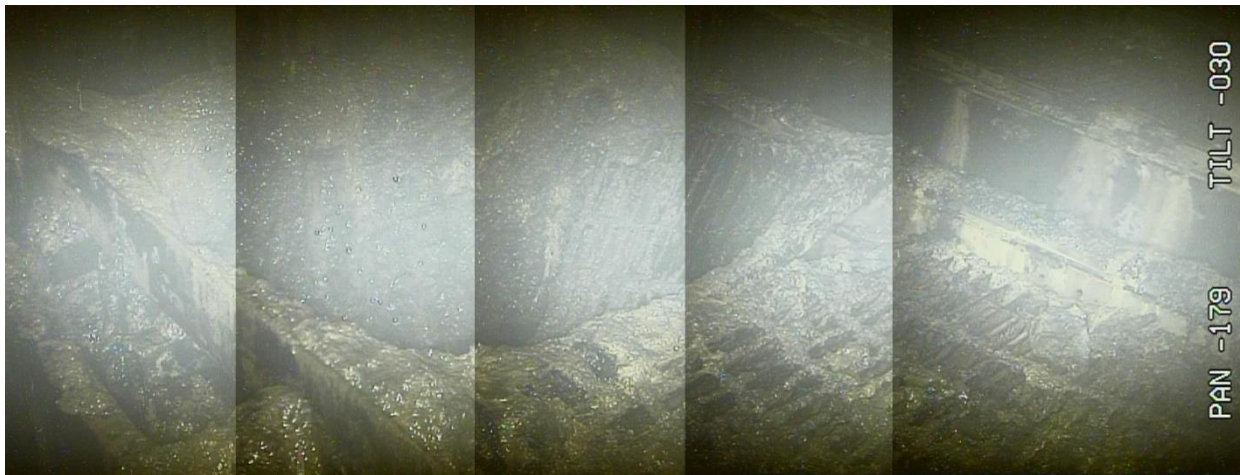
Deformed platform

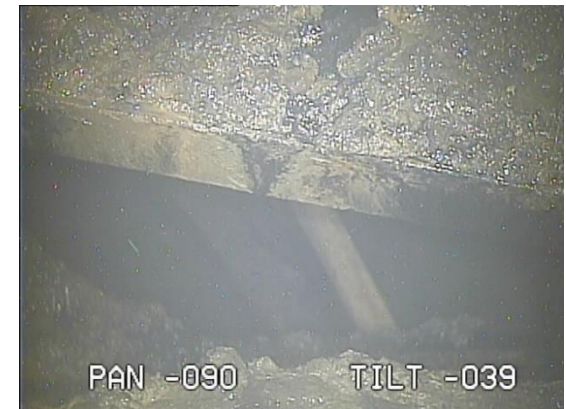
Gap between platform and CDR rail

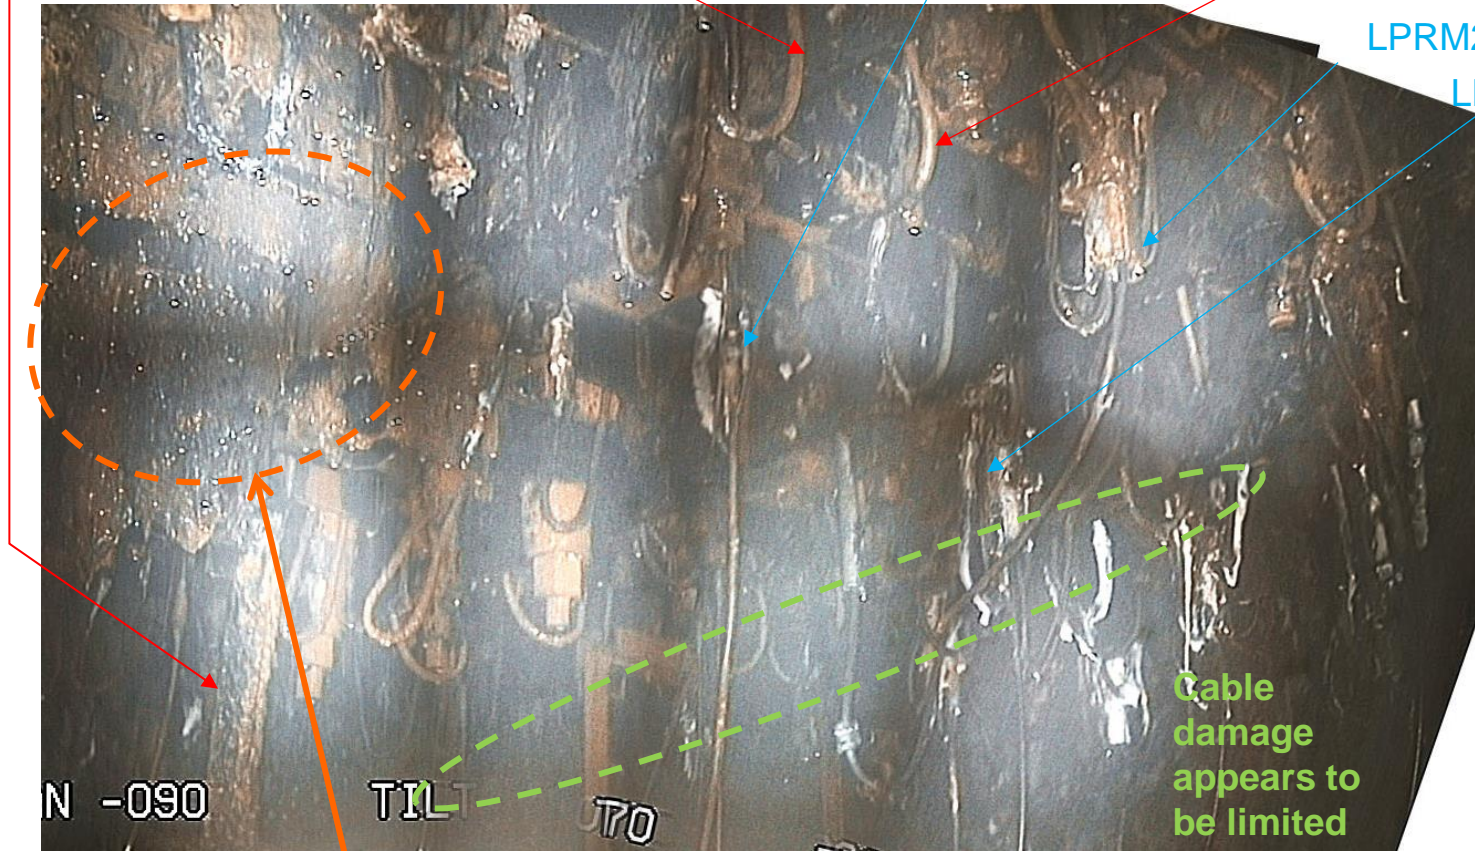
Inside the pedestal (upper section of platform, middle-right side)

Cable damage appears to be limited

Area where PIP cables and LPRM cannot be confirmed
