“Development of a technology to investigate inside the Reactor Primary Containment Vessel (PCV)”

-- Site test “Investigation B1” on grating around the pedestal inside Unit 1 PCV -

April 13, 2015

Tokyo Electric Power Company

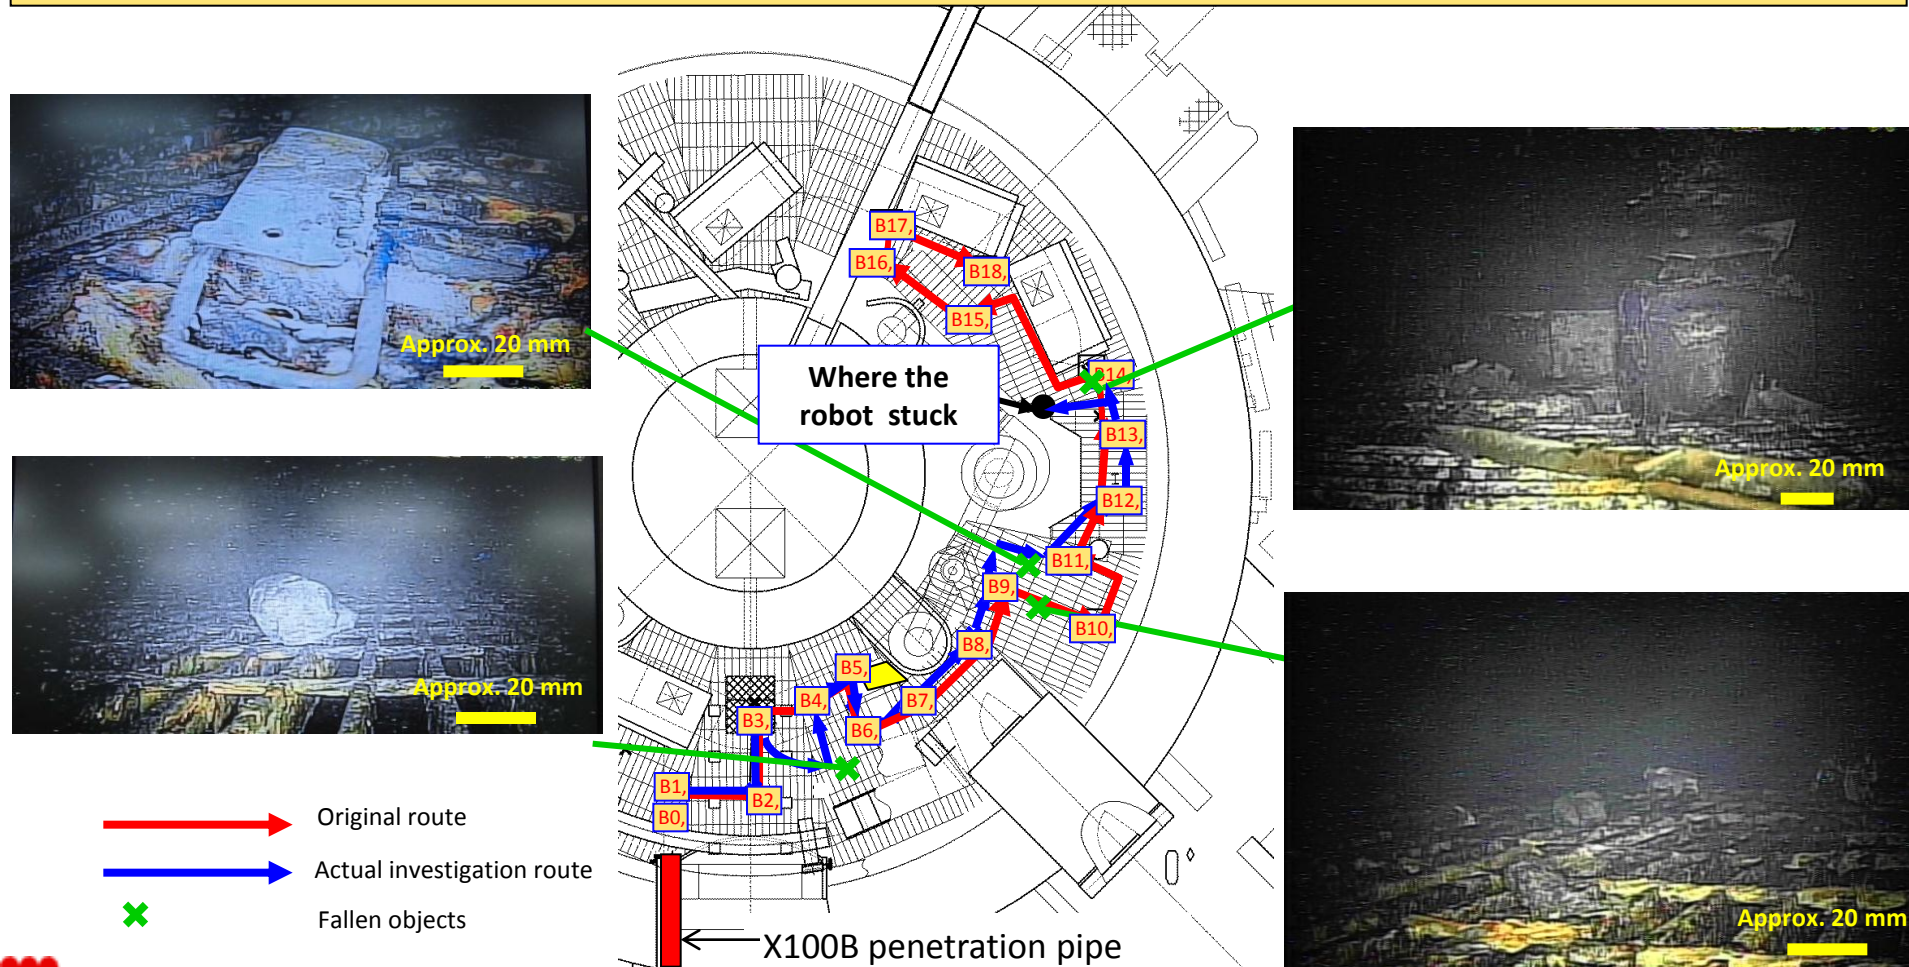
- The investigation was conducted taking on a different route as some objects were found to be fallen on the original access route planned.
- The robot was stuck on the route between B14 and B15.

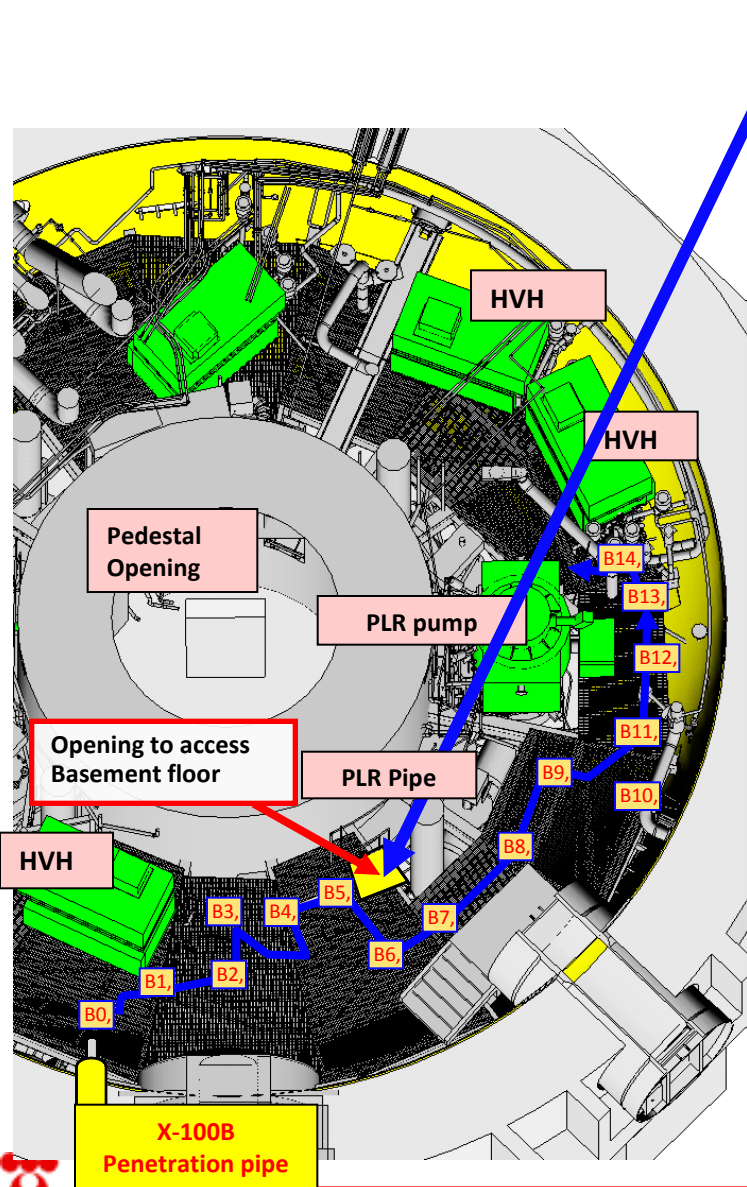
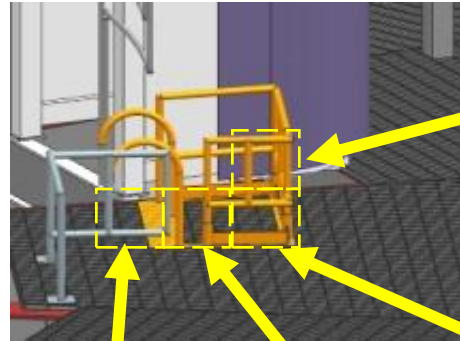
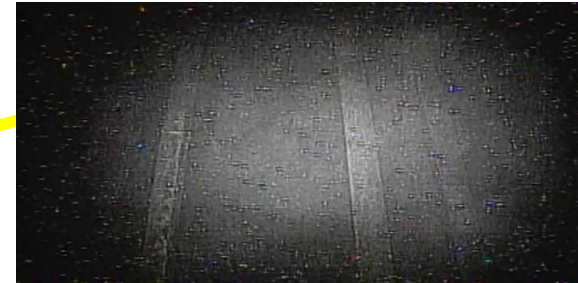
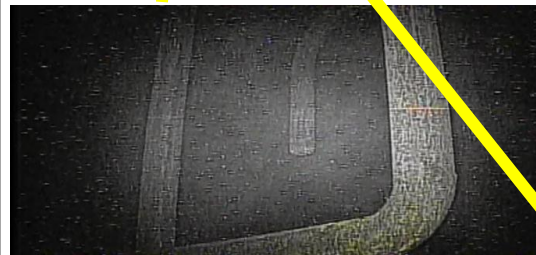
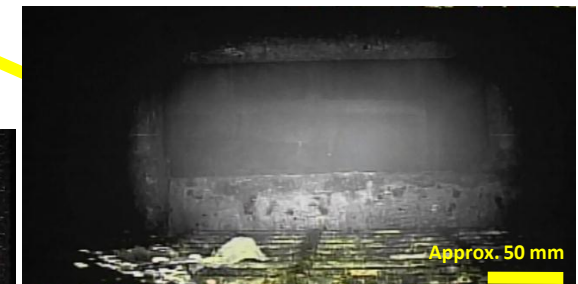
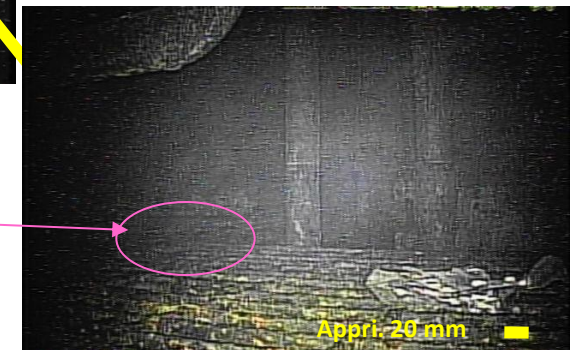
B4

With B2 investigation to be conducted next time, TEPCO confirmed there is an opening accessible to the basement as well as no obstacles around it.

Spot where the robot can be inserted.

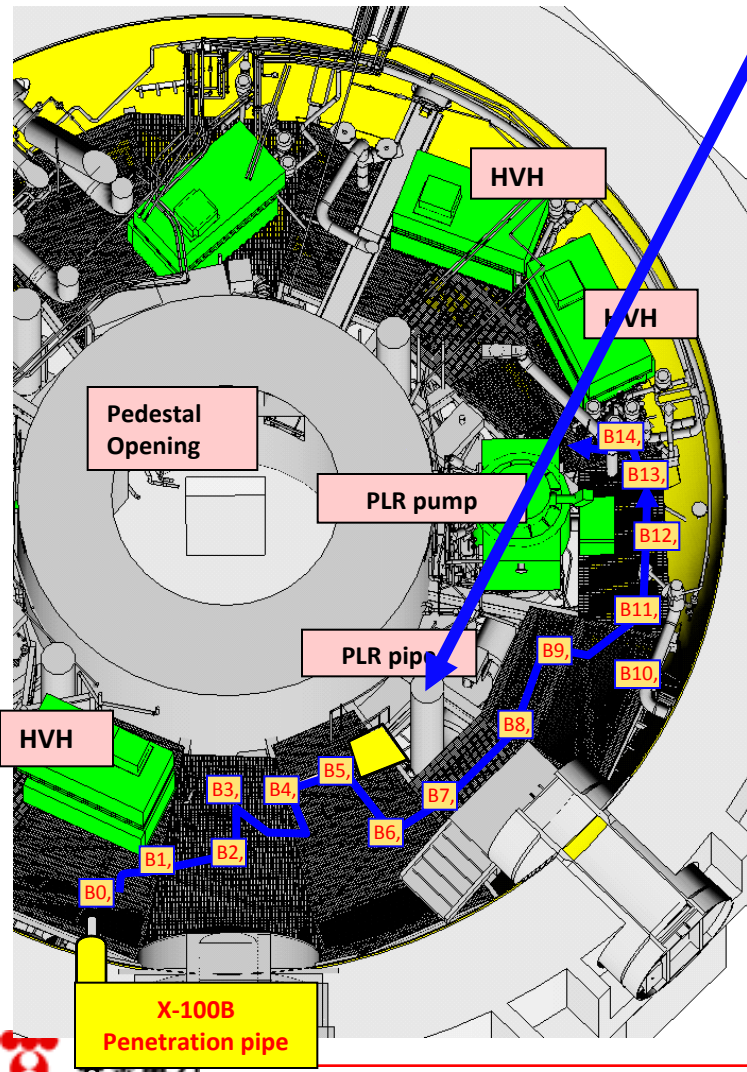
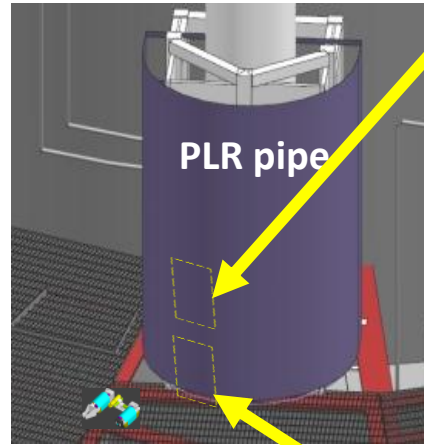
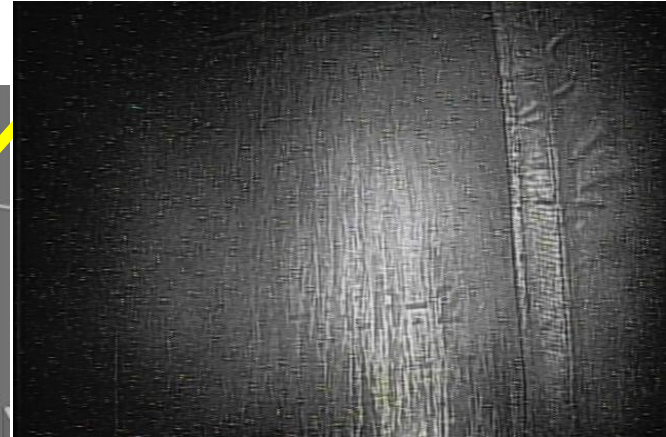
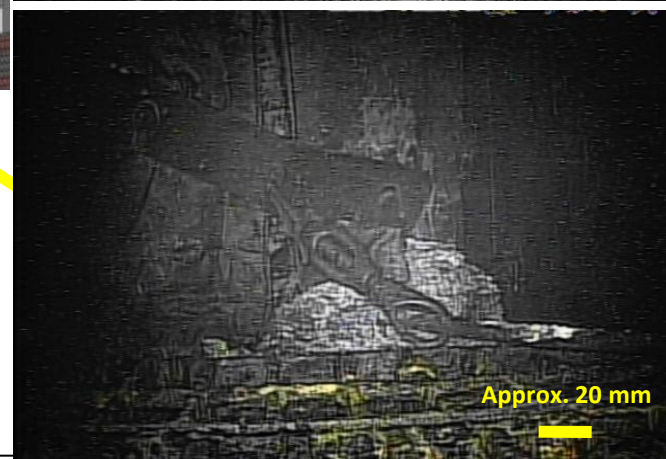
B7

- No significant damages were found on the PLP pipe (for heat retention).
- It was found that a part of the shield has been fallen off.

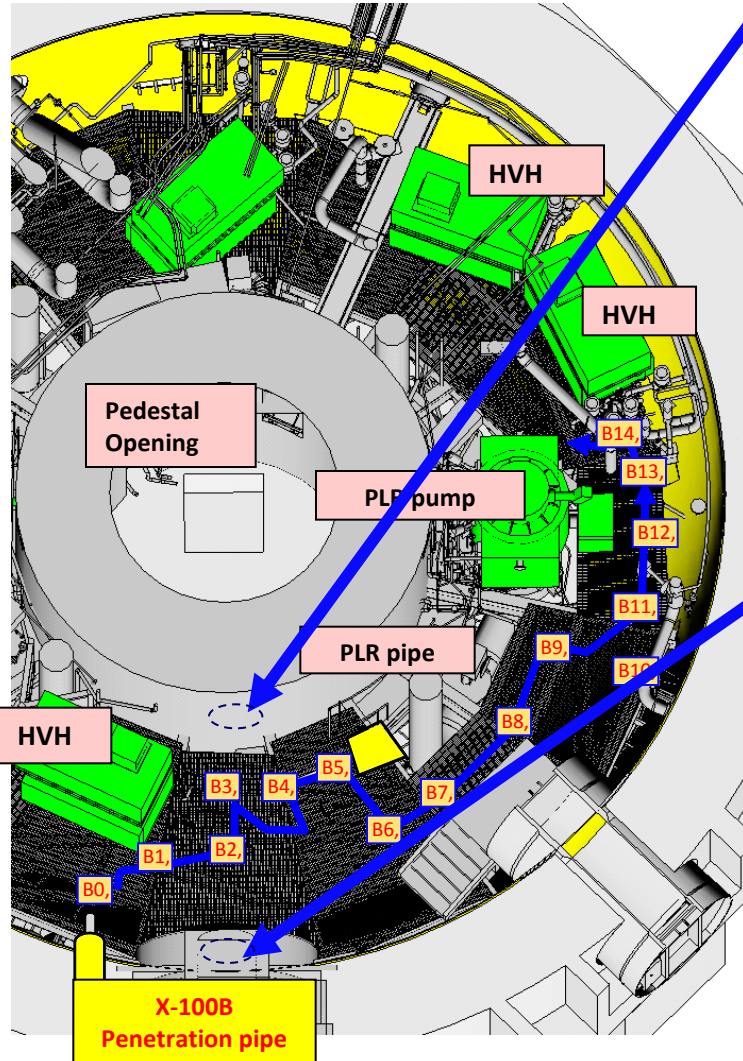
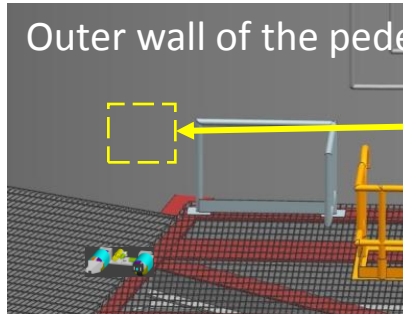
B3

Exterior of the outer wall of the pedestal

No significant damages were found on the outer wall of the pedestal.

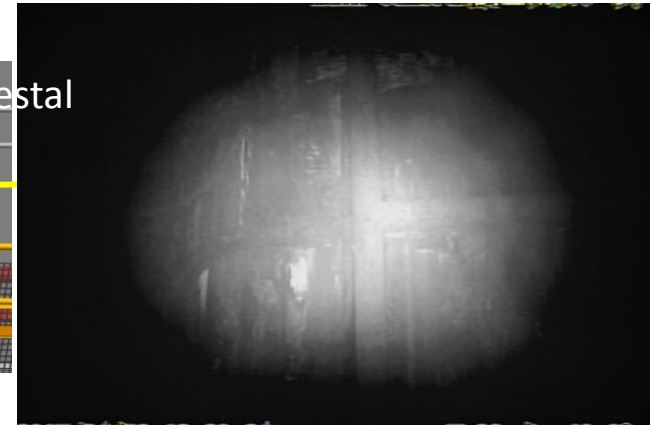
B2

Exterior of the equipment hatch.

No significant damages were found on the equipment hatch.

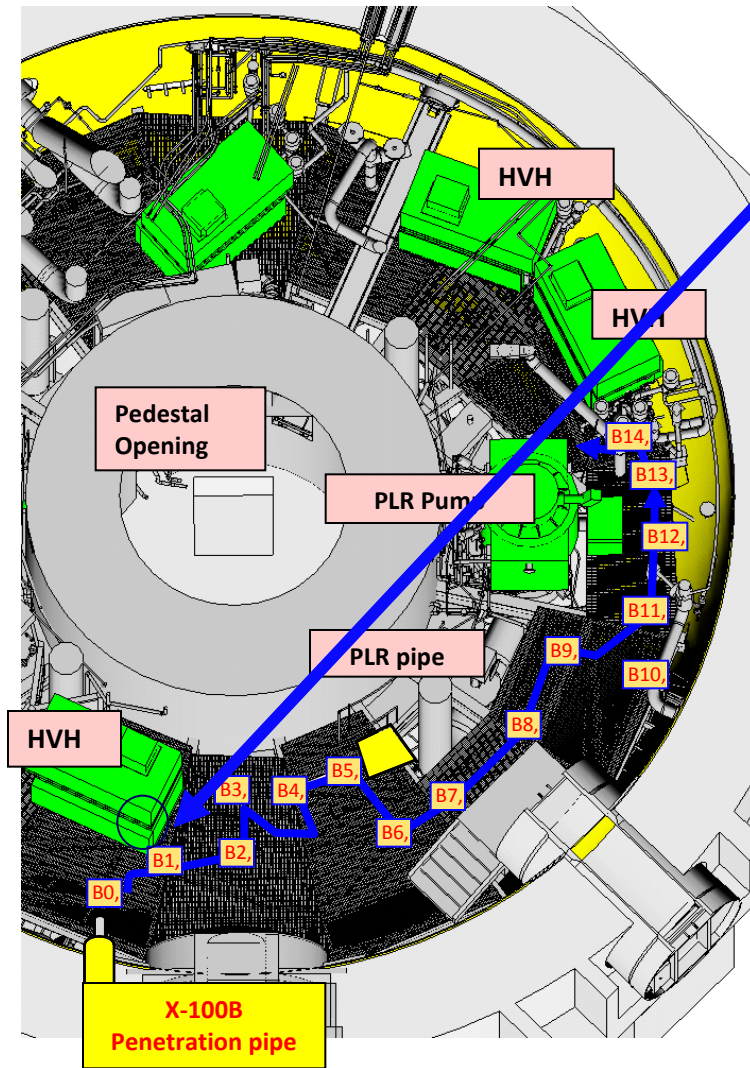
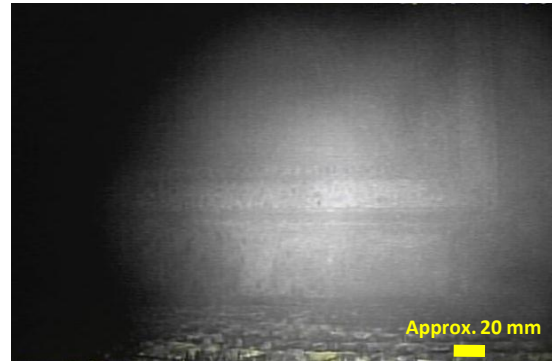
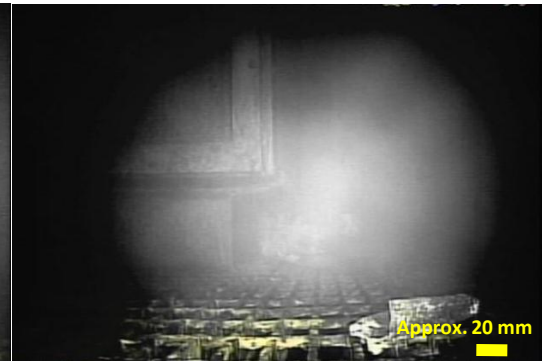
B1

No significant damages were found on HVH (D).

HVH (In the center at the bottom)

HVH (At the edge of the bottom)

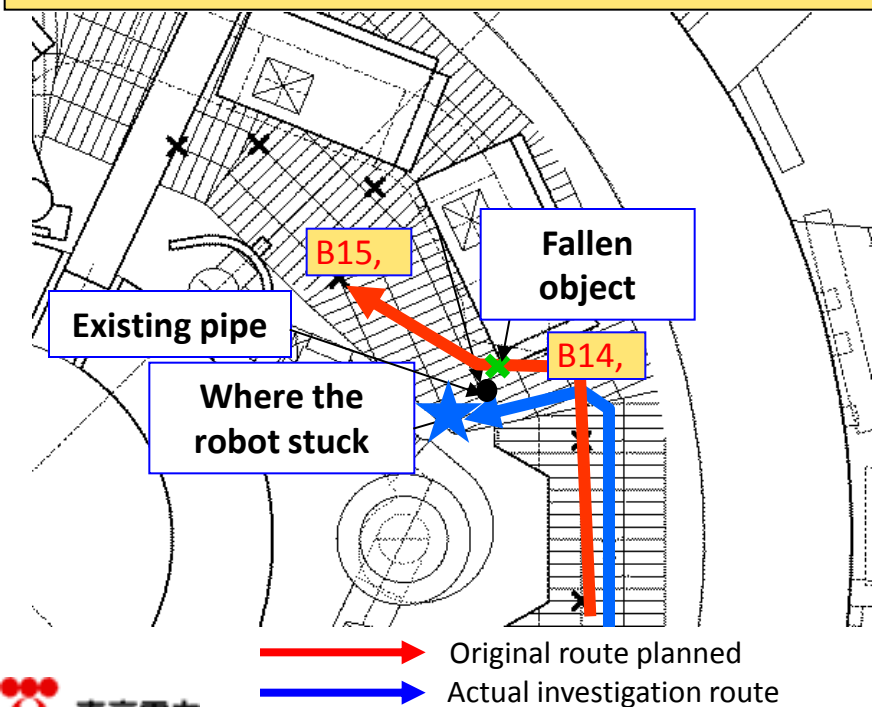
- Object was found to be fallen on the planned route between B 14 and B 15 where was the narrowest part of it.
- Following the procedures, the investigation continued by choosing another route avoidable the objects.

- After that, although the robot stuck at a narrow point, it captured some images facing to the direction of CRD rail. (currently the images are under evaluation)

The robot got stuck with an existing pipe and some shut parts of the grating or uneven part at the joint, which resulted in making the route hard to run on.

Measures to be taken are under study.

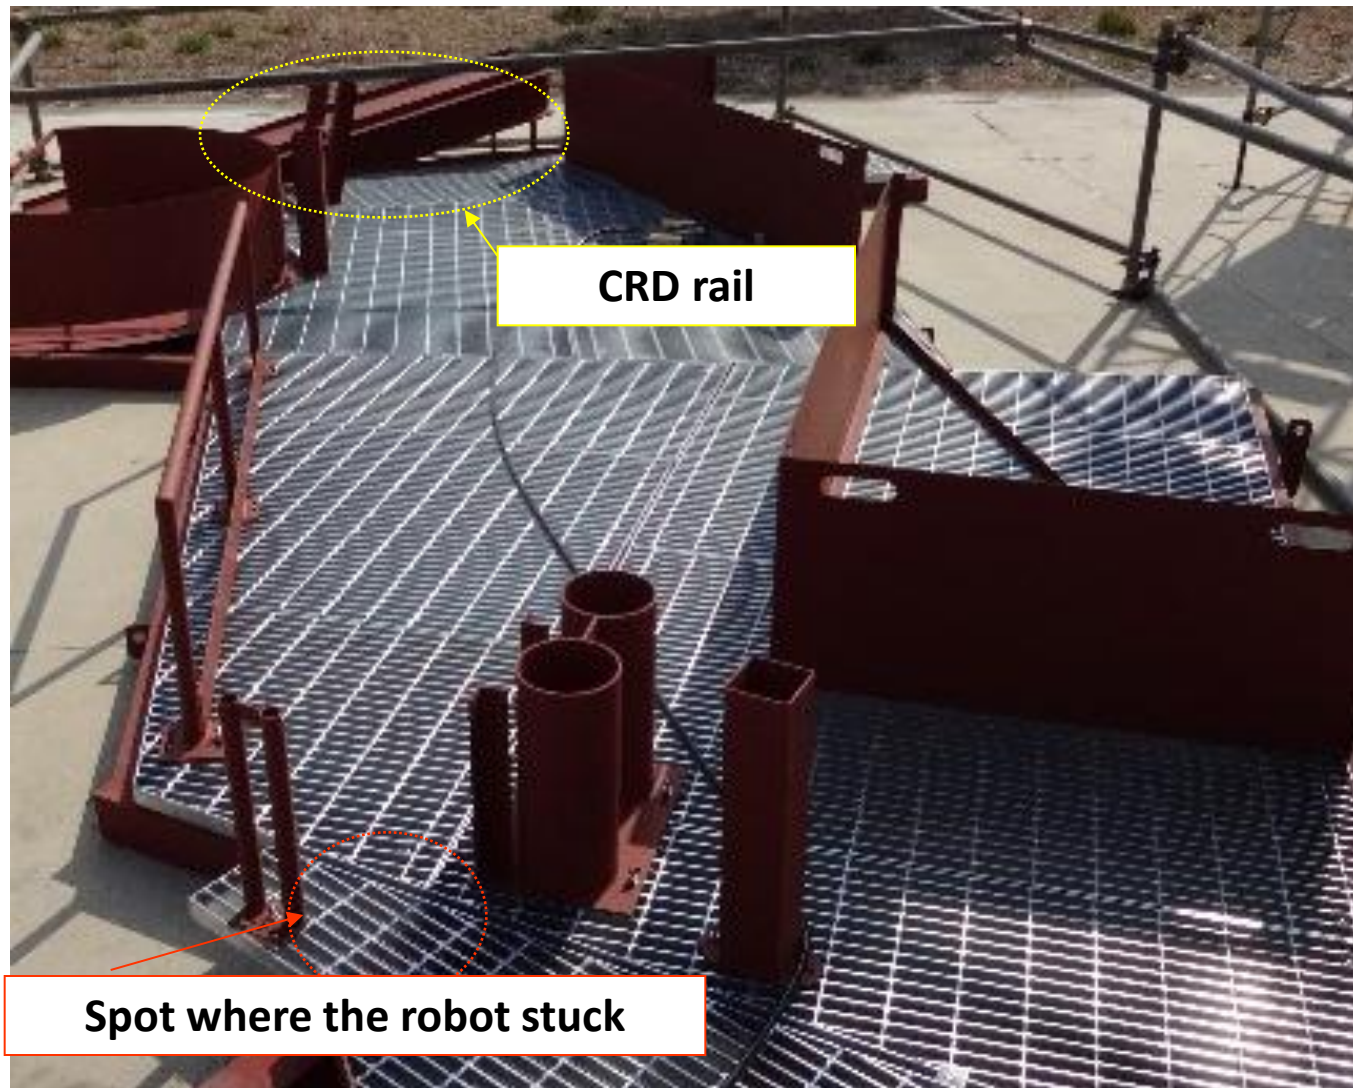
Spot where the robot stuck
