“Development of a technology to investigate inside the Reactor Primary Containment Vessel (PCV)”

**- Results of site test “Investigation B1” on grating around the
pedestal inside Unit 1 PCV -**

April 30, 2015

Tokyo Electric Power Company

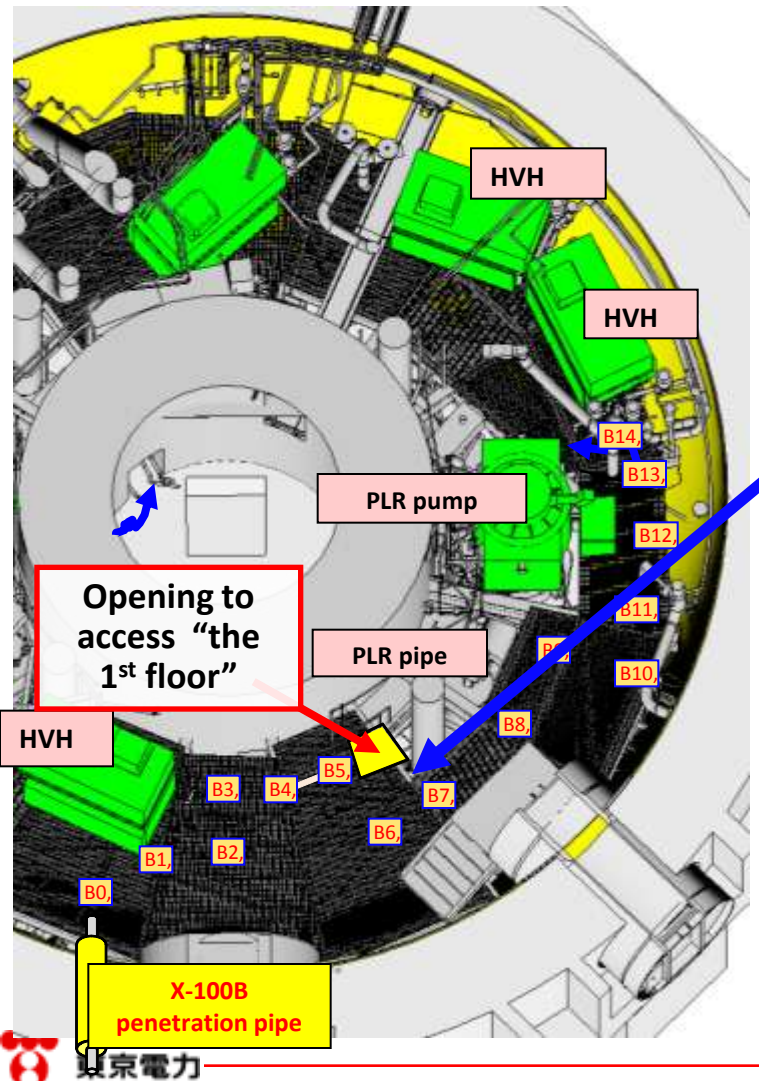
Taken from B4

- It was confirmed that there is an accessible opening at the basement for B2 investigation planned to be conducted, and thus, there are no obstacle objects existed around it.

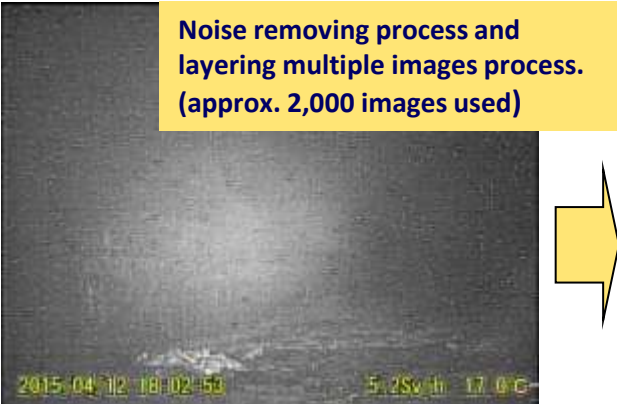
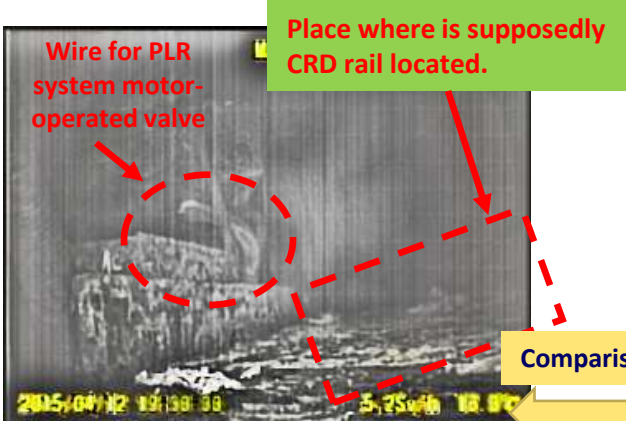
Image (taken at 6:00 PM, Apr. 12)

■ Shooting was performed towards the direction of CRD rail at the end point where the device reached at (around B14) during the investigation along counterclockwise route. The images taken were processed but CRD rail could not be visually identified.

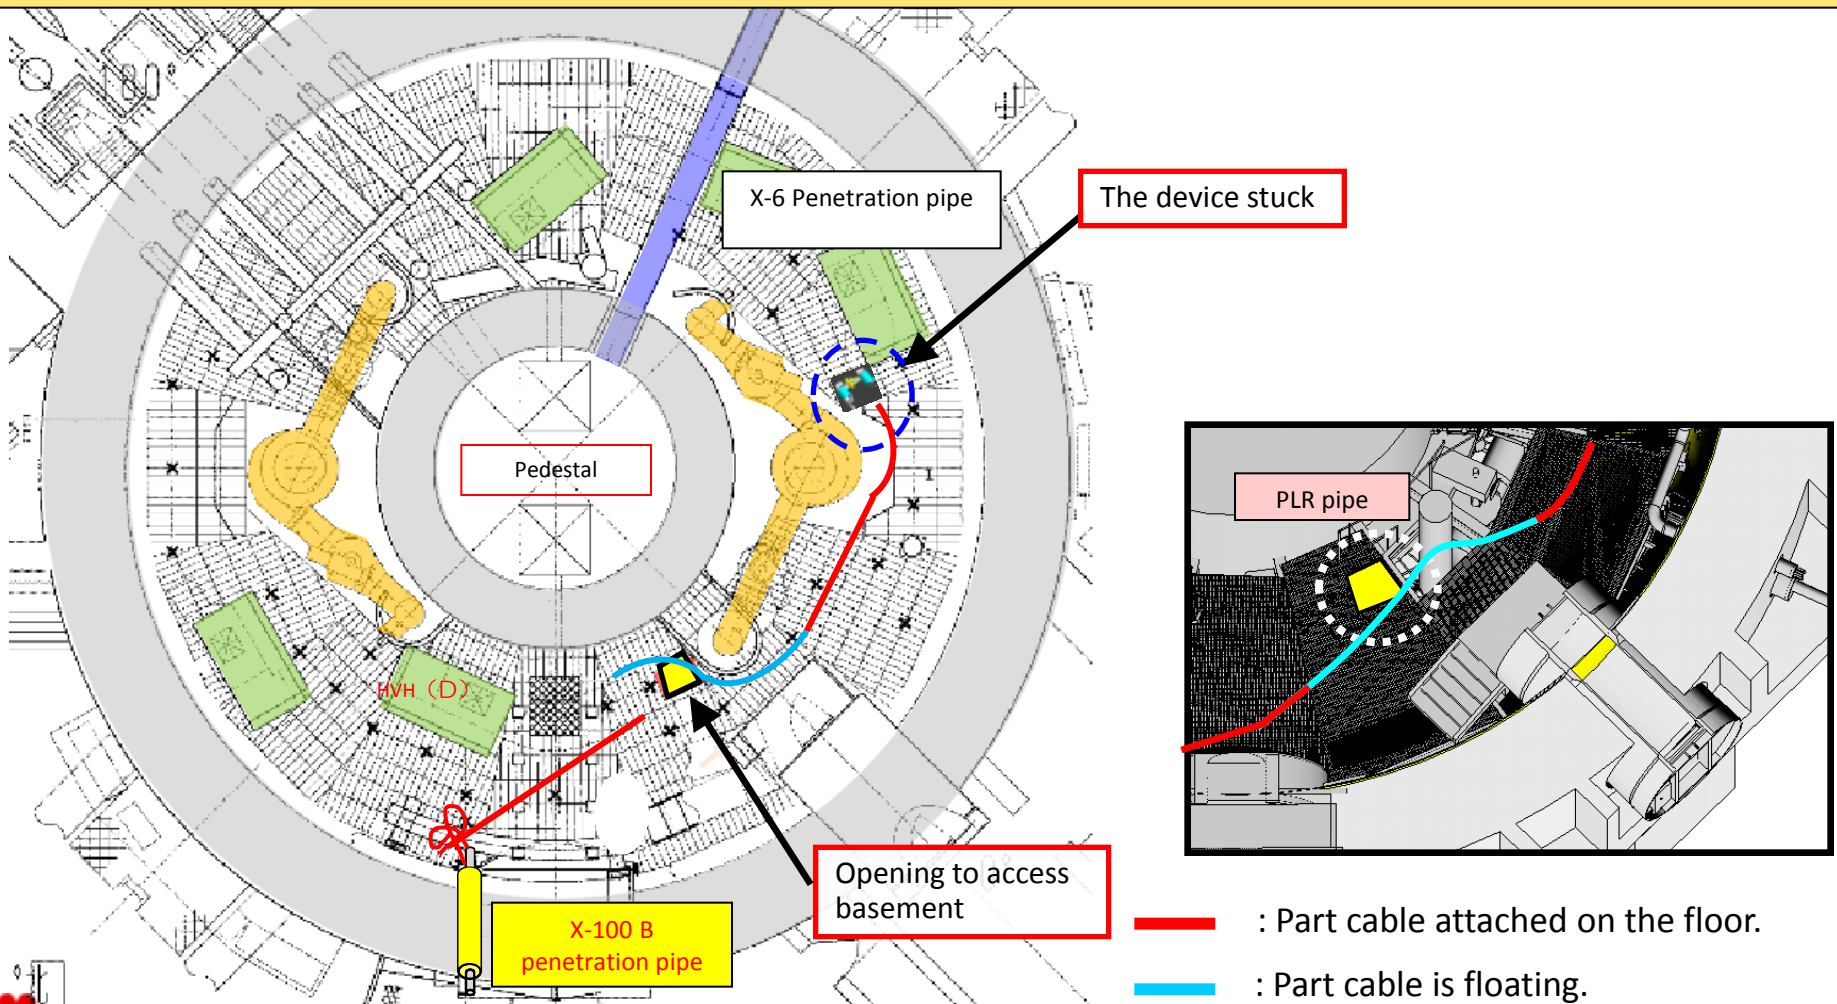
- The route of the cable remained is shown as below.
- It was confirmed that the cable remained around the opening to access the basement will not interfere with B2 investigation.

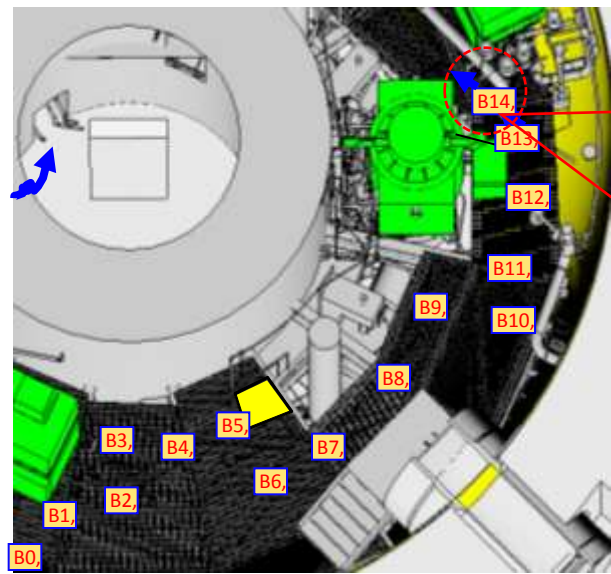
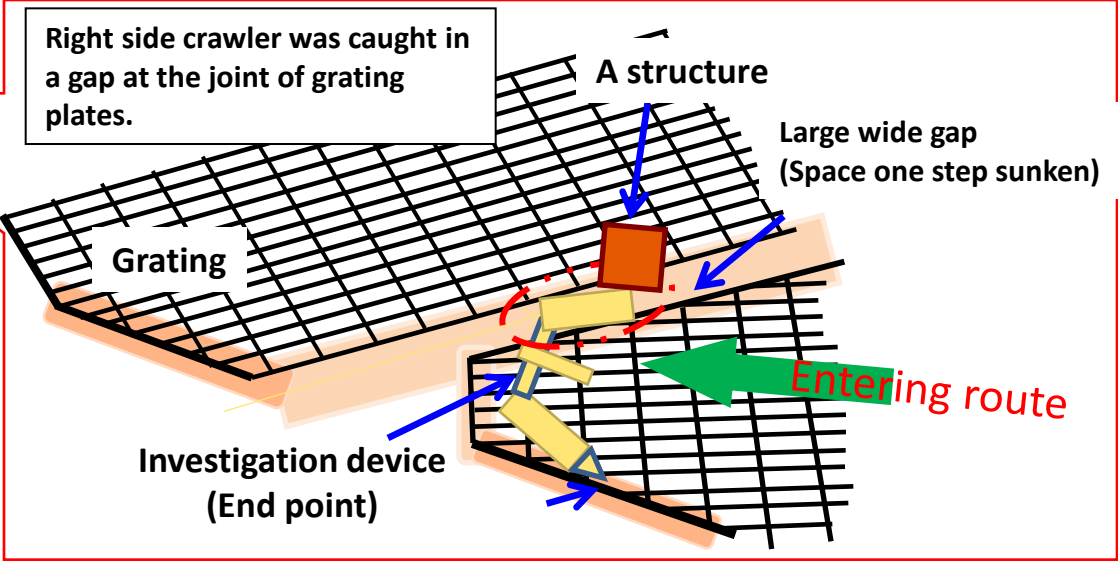
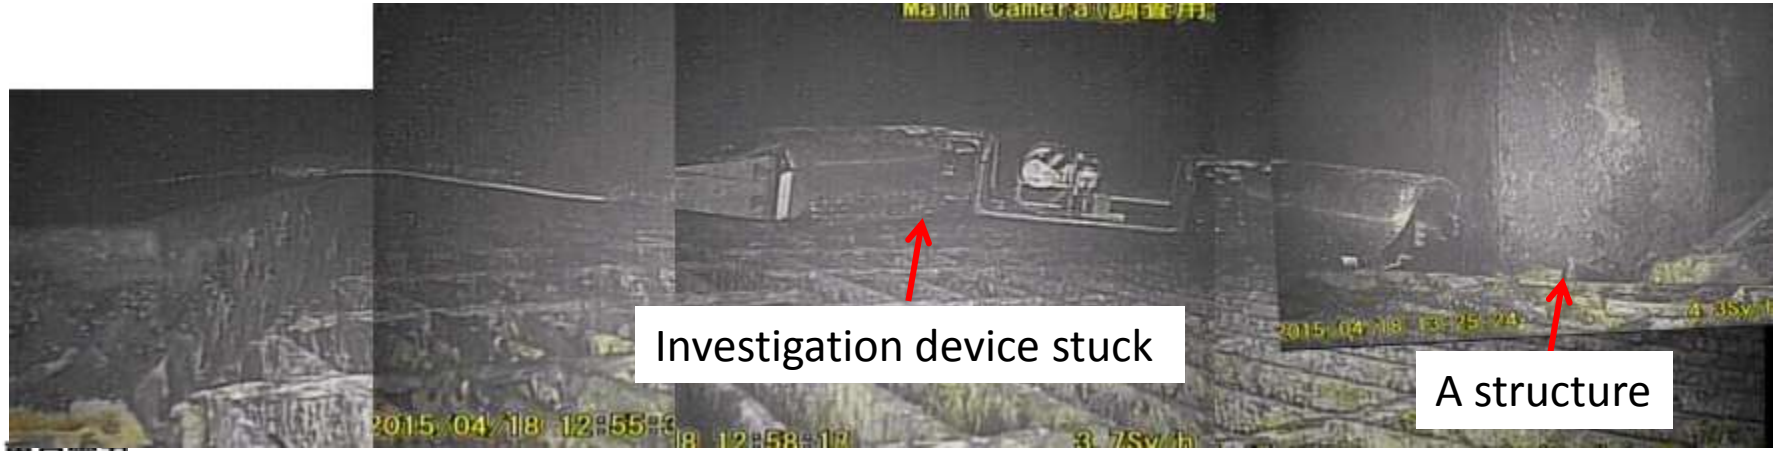
Investigation point	Investigation results
Check the route of the cable remained	<ul style="list-style-type: none">• The cable being left around the opening to access the basement is confirmed of having no problem with B2 investigation.
Investigation device stuck	<ul style="list-style-type: none">• Checked on the condition of the crawler of the device stuck.
Check the access route up to CRD rail	<ul style="list-style-type: none">• The access route up to CRD rail goes through a narrow part between structures, which resulted in the investigation device having been disabled to pass through.

■ The status of the investigation device stuck was checked.

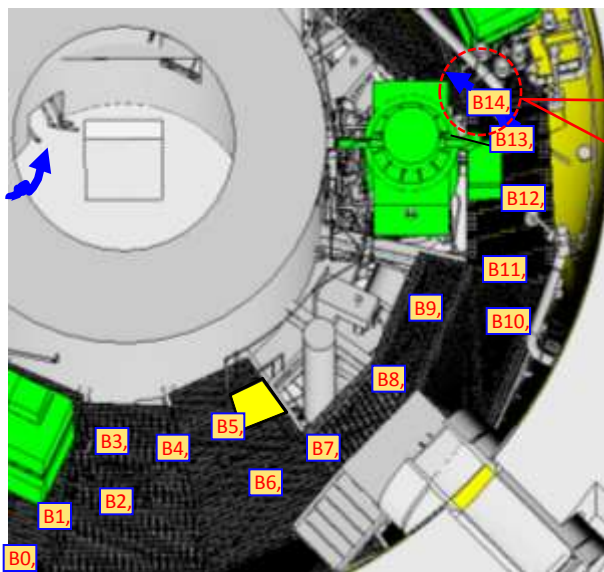
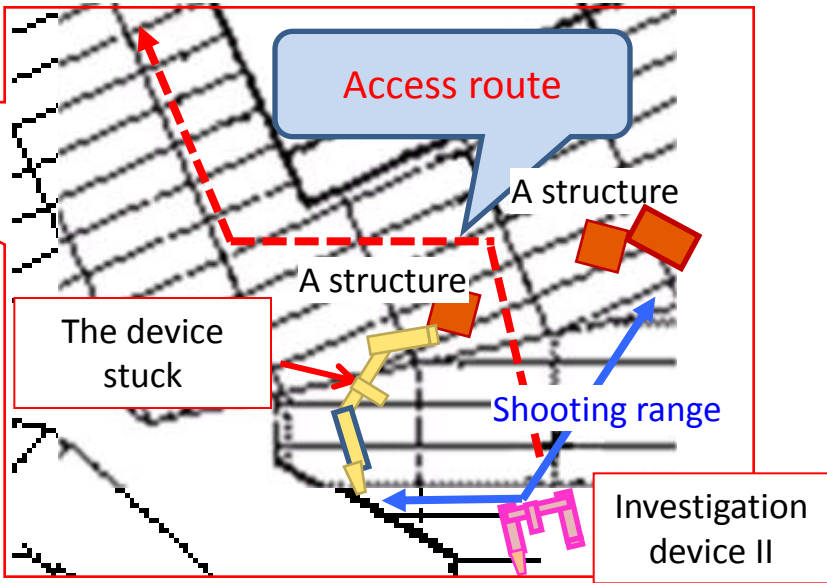
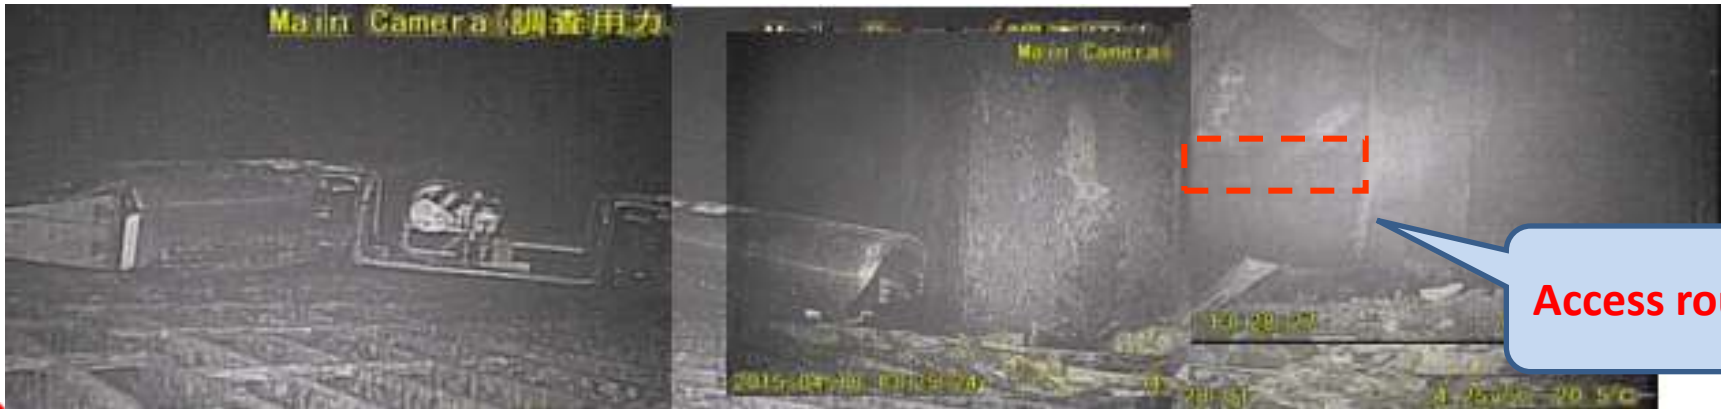
■ It was **concluded** that the access route up to CRD rail is **too narrow** to get the device pass through.

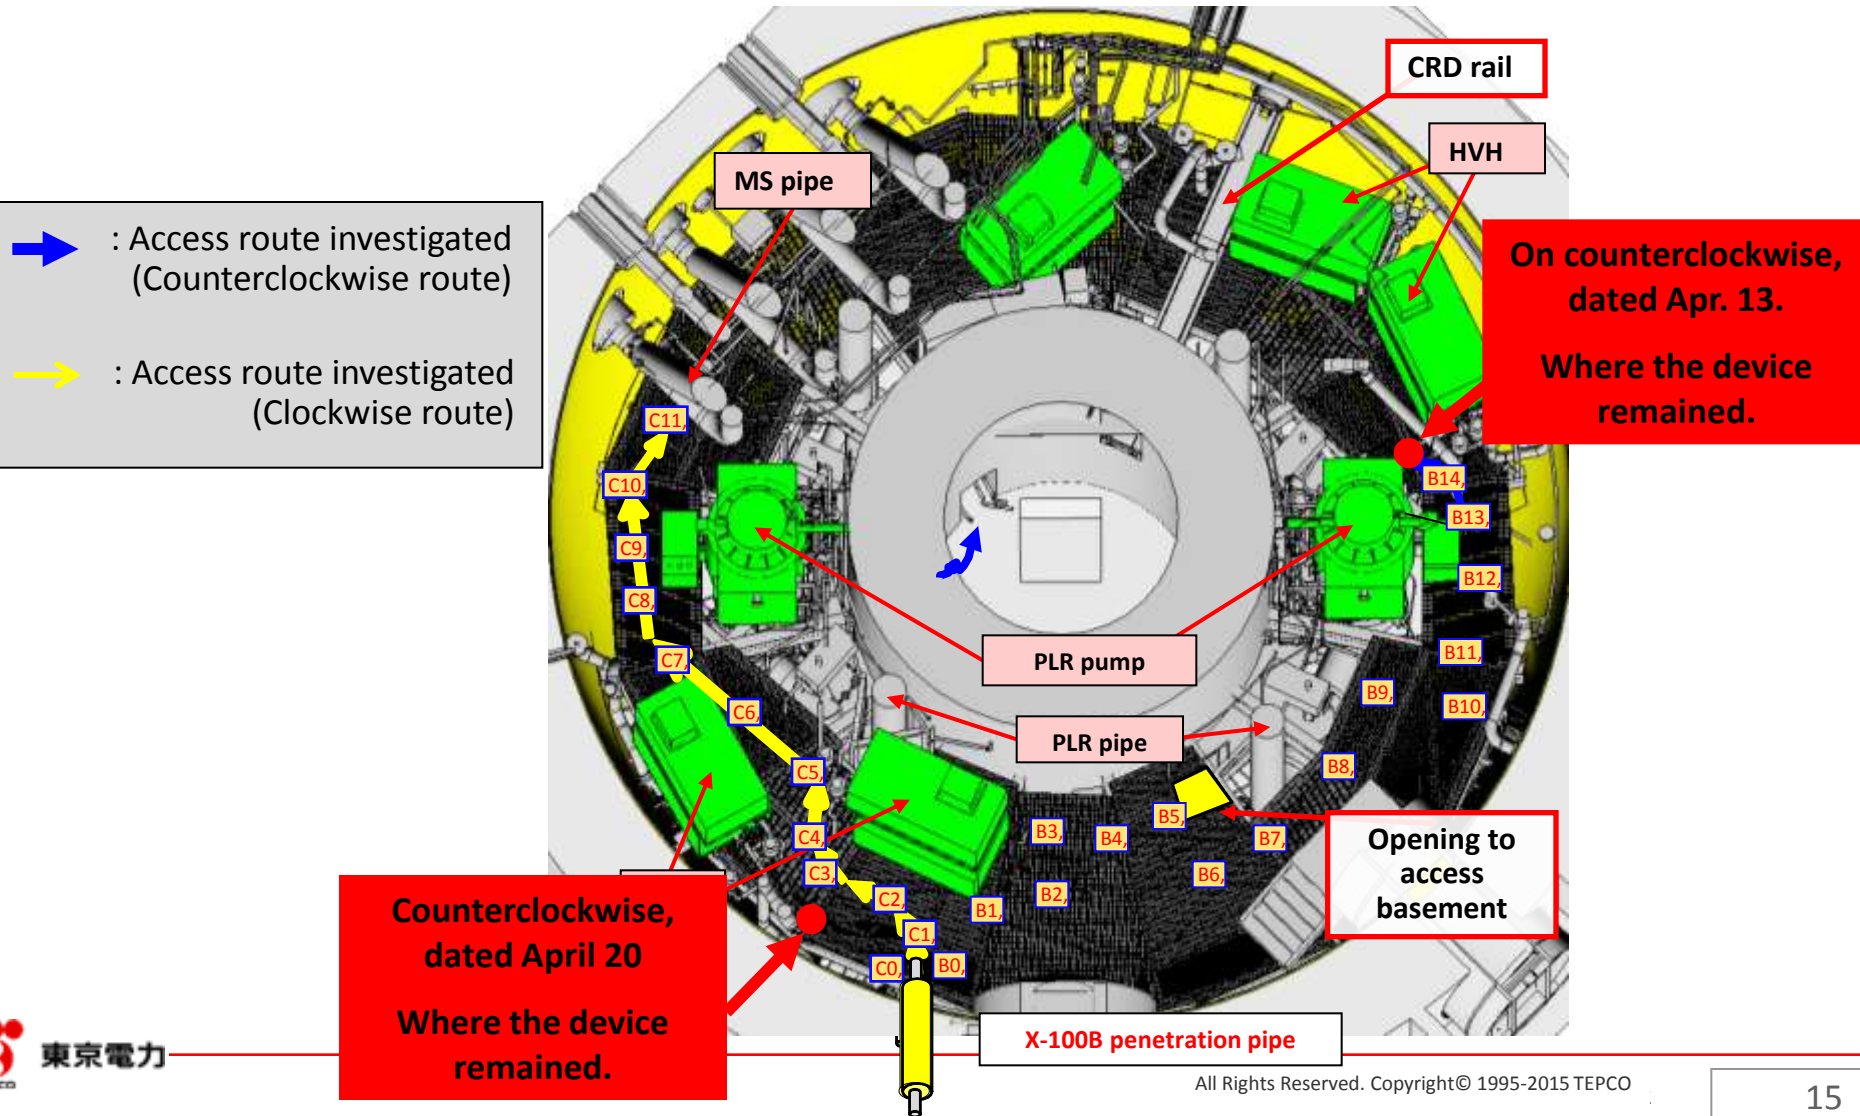
- Where the device remained is as shown in the figure below.
- The investigation device remained will not interfere with B2 investigation planned to be conducted.

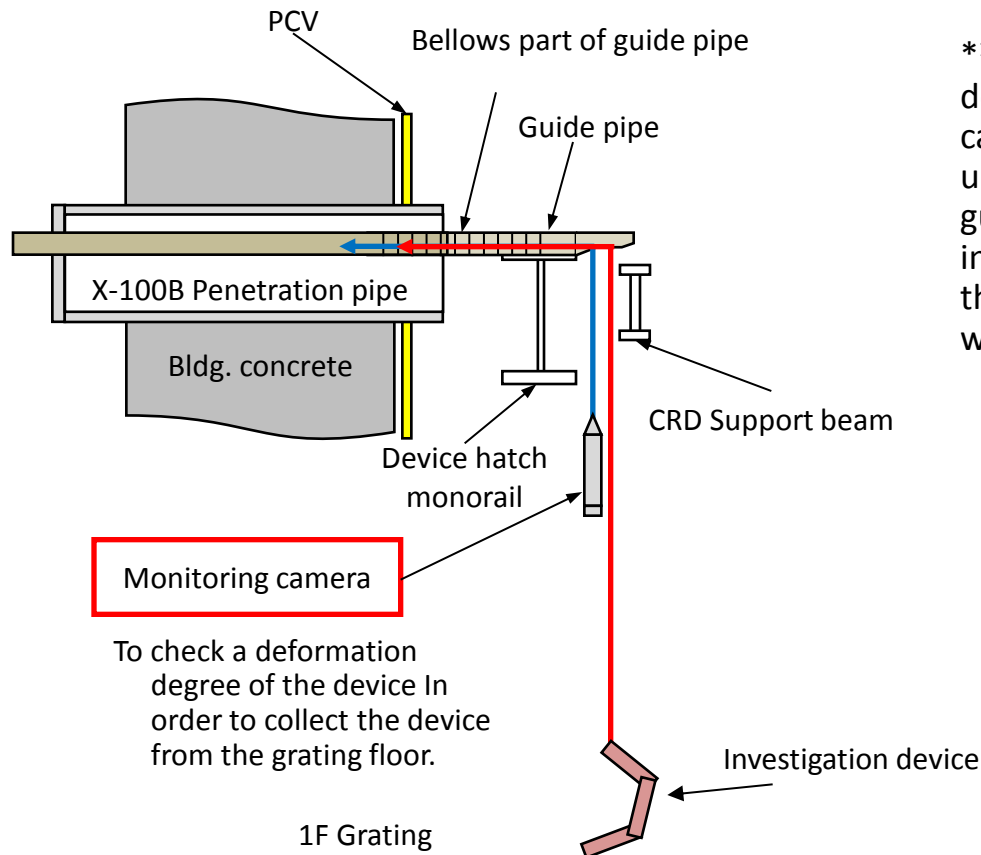
■ Due to the deterioration of the monitoring camera with radiation (assumption), the camera's visibility was extremely dropped to the point disable to perform a deformation check on the device at the time of retrieving it from the vessel. Accordingly, the collection of the device to outside the reactor primary containment vessel was judged as risky. (*1)

*1 Judging from the facts that the deterioration of the monitoring camera and that there was a slight unevenness at the bellow part of guide pipe for inserting the investigation device, there is a risk that the device might get caught when passing though the bellows.

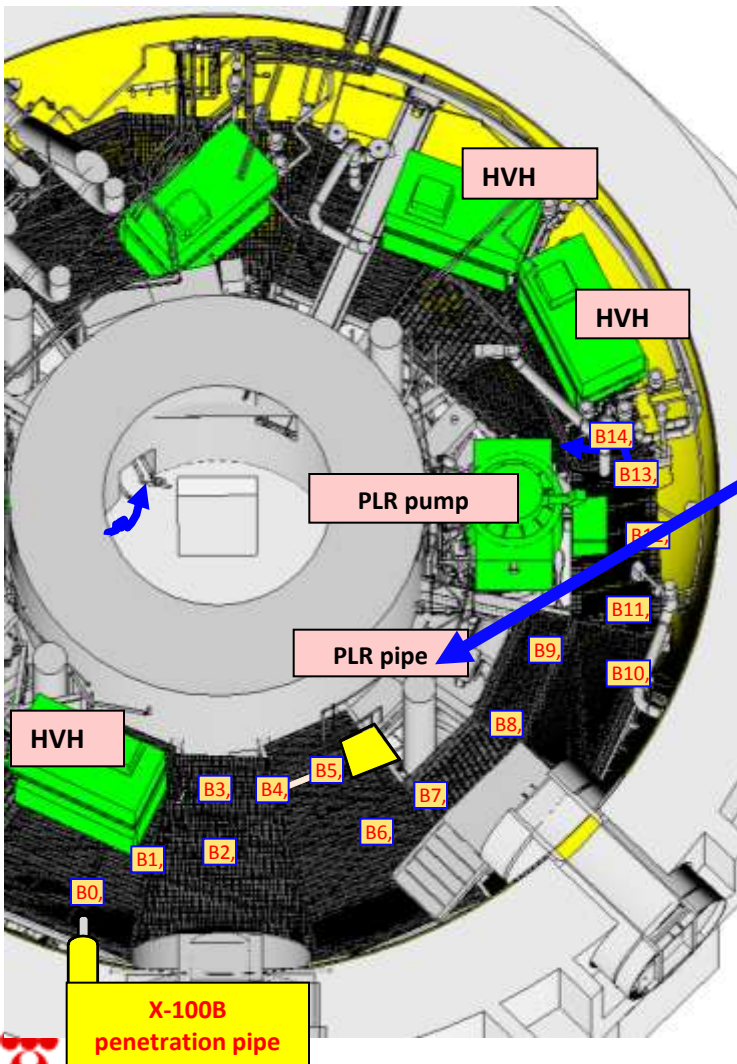
Taken from B7

- No significant damages were found on PLR pipe (heat insulation)
- Pieces of the shield of the pipe was found to be fallen off.
