Request for Information (RFI) of Innovative Approach for Fuel Debris Retrieval

Technological Aspects of RFI

December 17th, 2013

International Research Institute for Nuclear Decommissioning

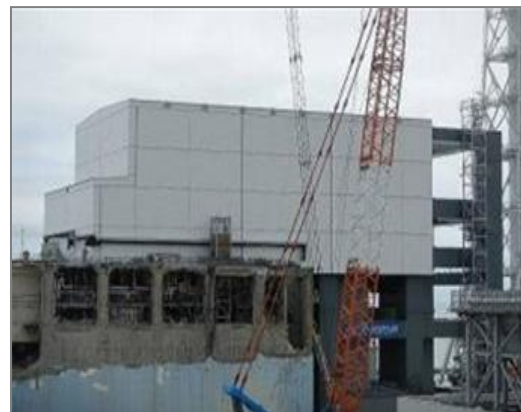
Started first fuel assembly removal from Unit 4 SFP on Nov. 18, 2013

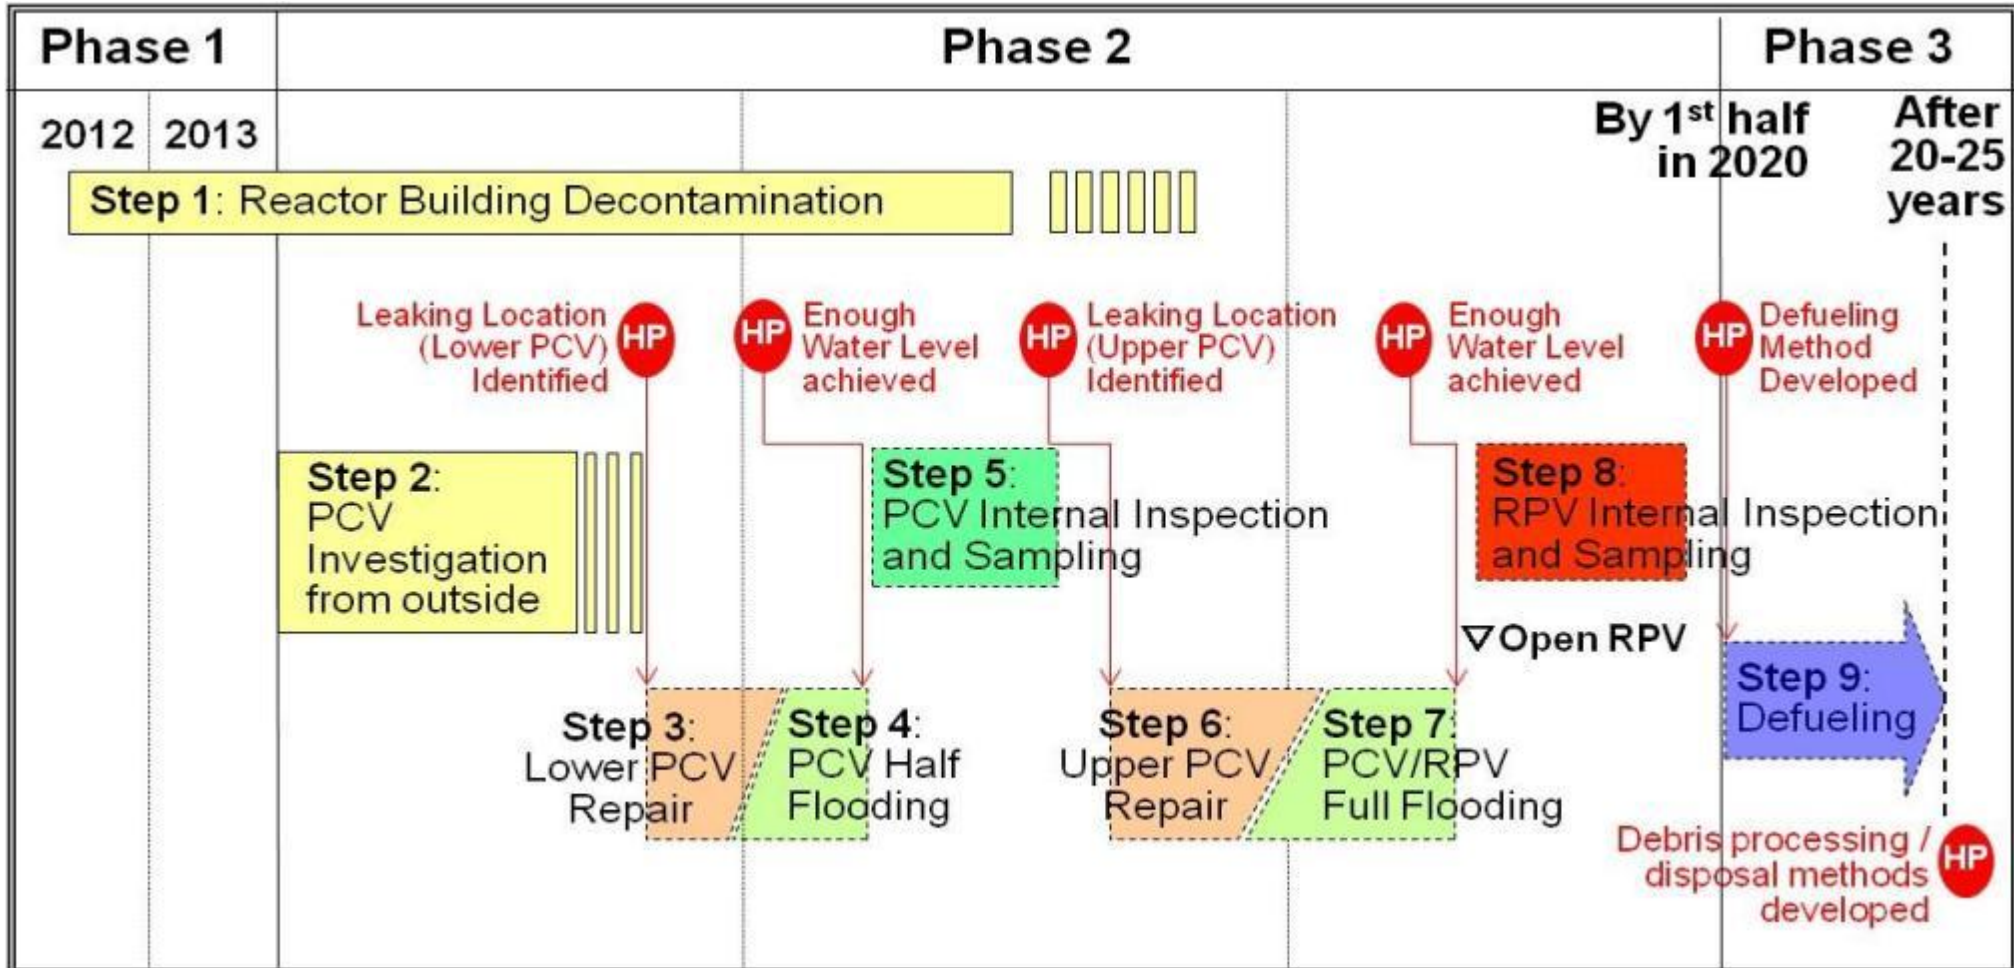
Steps for Fuel Debris Removal premised on of the Existing Flooding Method

- The most reliable method of fuel debris removal at present is considered to remove the fuel debris by keeping them covered with water to reduce the risk of radiation exposure during the work process.

HP : Technical holding points.

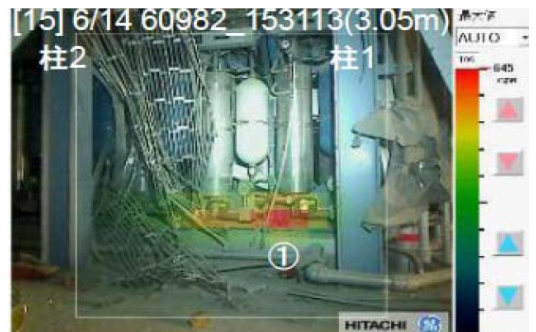
- Dose rate survey results
 - Unit 1: 3.2-8.9mSv/h
 - Unit 2: 6.8-30.3mSv/h
 - Unit 3: 15.8-124.7mSv/h
- Radiation source survey results
 - the primary hotspots are containment vessel penetration seals, water pressure control units (HCU) and the Unit 3 equipment hatch

Radiation source survey (gamma camera) results example (Unit 3 South side HCU)

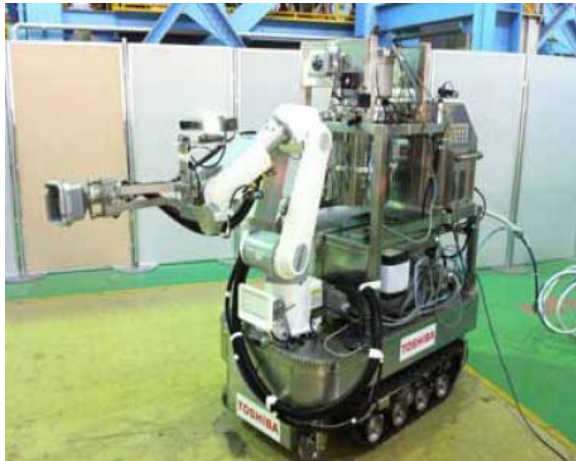
Dry ice blast decontamination device

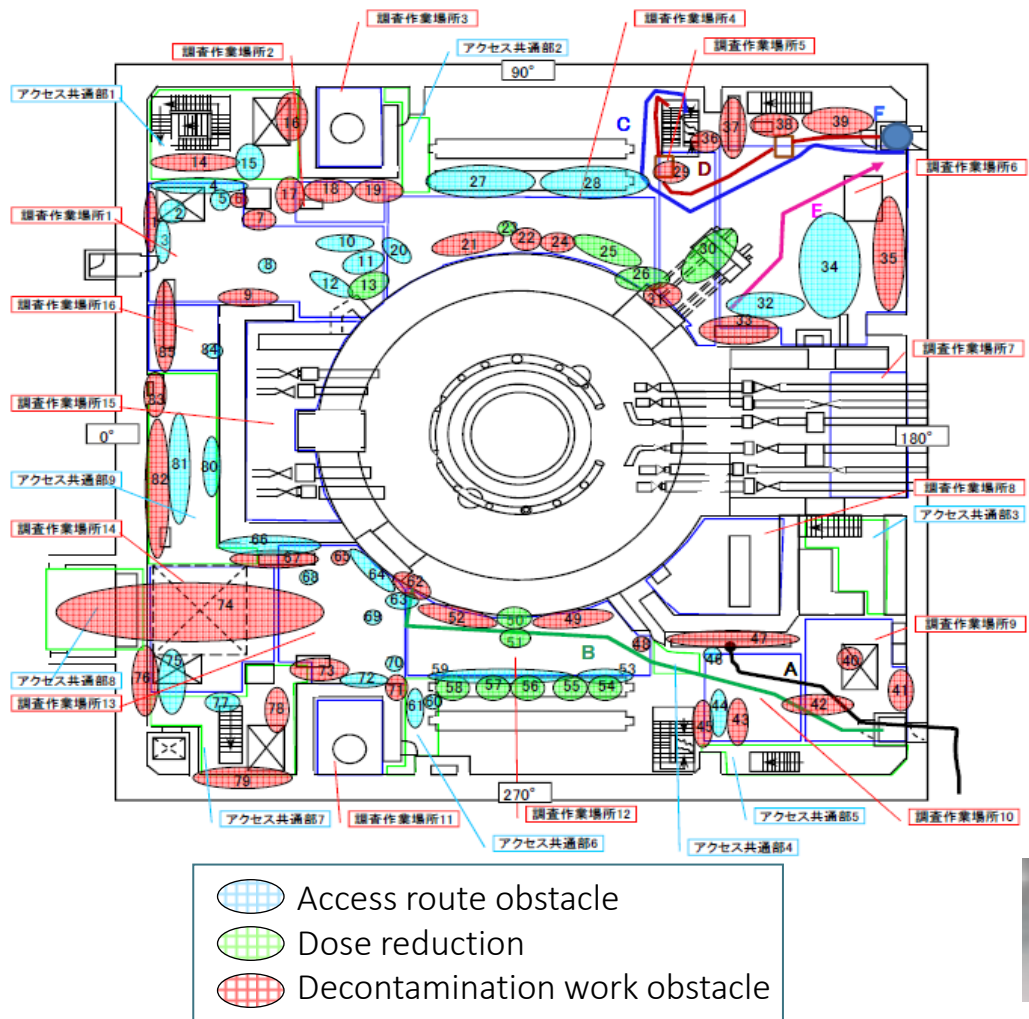
Unit 3 1FL

■ Retrieval of rubbles in Unit 3 is planned as below;

Image of rubbles

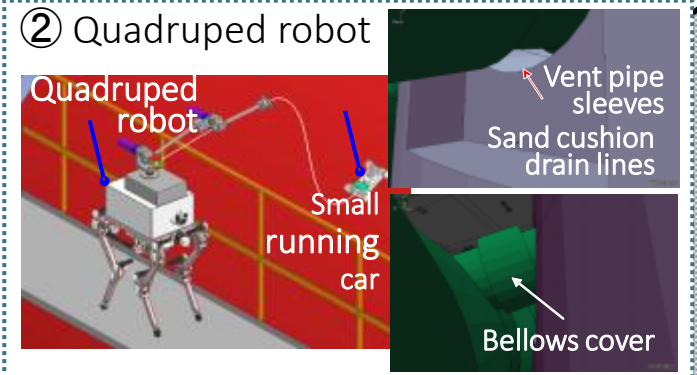
Device	Characteristics
① Survey robot of Vent pipe joint	This robot adheres itself to the surface of the outside of the vent pipe and approaches joints between bent pipes and the D/W from between the vent pipe and concrete wall in order to survey the damage.
② Robot for surveying the upper part of the S/C	This robot checks for leaks from structures at the top of the S/C, which is high up (Approx. 3m at its highest), after accessing it from the catwalk outside the Torus.
③ Quadruped robot (& small running car)	This robot is used to ascertain conditions (advance survey) inside the S/C, such as the presence of leaks, within the scope that can be photographed from near the area beneath the vent pipe. Unit 1's triangular corners are currently submerged and cannot be accessed.

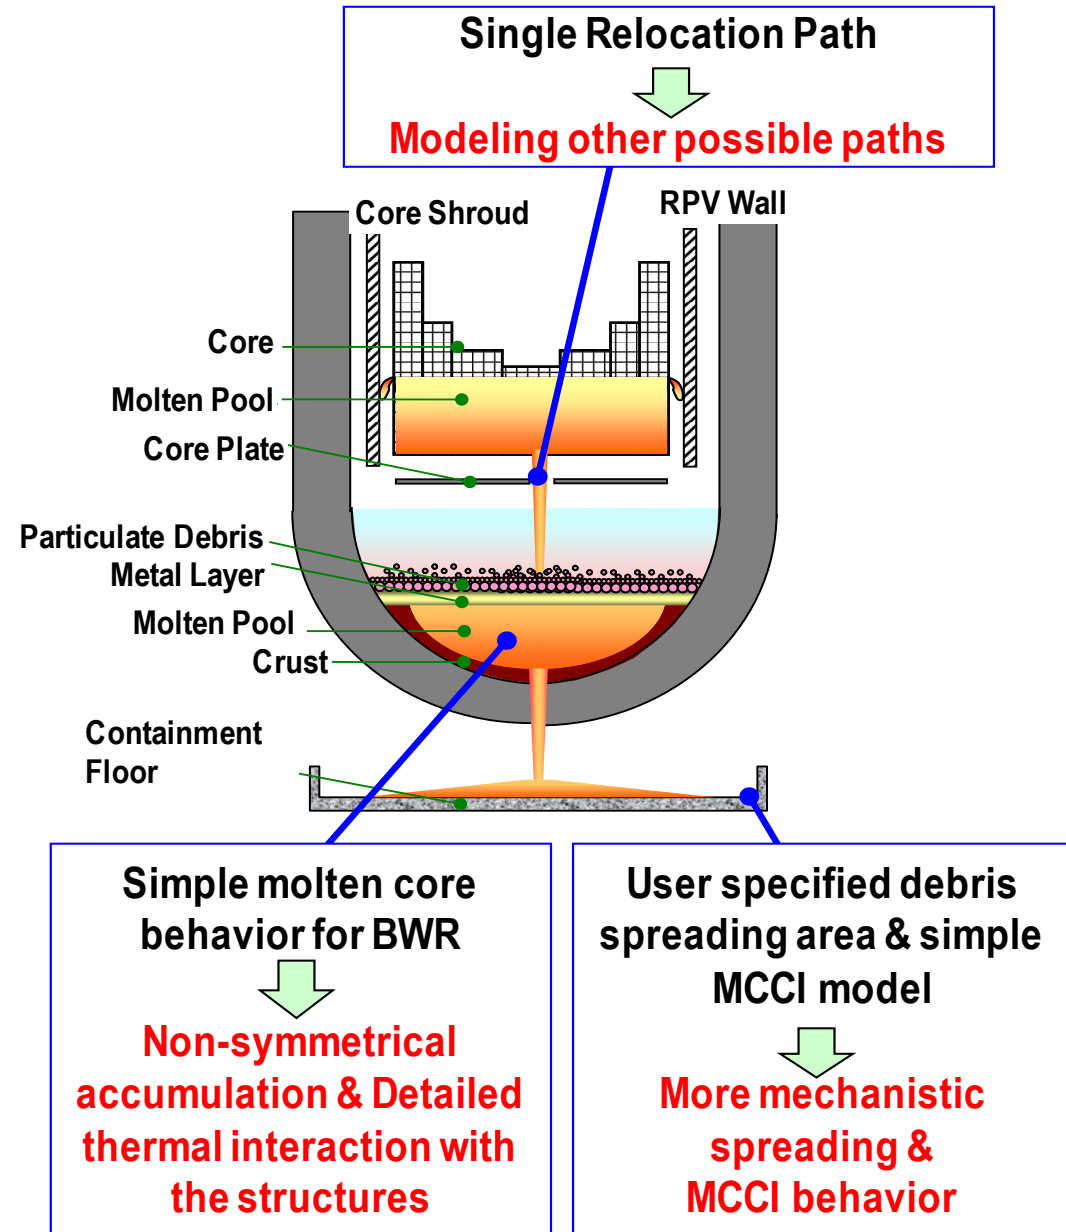
Using the current severe accident analysis code to perform accident progression analysis.

- Identifying code improvement items based on comparison with actual parameters and also PIRT.
- Advancing improvement items in the accident progression analysis code.
- Using an advanced analysis code to estimate and identify core and PCV status.
