FY2014 Technology Research Association International
Decommissioning R&D Institution Symposium

Current Status on Fukushima Daiichi NPS

July 18, 2014

Tokyo Electric Power Company

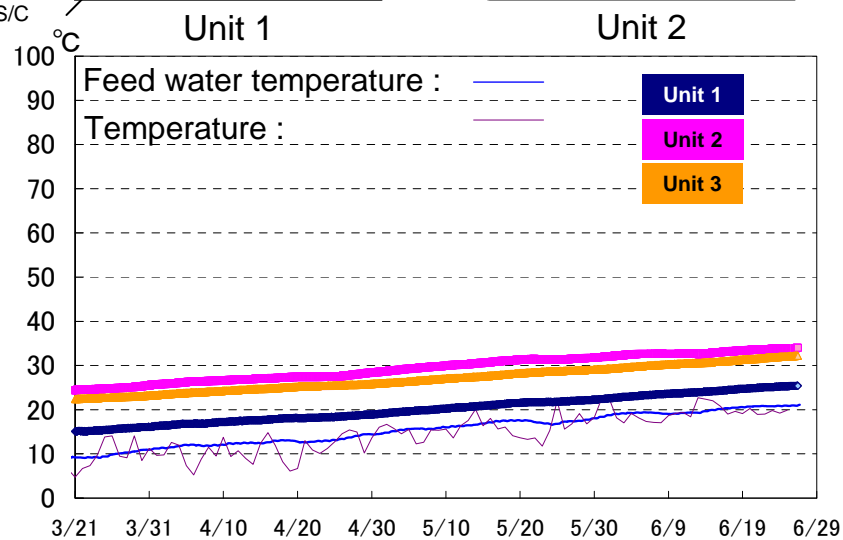
Temperatures of RPV bottom (for three months)

■ All units maintain cold shutdown state

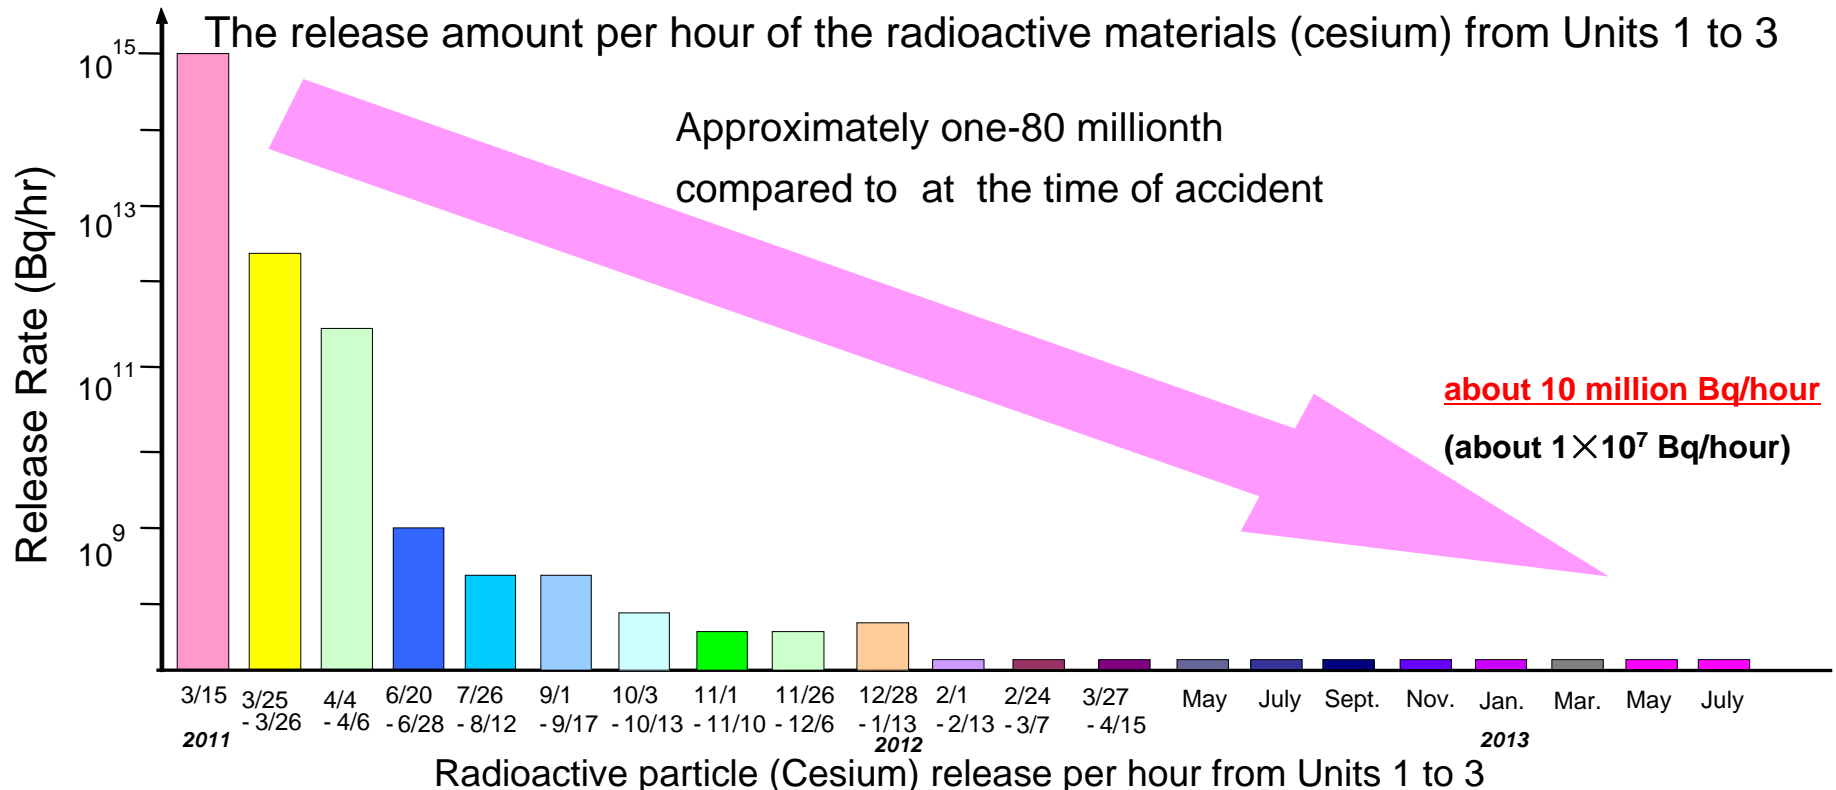
- The amount of radioactive materials (cesium) released from Unit 1-3 PCVs is assessed based on airborne radioactive material concentrations (dust concentration) at the top of Reactor Buildings
 - Calculated the assessed value of total release amount (as of July, 2013) as **about 10 million Bq/hr.**
 - **About one-80 millionth** compared to immediately after the accident.
- Accordingly, assessed the exposure dose at site boundary as **0.03 mSv/yr. at maximum.**
(Excluding effect of already released radioactive materials) Note: Exposure limit established by law is 1 mSv/yr.

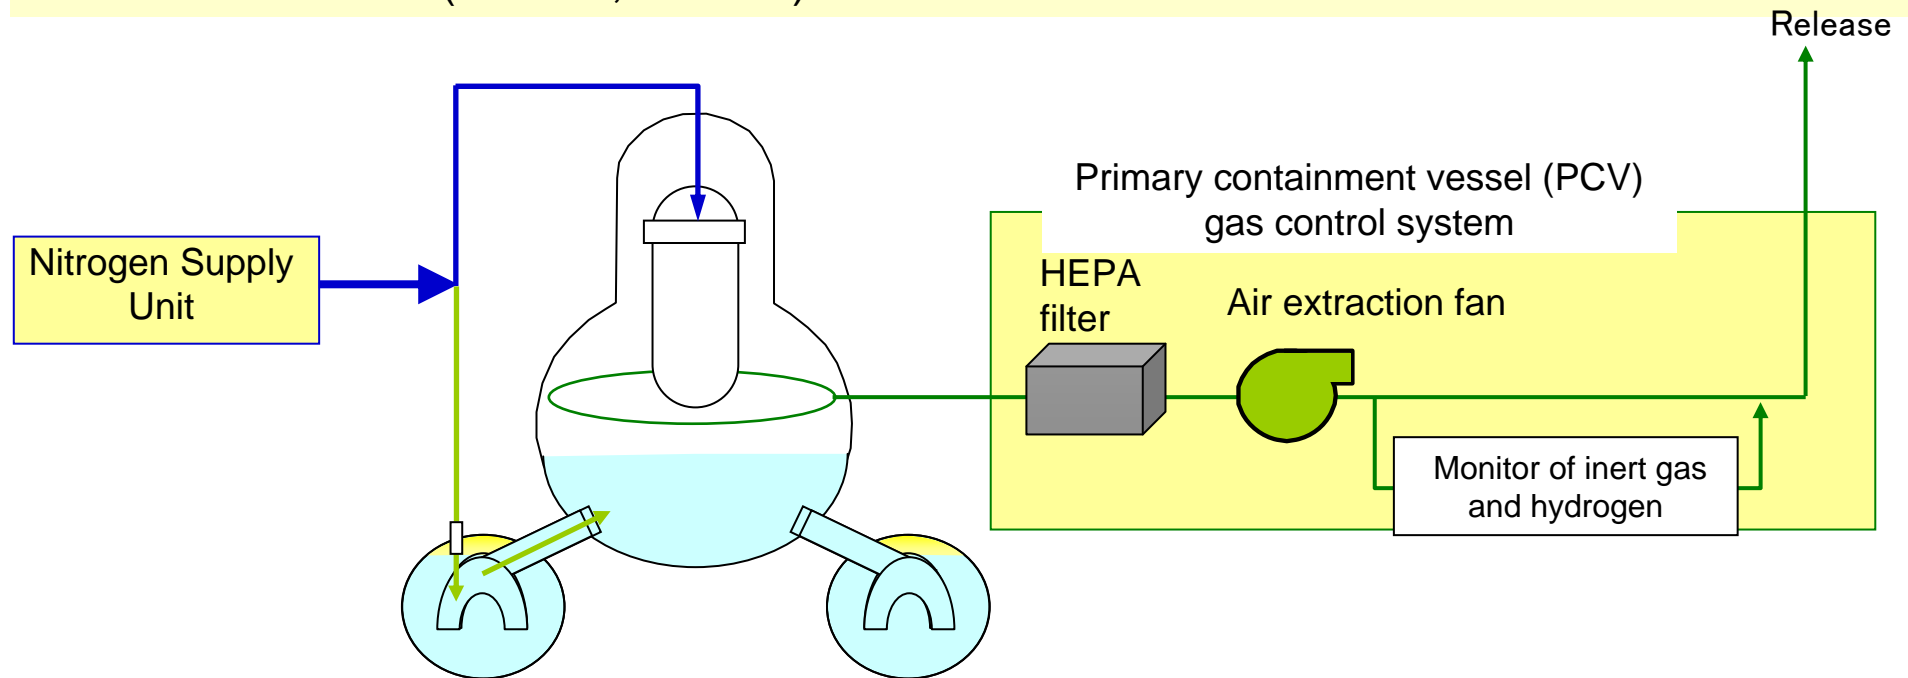
Nitrogen injection and gas control system (Unit 1)

- Hydrogen concentration has been kept below inflammability limit by nitrogen injection into PCV and RPV to prevent hydrogen explosion.
- Gas is extracted from PCV and filtered, radioactive materials released into environment are reduced.
- Concentration and amount of radioactive materials released into atmosphere are monitored.
- Subcritical state is also monitored by monitoring radioactive concentration of short-lifetime nuclides (Xe-133, Xe-135).

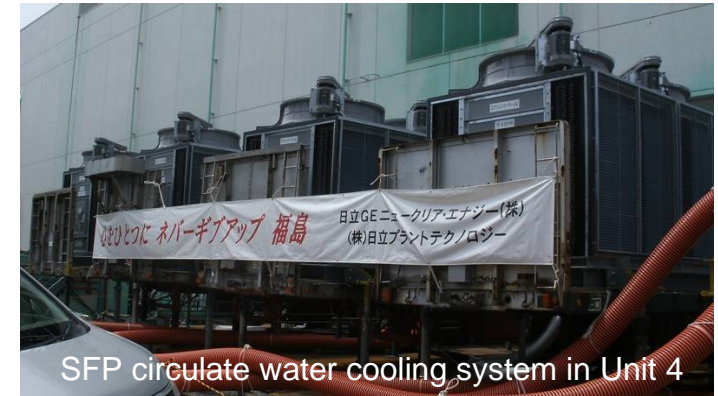
SFP circulate water cooling system in Unit 4

- To continuously remove decay heat generated from fuel in SFP, water in SFP is cooled by using both existing facilities and newly installed facilities.
- Chlorine concentration was decreased by mobile reverse osmosis (RO) no later than March 18, 2013. It is regularly monitored to be less than 100 ppm.

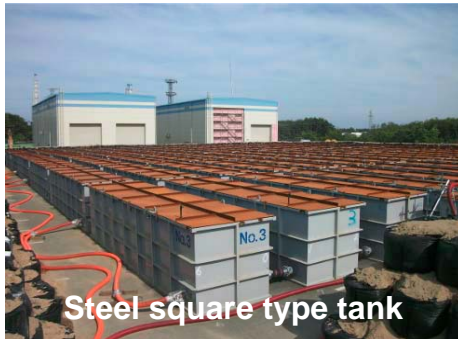
Steel square type tank

Steel square type tank: approx. 3,000m³

(Accumulated water in Units 5 and 6, concentrated salt water at RO device)

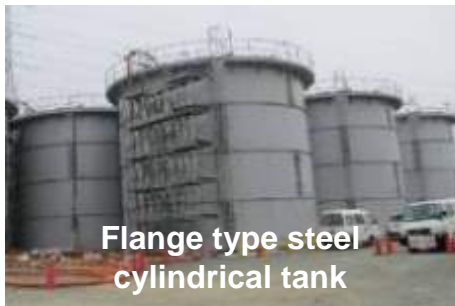
Flange type steel cylindrical tank

Flange type steel cylindrical tank: approx. 291,000m³

(Fresh water, concentrated salt water at RO device, water treated by ALPS)

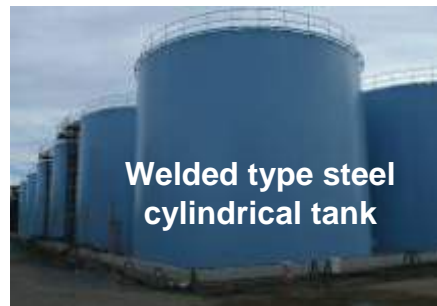
Welded type steel cylindrical tank

Welded type steel cylindrical tank: approx. 174,000m³

(Concentrated salt water at RO device, water treated by ALPS)

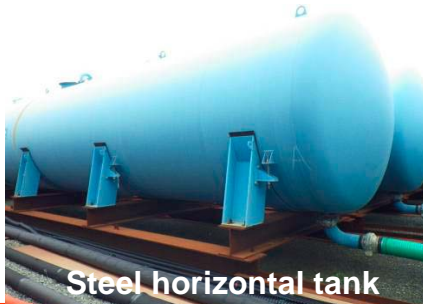
Steel horizontal tank

Steel horizontal tank: approx. 38,000m³

(Concentrated salt water, waste water generated by evaporative concentration)

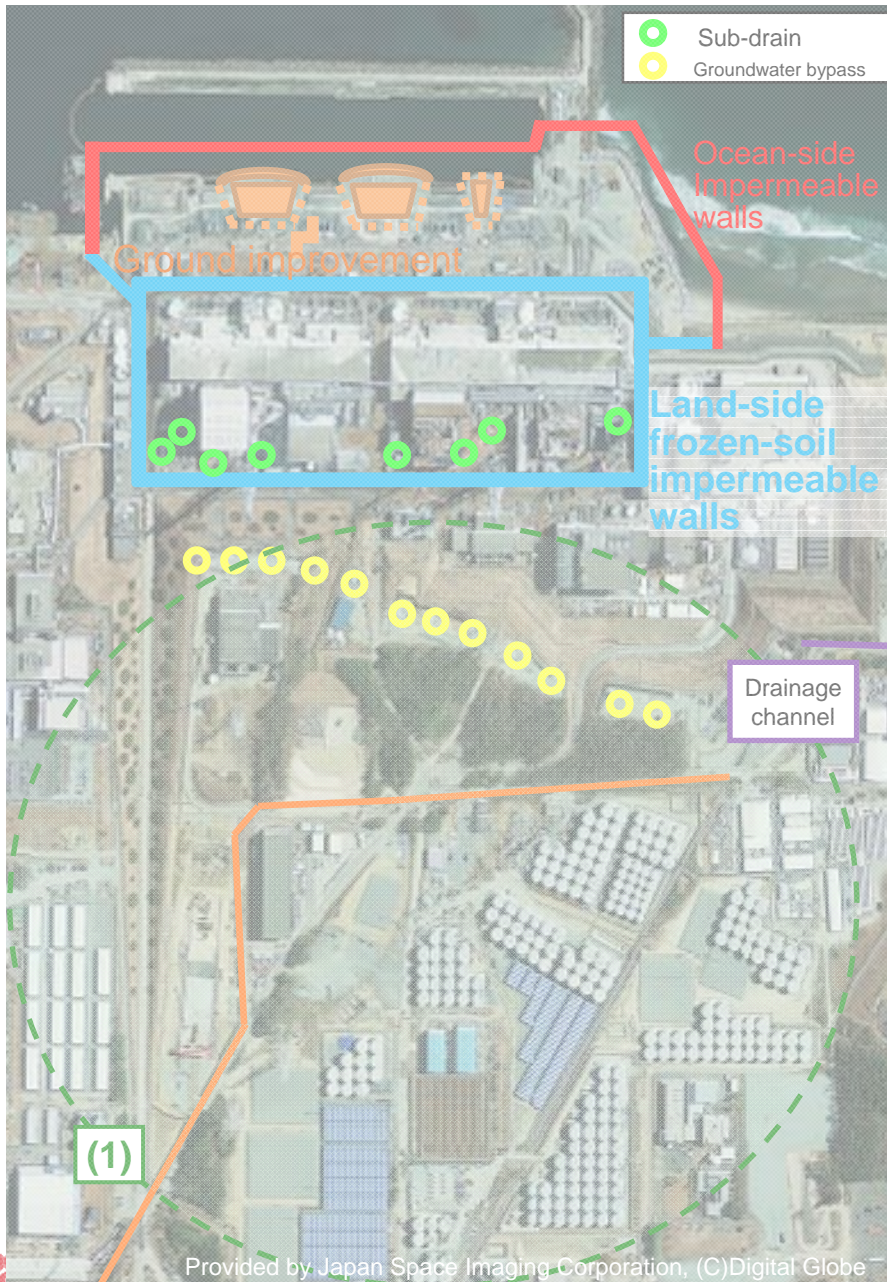
< Overview on groundwater flow around buildings at Units 1 to 4 >

- Approx. 800 m³/day of groundwater flows into the site from the mountain side. It is assumed that approx. 400 m³/day out of 800m³/day flows into the buildings and the remaining (approx. 400 m³/day) flows into the sea.
- As the groundwater flowing into the buildings becomes contaminated, it needs processing.

Three basic principles of measures against contaminated water

1. **Removal** of contamination source ●
2. **Isolation** of water from contamination source ○
3. **Leakage Prevention** of contaminated water ◆

1. Removal of highly contaminated water from trenches ●
2. Ground improvement at contaminated area with water glass, pavement of ground surface with asphalt, etc. and pumping up groundwater ○◆
3. Pumping up groundwater from the mountain side (Groundwater bypass) ○

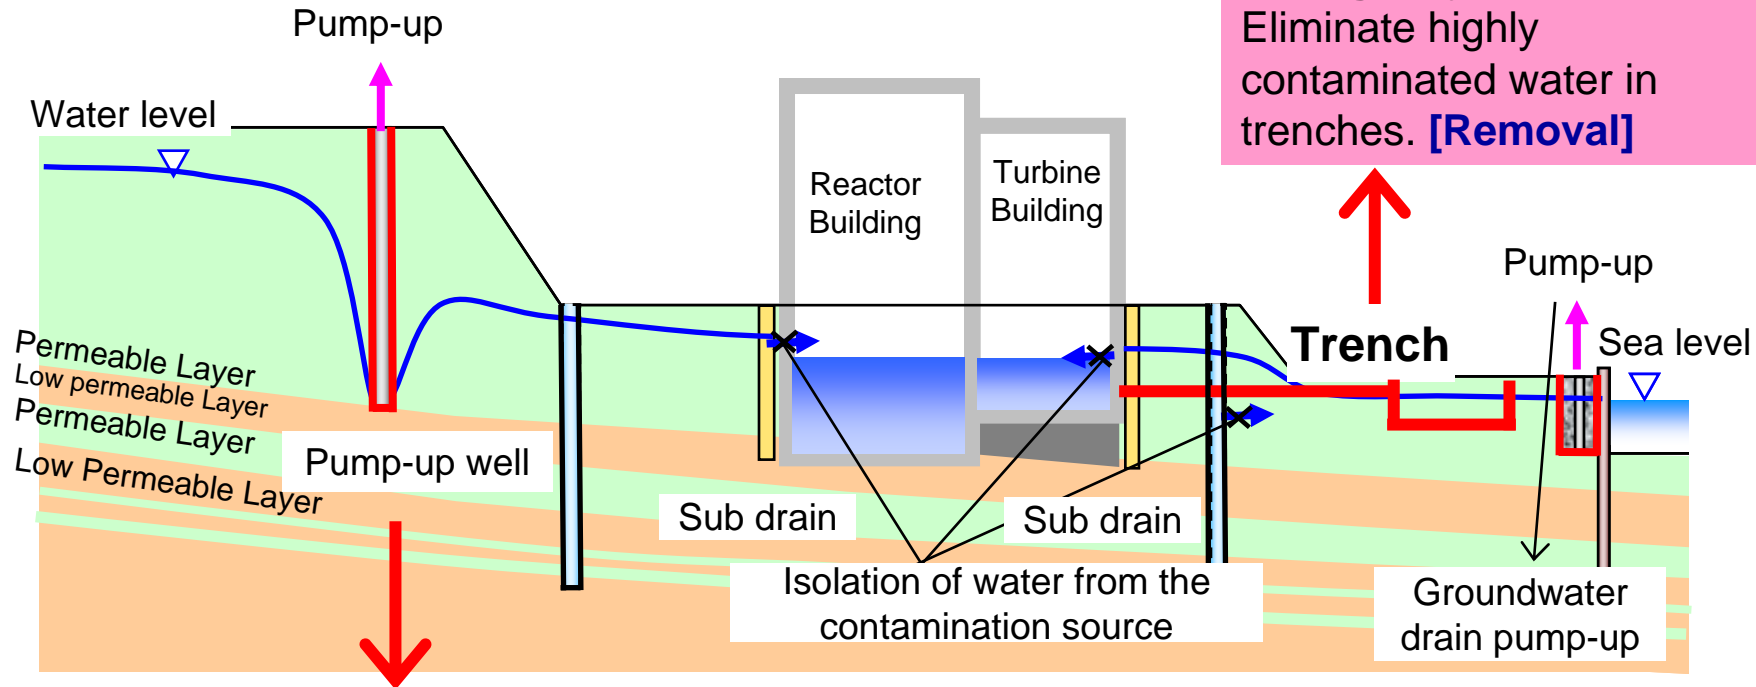
Emergency measure (3)
Pump up groundwater from the mountain side (groundwater bypass)
[Isolation]

- April 9, 2014, pumping up ground water at the wells was started.

- Groundwater will be pumped up from the mountain side and discharged into the ocean (Groundwater bypass). It is expected that the amount of inflow into the buildings is to be reduced by tens to 100 tons of water at maximum.
- The water pumped up from pump-up wells is temporarily stored in tanks to measure the radioactivity. It is ensured that the values are less than the target values prior to discharge.

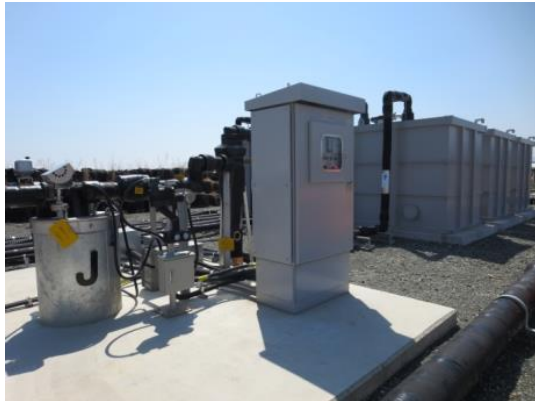
Groundwater bypass

<Discharged water date/amount>
Unit: ton

Date	Discharged amount
1	May, 21	561 ton
2	May, 27	641 ton
3	Jun, 2	833 ton
4	Jun, 8	1,563 ton
5	Jun, 14	1,443 ton
6	Jun, 20	1,765 ton
7	Jun, 26	1,829 ton
8	Jul, 2	1,858 ton
9	Jul, 8	1,725 ton

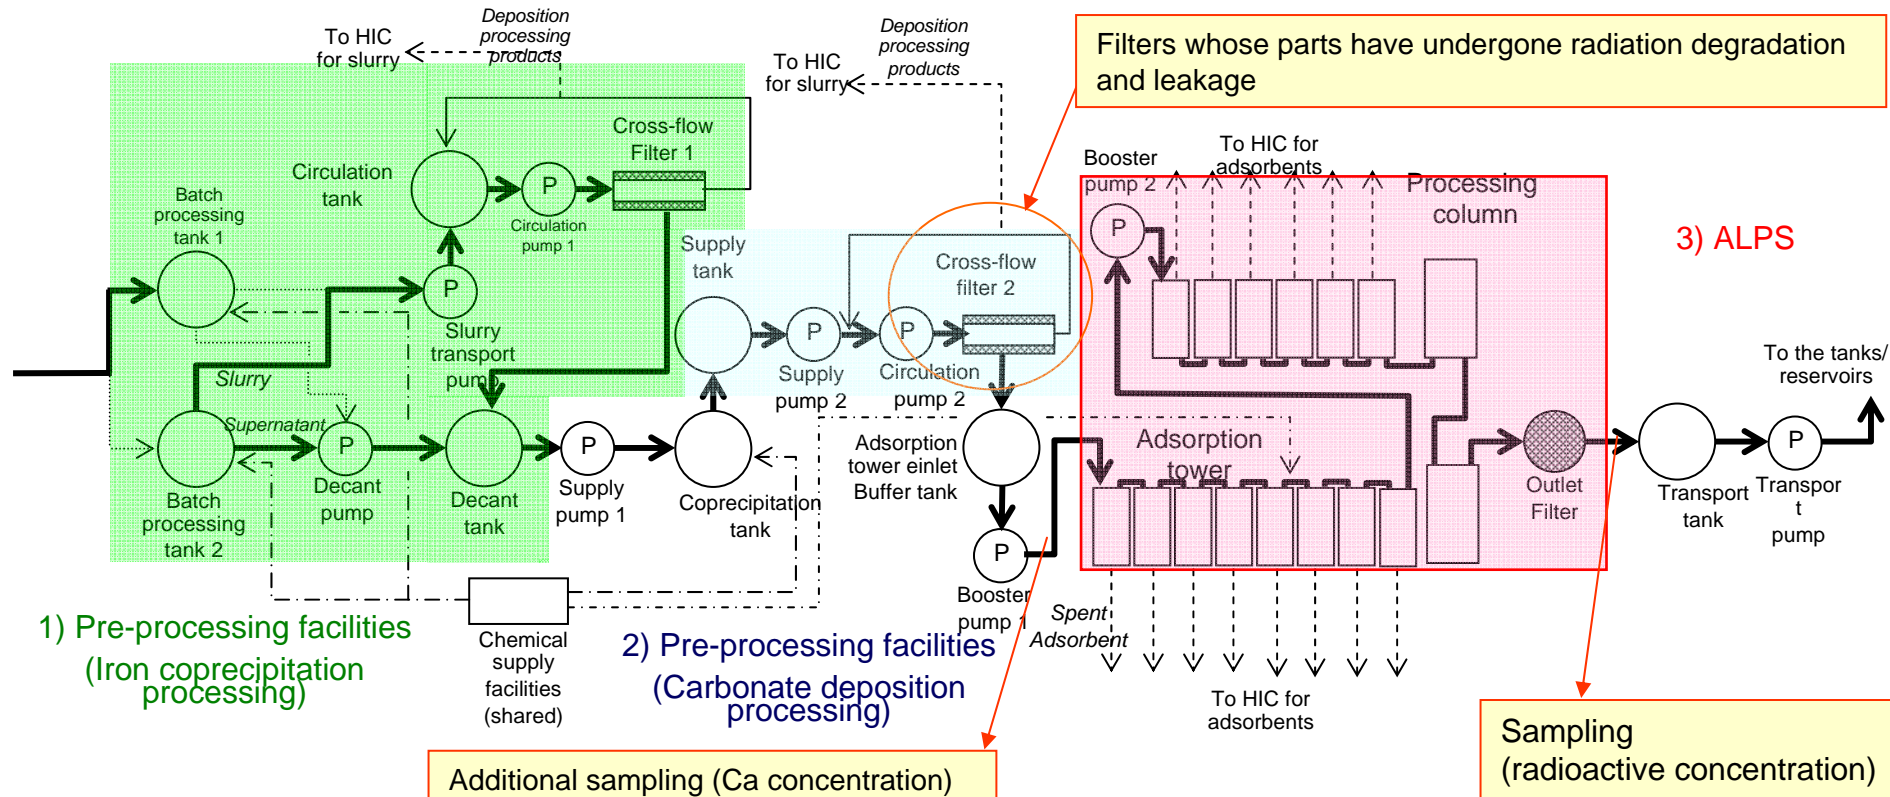
Configuration of existing ALPS

- In train-B, filter components have degraded due to radiation, causing contamination to moving downstream. The parts were replaced with those higher resistant against radiation, and operation of train B restarted on May 23.
- In trains A and C, measures are taken to allow earlier detection on contaminant (additional sampling) to prevent them from moving downstream.
- Operation of train A was also restarted on June 9 after the filter were replaced with another one. Operation of train C was restarted on June 22 after taking same measures.

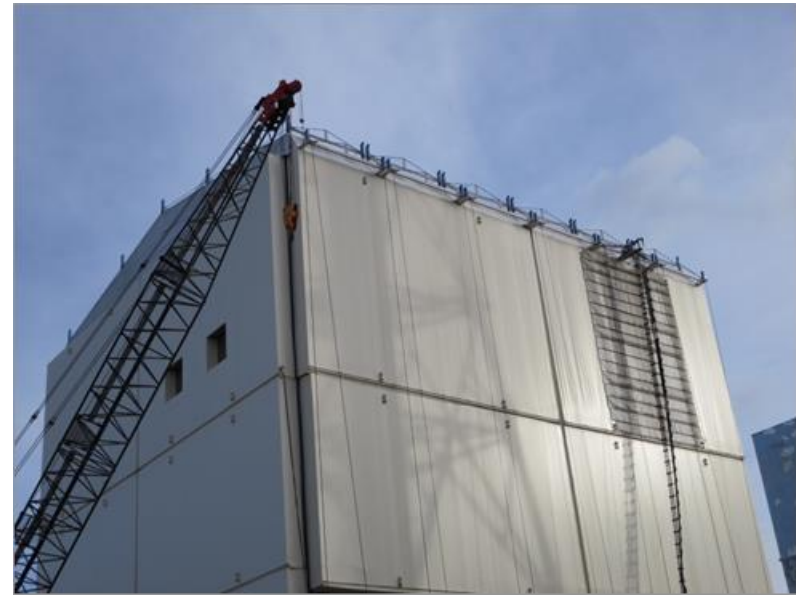
Completion of building cover structure
Present

- Removal of the building cover
- Identification of the status of debris on the defueling floor and inside the pools
- Countermeasures for the dispersion of radioactive materials during the removal of the building cover
- Shortening the period of the time of removing the building cover

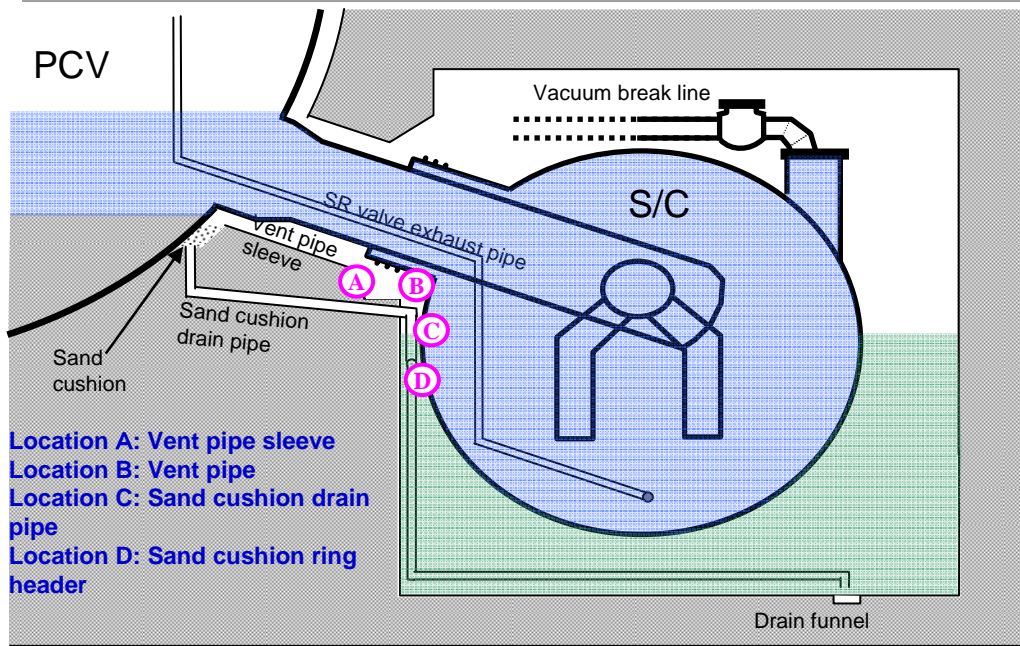
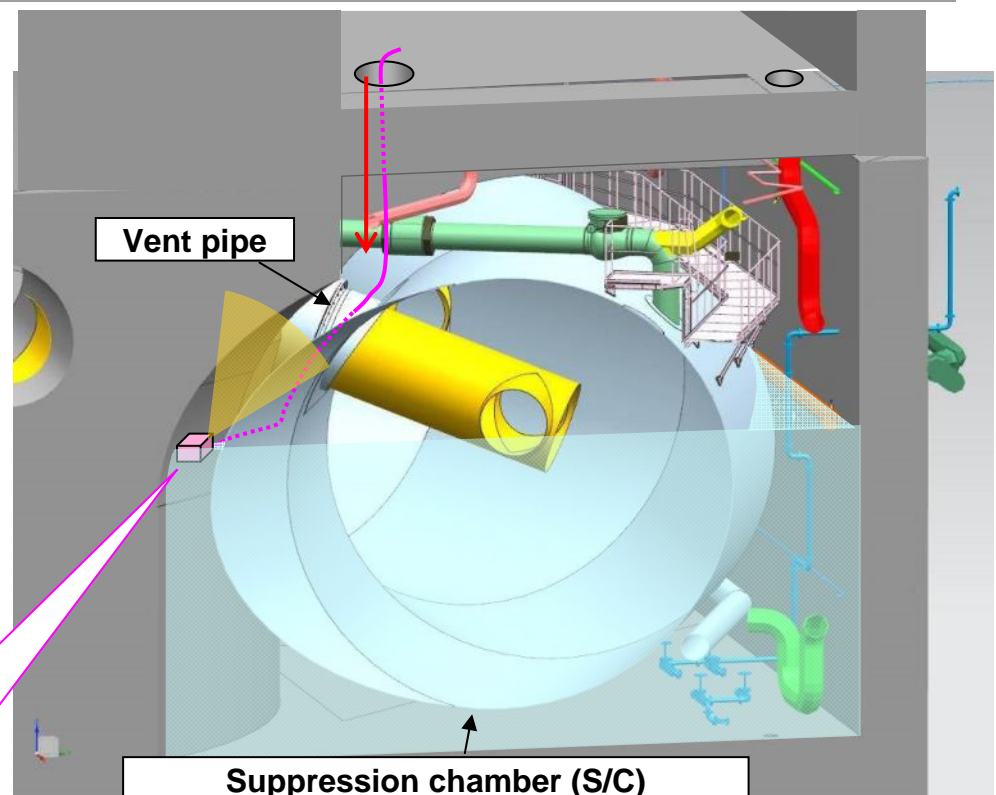
Water boat

- To repair (seal the water leak locations of) the PCV in preparation for the fuel debris removal, investigation under vent pipes was conducted to identify the leak locations in the PCV.
- With the images taken by the camera equipped with the water boat, it was checked whether there is any water flow from the sleeve ends of vent pipes or not, and the status of the sand cushion drain pipes was also checked (by viewing appearance).

Water boat: trial operation at the plant

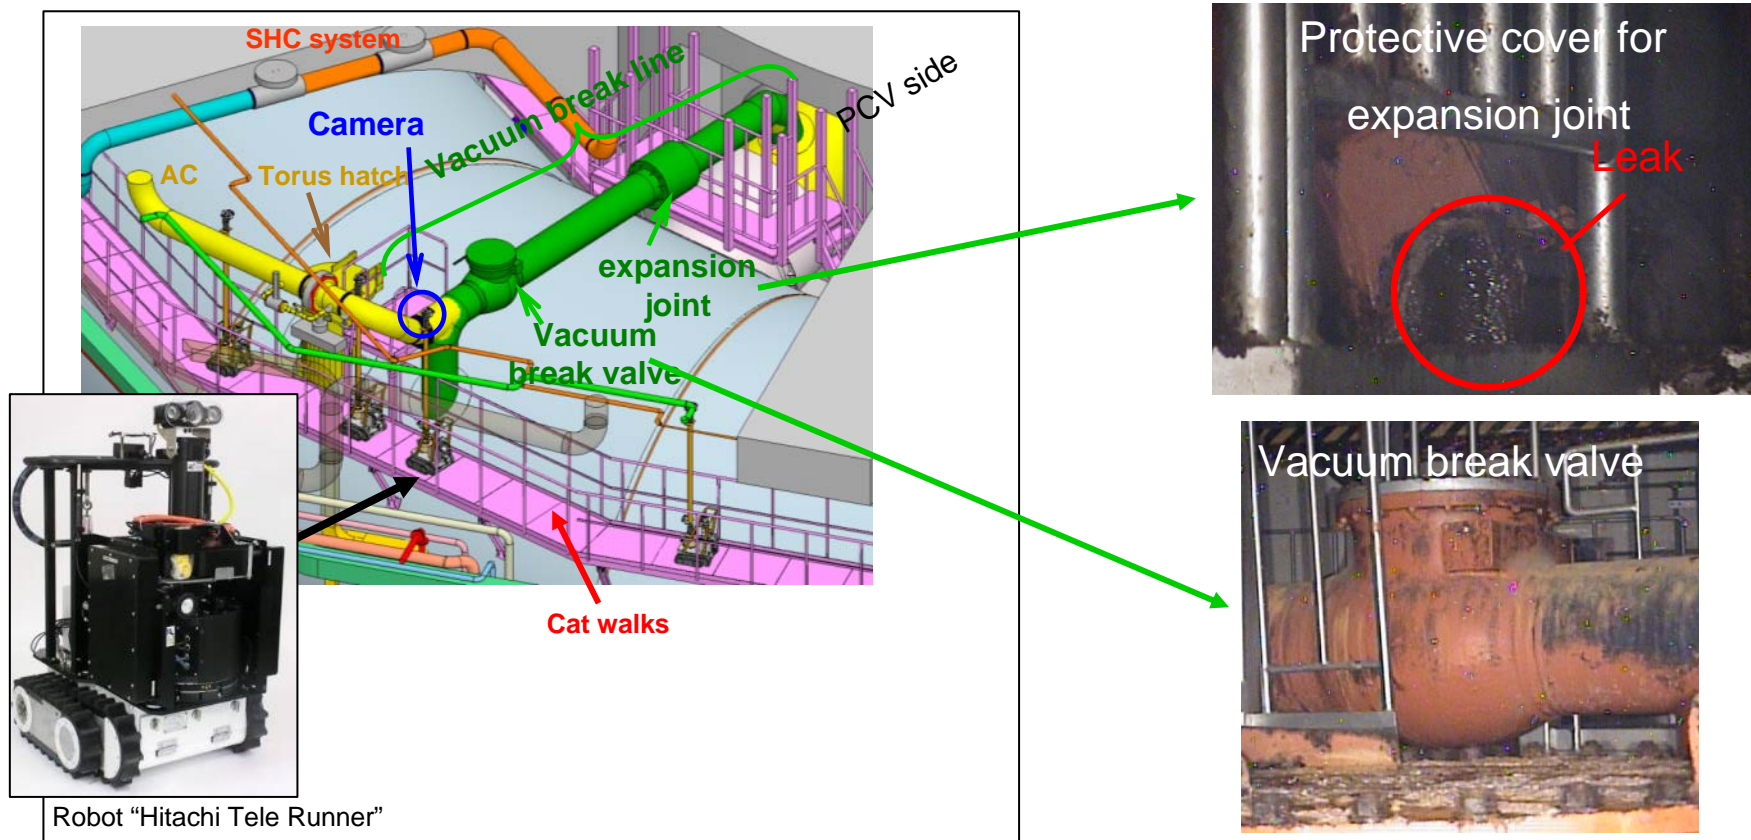
Image of investigation on upper part of suppression chamber

- By deploying a remote controlled robot on the cat walks in the torus room in the Unit 1 from May 27, a leak from the protective cover of a expansion joint on vacuum break line was identified.
- The investigation results will be reflected into the planning for further investigation and sealing the water leak location of the PCV for filling the PCV with water in the future.

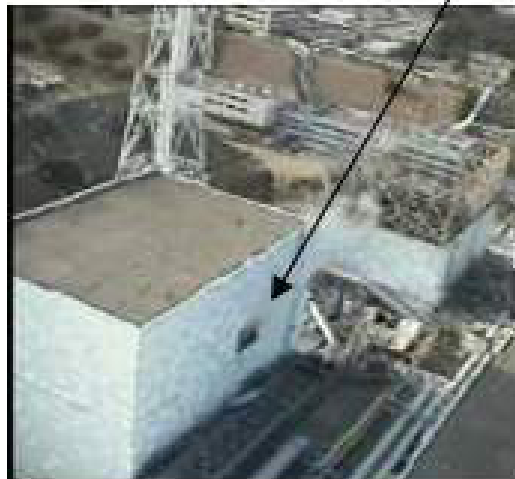
As of Apr. 10, 2011

Opened blowout panel

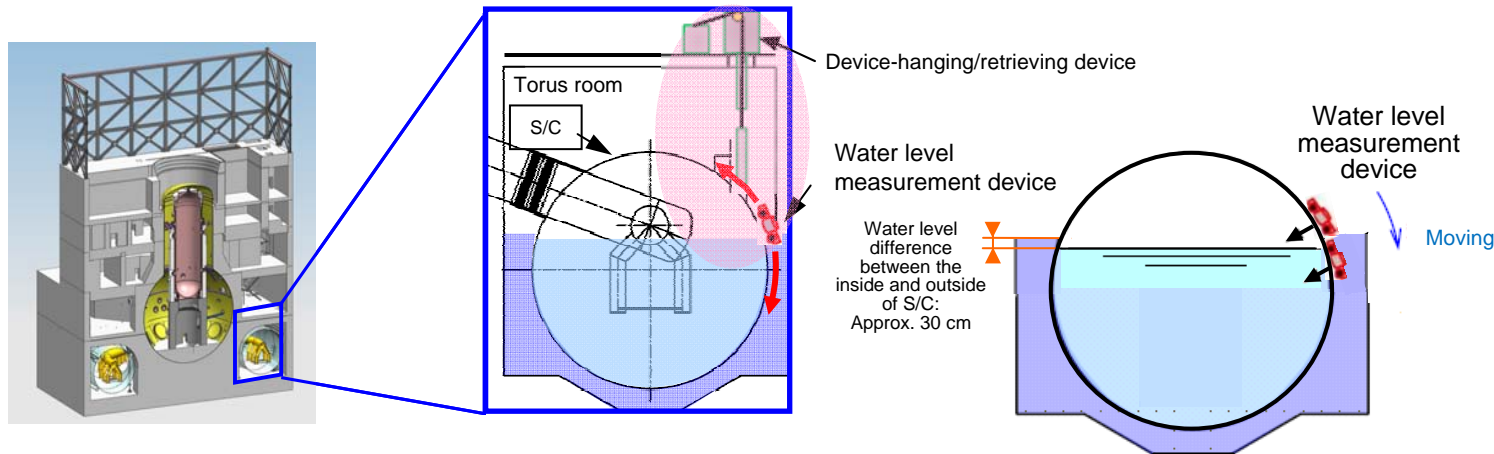
Overview on water level measurement in S/C at Unit 2

- To repair (seal the water leak locations of) the PCV in preparation for the fuel debris removal, the water level in the S/C was measured to assume the state of the opening area at leak locations in the PCV. (By checking the water level difference between the inside and outside of the S/C, the opening area was assumed, and it will be considered that it is possible whether the water sealing material might flow out of the S/C or not.)

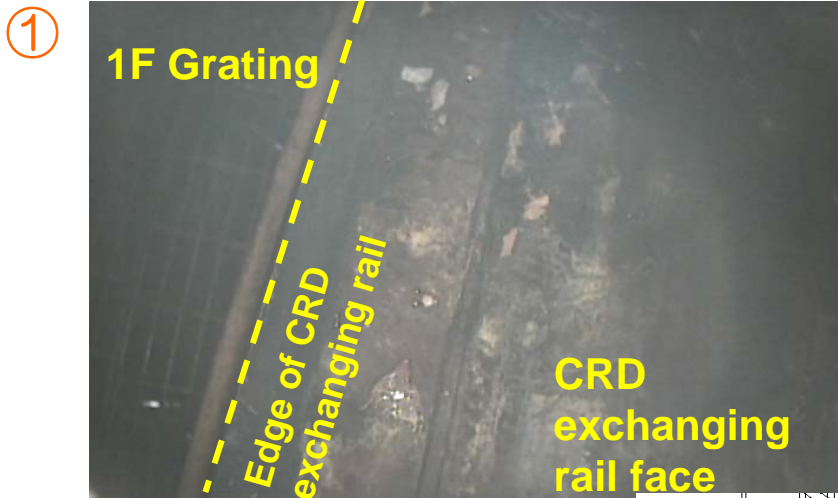
PCV (inside of pedestal) investigation In Unit 2 (Investigation results)

Finding of water levels inside unit 2 Pressure Containment Vessel

- After failing to insert a measurement instrument in March 2012, re-inserting of an instrument was successful in early June 2014.
- Water levels and temperatures inside PCV have since been monitored.

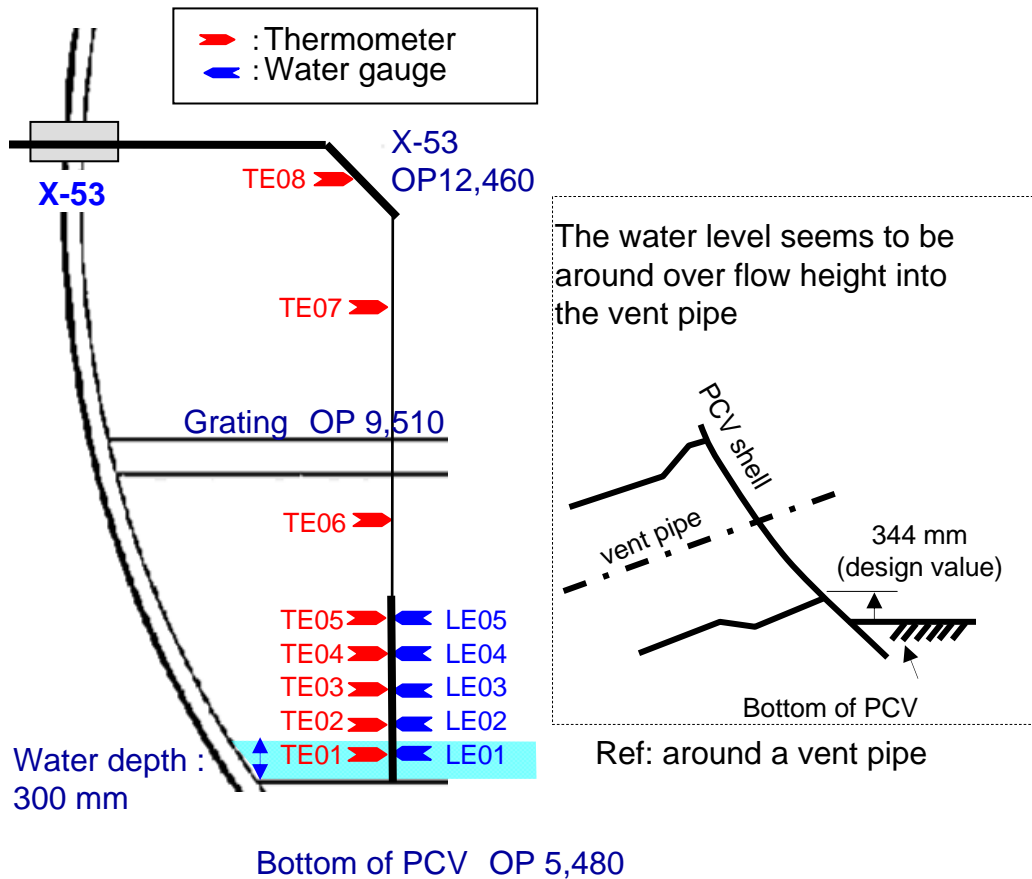
Monitoring results				Height
	Temp.[°C]	Water level		
TE08	33.7	-	-	OP.11,920
TE07	33.7	-	-	OP.10,690
TE06	33.5	-	-	OP.8,100
TE05	33.5	LE05	OFF	OP.6,430
TE04	33.5	LE04	OFF	OP.6,230
TE03	33.6	LE03	OFF	OP.6,030
TE02	35.0	LE02	OFF	OP.5,830 *350 mm from the bottom of PCV
TE01	35.8	LE01	ON	OP.5,630 * 350 mm from the bottom of PCV

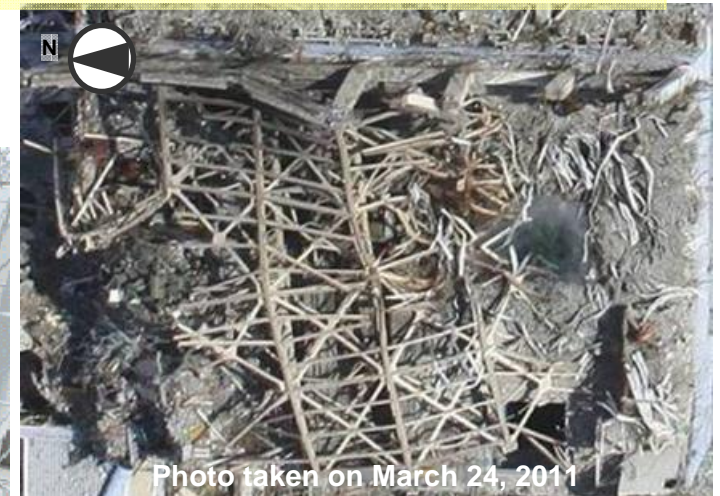
Before large debris removal

- With remotely operated heavy machinery, the removing activity of debris from the top floor completed (October 11, 2013)
- Fuel removal from spent fuel pool continuously conducted
- Currently developing/implementing the plan for decontamination and shielding against radiation

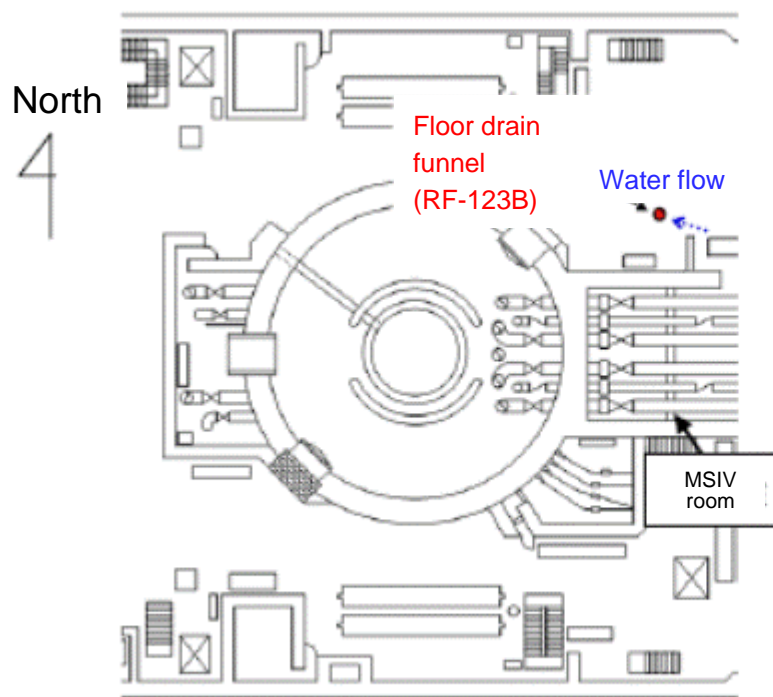
Floor map of 1st floor in R/B at Unit 3

- On January 18, 2014, checking the camera images from the debris removal robot (ASTACO-SoRa) in unit 3, our personnel found that water flowing from the area near the door of the main steam isolation valve (MSIV) room toward the floor drain funnel in the vicinity in the north-eastern area on the 1st floor at Unit 3 R/B.
- On January 21, 2014, it was identified that water injection amount was greatly reduced while the robot was operated for debris removal work.
- No change on plant parameter, etc has been found.

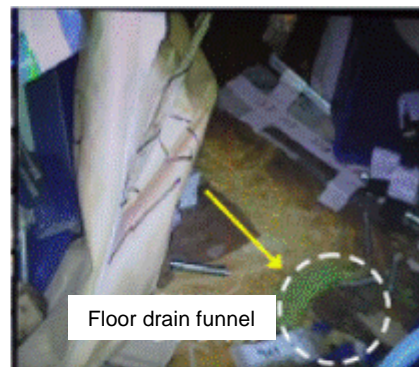
Water flow confirmed (on Jan. 18)

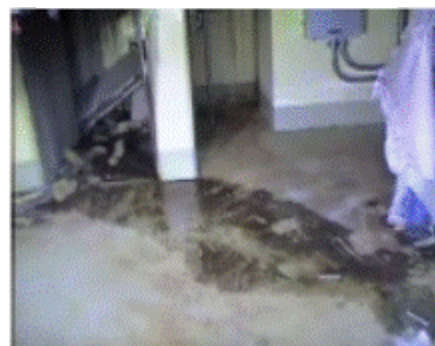
Water flow reduction confirmed (on Jan. 21)

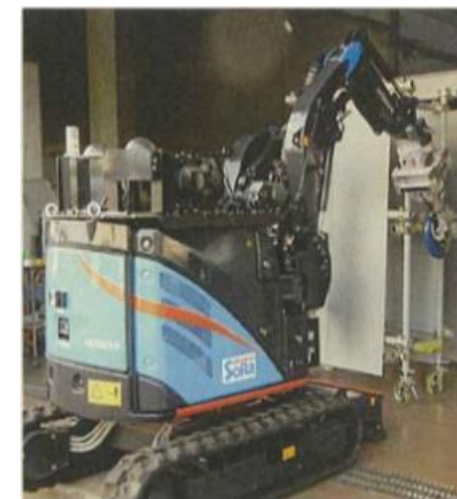
Remote-controlled heavy machinery (ASTACO-SoRa)

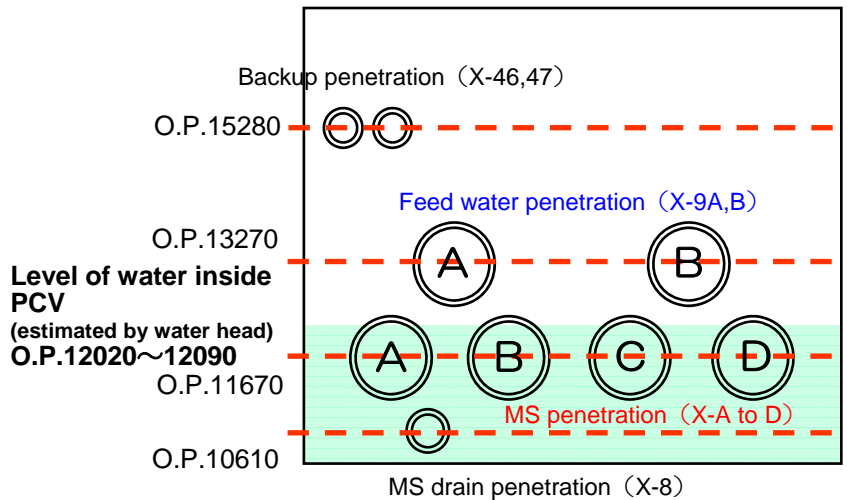
- On May 15, by inserting a camera into the Main Steam Isolation Valve (MSIV) room, a leak from around a Main Steam (MS) line was identified. It was the first confirmation of a leak from the Unit 3 PCV.

Penetration on PCV in MSIV room

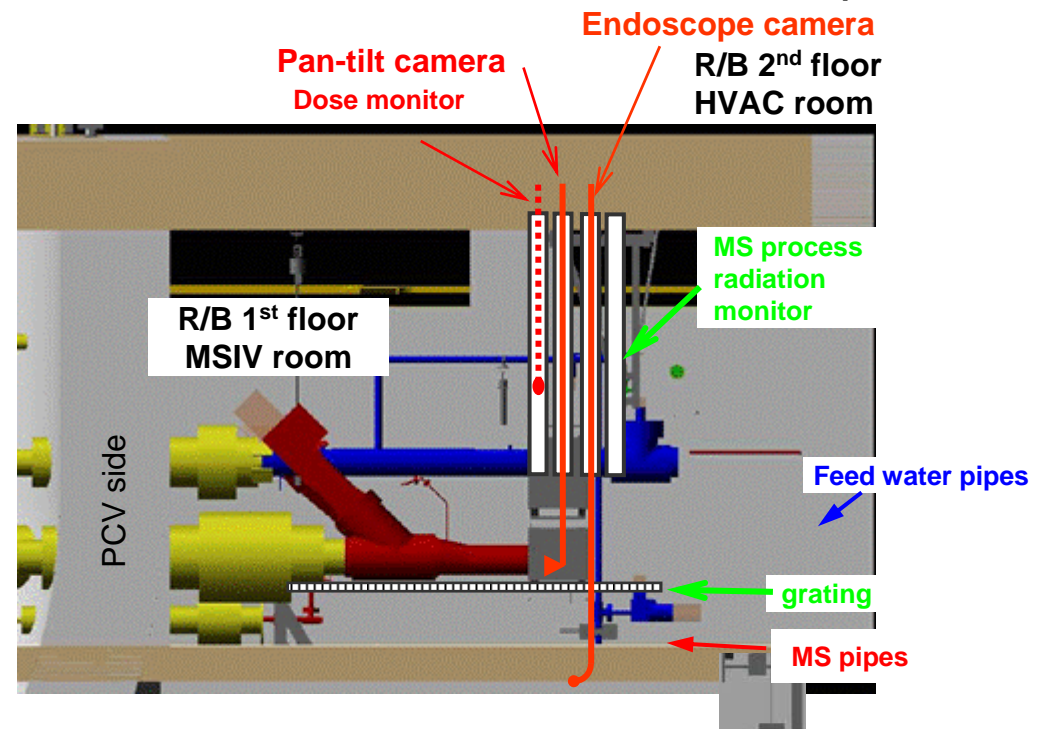
Cross section of MSIV room

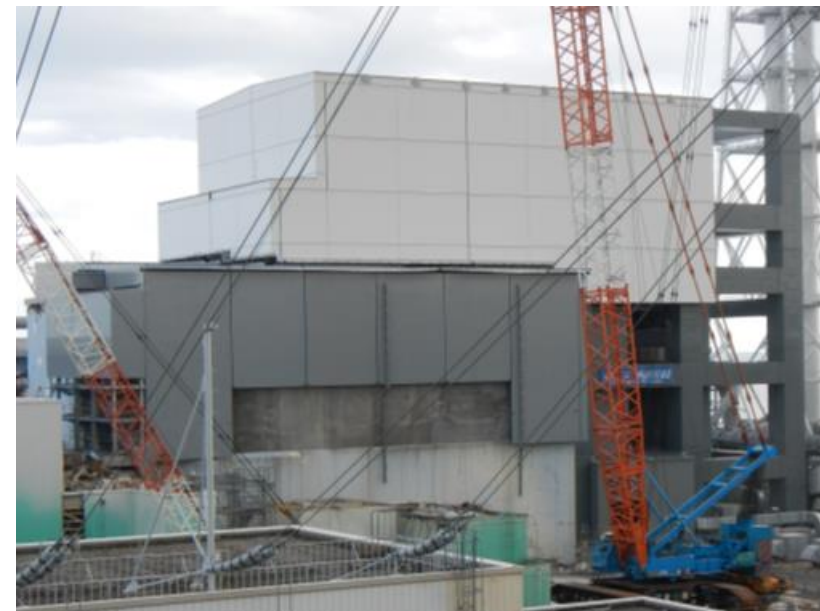
Fuel Removal Cover Structure
Present

- Continuing work while ensuring safety
- Exploring the methodology for the removal of the fuels with their leaks confirmed

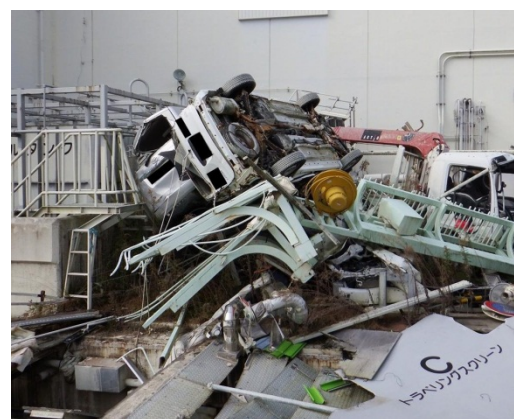
(Before)

Removal of damaged vehicle rubbles
