# Reactor imaging technology for fuel debris detection by cosmic ray muon

## Measurement status report in Unit-1

March 19, 2015

Tokyo Electric Power Company

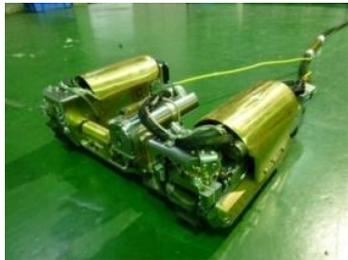
Photo of the exterior of B1 device

**B1. Investigation on the surface of grating on the first floor except for the area of the pedestal (Around April 2015 planned to start) : use of X-100B pipe**
