**Development of Technology for Detailed Investigation inside
Primary Containment Vessel (PCV)**

**(Onsite Demonstration for Detailed Investigation inside PCV
Through X-6 Penetration)**

Final Report for FY2021

International Research Institute for Nuclear Decommissioning
(IRID)

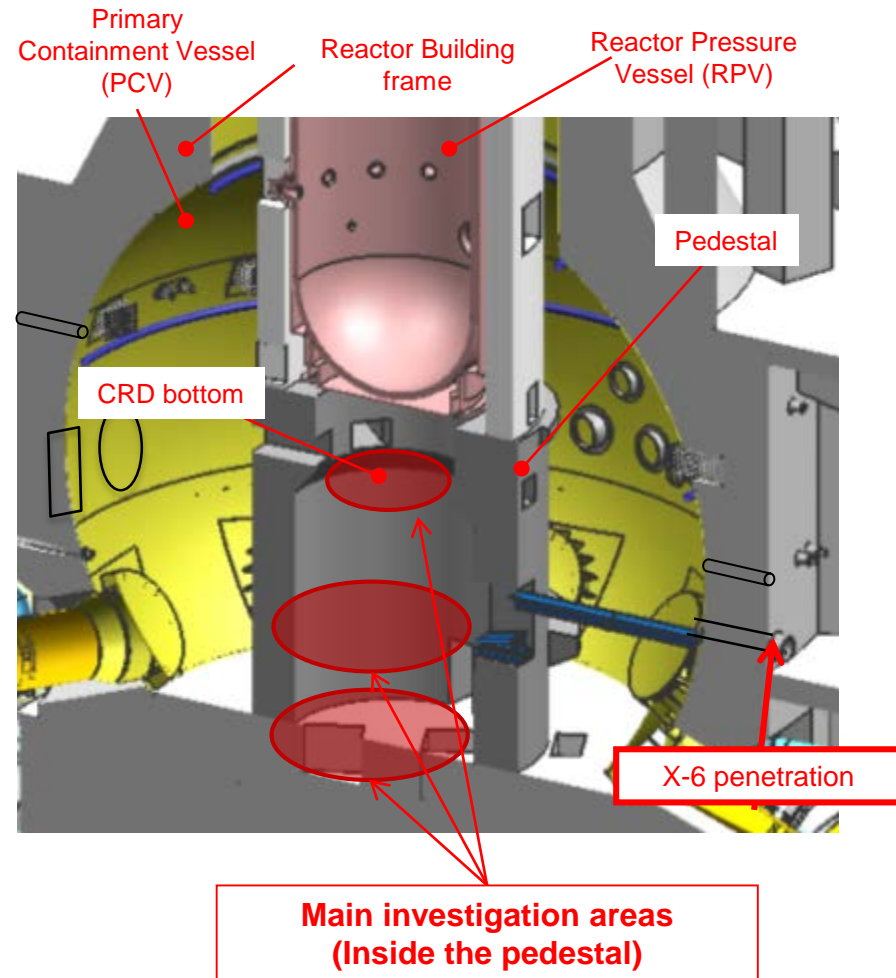
[PCV cross-section and overview of the sites to be investigated]

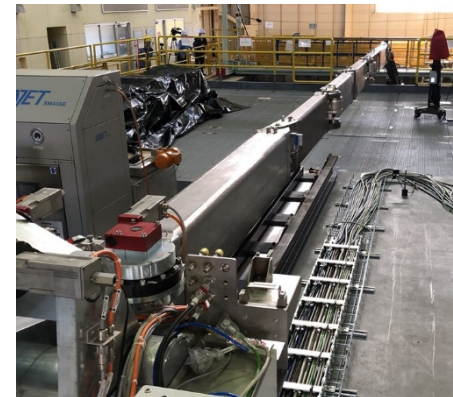
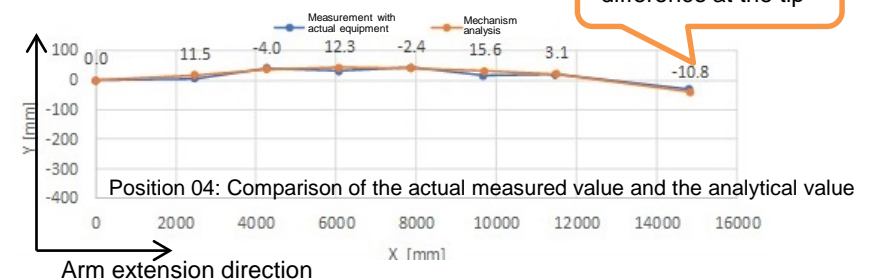
- Acquisition of data on arm deflection in every position (Verifying that the actual measured value roughly matches the analytical value)
- The deflection data will be reflected in the arm operation and control program and is planned to be verified at the JAEA Naraha mock-up facility.

Onward motion of the arm

Vertical direction

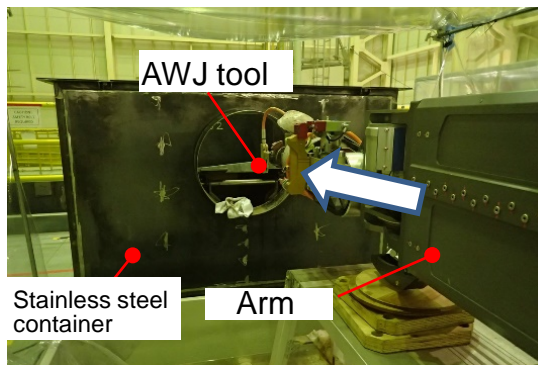
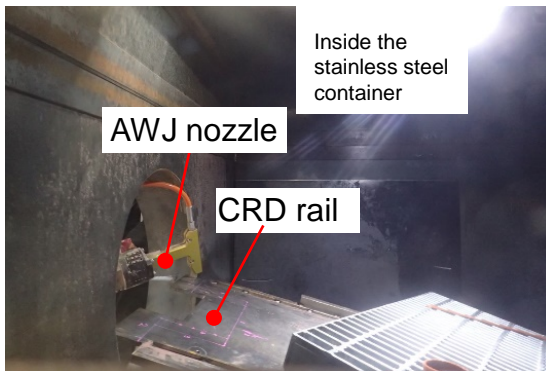
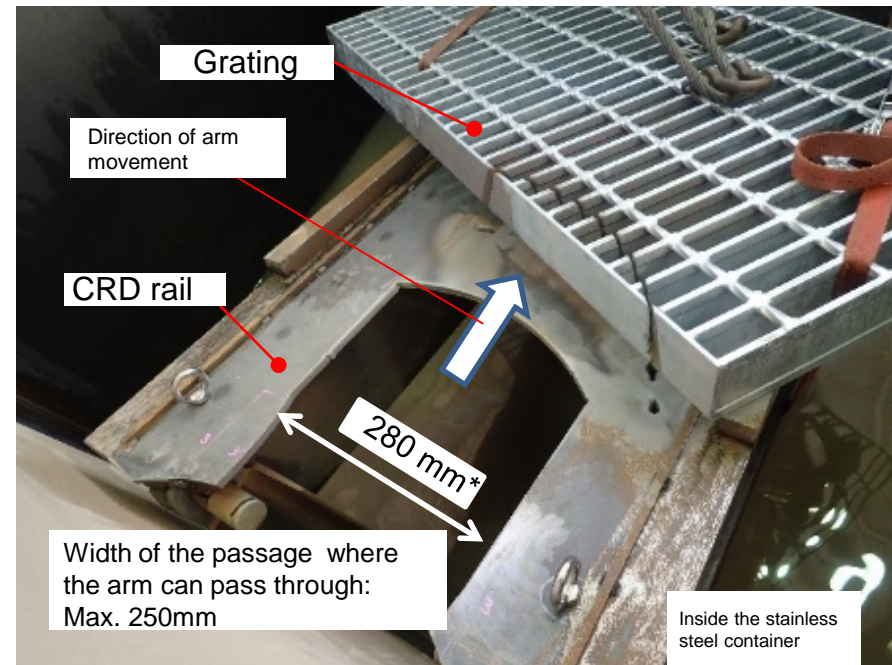
- The tip tool (AWJ) installed on the arm cut the CRD rail and the grating (without the cables).
- The prospects of removing obstacles from the area through which the arm can pass through, were verified.

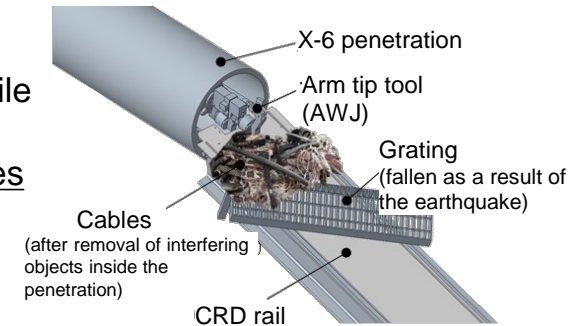
- The prospect of cutting and removing the cables on the CRD rail were verified while the tip tool (AWJ) was installed on the arm.
- From the viewpoint of reducing operating time, the detailed and revised procedures are needed such as the order of cutting the sites to be cut (CRD rail, cables, etc.) and direction of AWJ spray, etc. ⇒ Continued testing at the JAEA Naraha mock-up facility.

Test status

Verification that the cables can be cut and removed by the AWJ spray

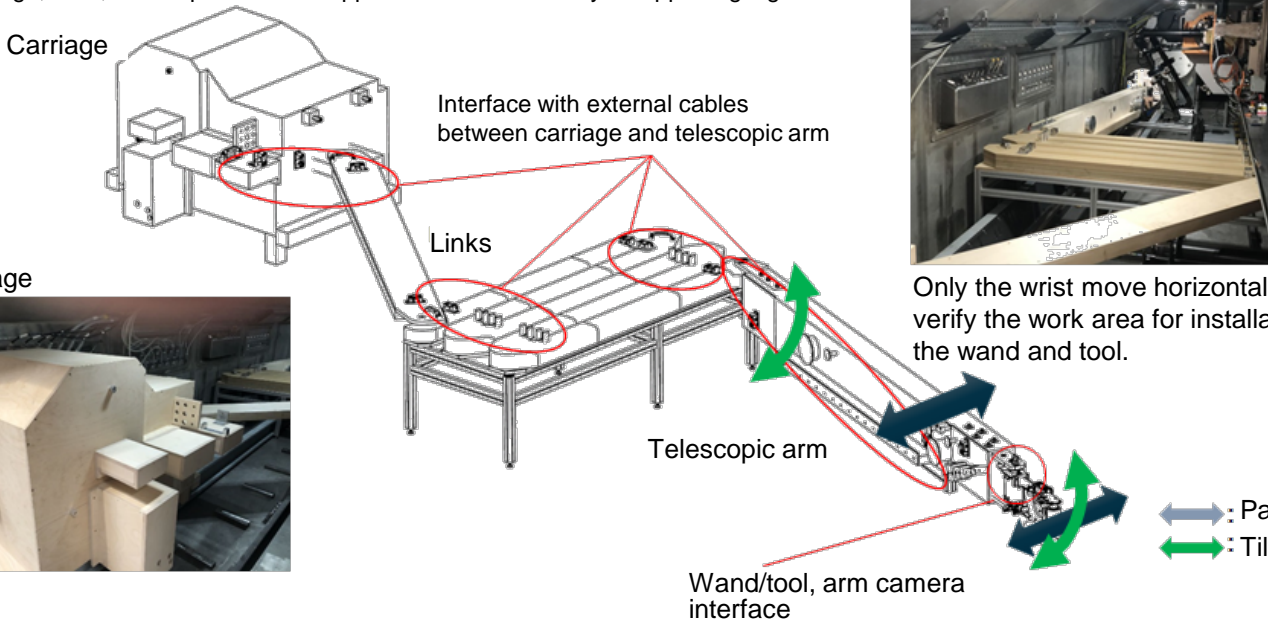
Range of motion of the carriage for the manipulator for maintenance

Only the wrist move horizontally and vertically to verify the work area for installation and removal of the wand and tool.

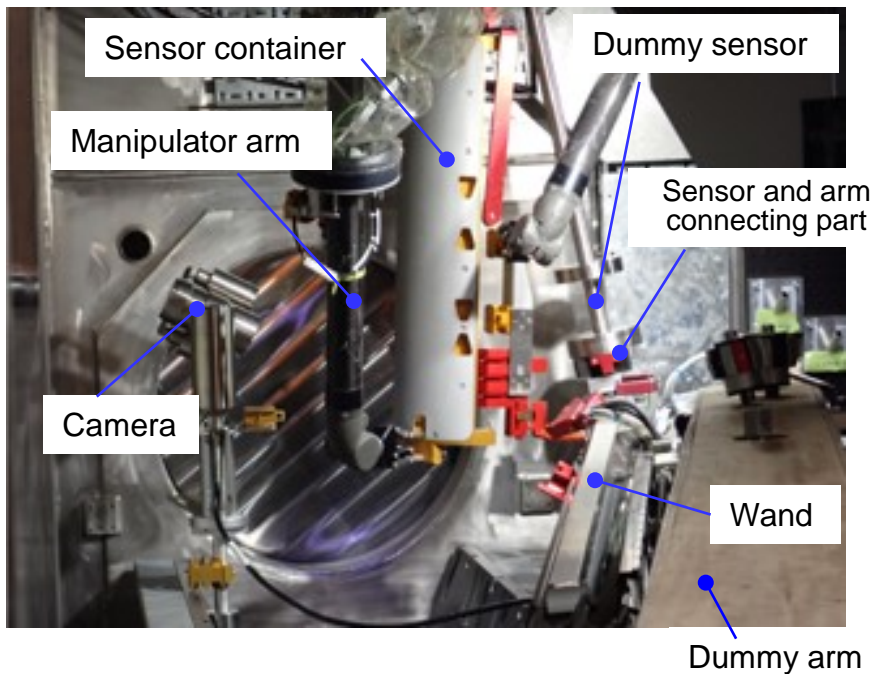
- The work of connecting with the dummy arm using the actual wand, a sensor container, a dummy sensor and a dummy tool was conducted and their viability was confirmed. The following improvements were identified.
- Improvement in the field of vision of the tool installation position ⇒ Effects of improvement will be verified at the JAEA Naraha mock-up facility.

Connection of the sensor and arm (wand)

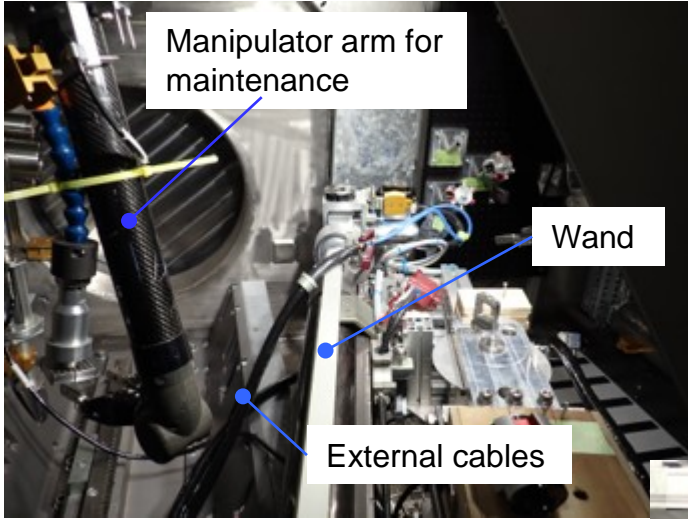
- The external cables on the wand was installed and their viability was confirmed. The following improvements were identified.
 - Modification of a part of the metal bracket structure for installing external cables in connection with drawing around the external cables to the wand
- ⇒ Effects of improvement will be verified at the JAEA Naraha mock-up facility,

Work of drawing around cables to the wand

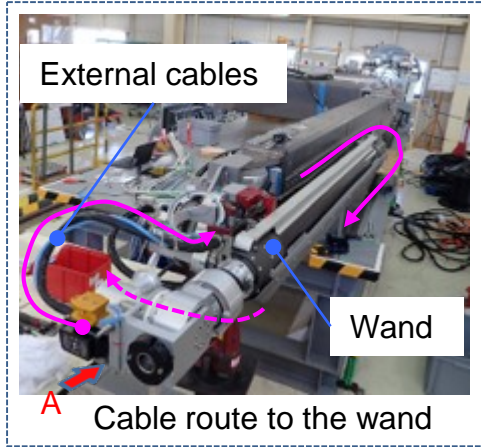
The structure of the metal bracket needs to be modified as the work of installing the metal bracket for installing the cables will be done in limited space.

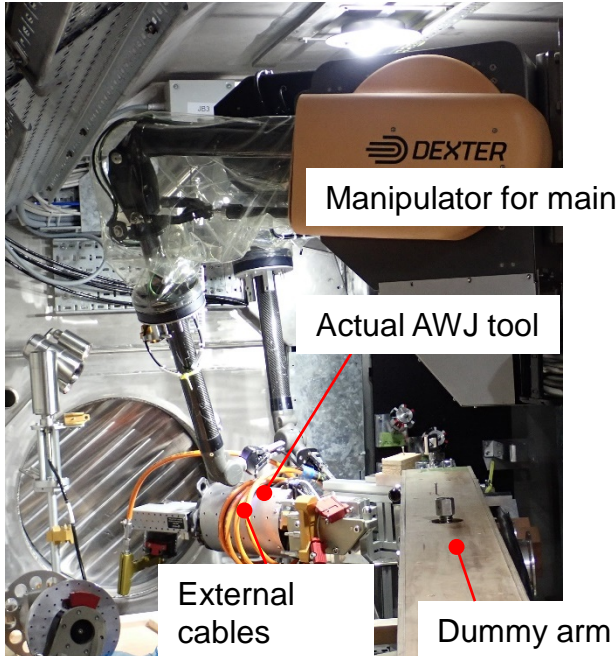
- The installation of the external cables with the dummy arm was conducted and their viability was confirmed. The following improvements were identified.
- Improvement of the metal bracket structure for installing external cables in connection with drawing around the external cables to the arm link part
 ⇒ Effects of improvement will be verified at the JAEA Naraha mock-up facility.

Installation of external cables on to the tool

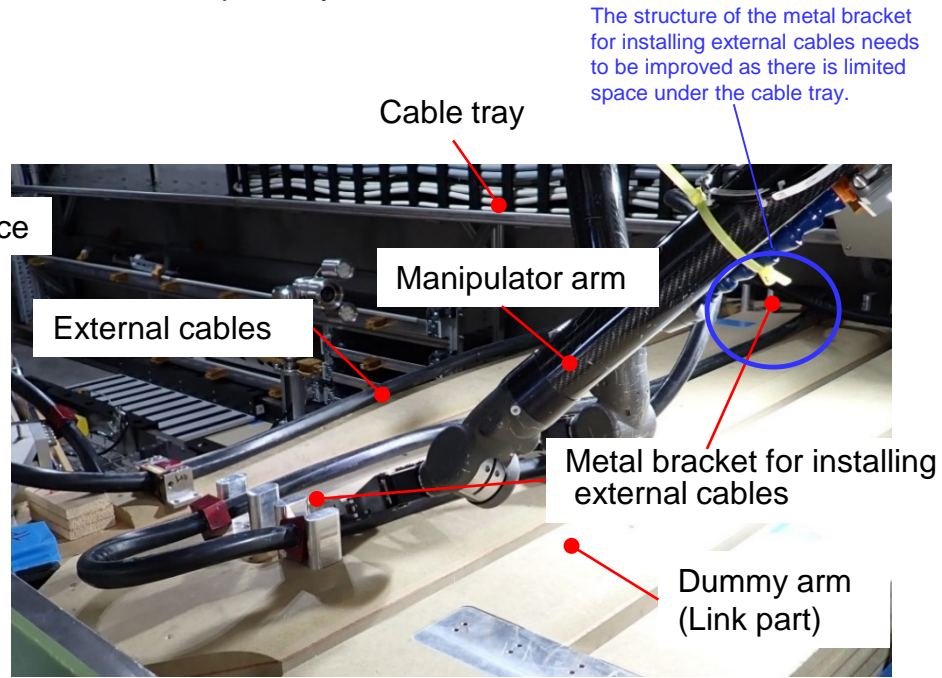
Installation of the external cables on to the arm link part

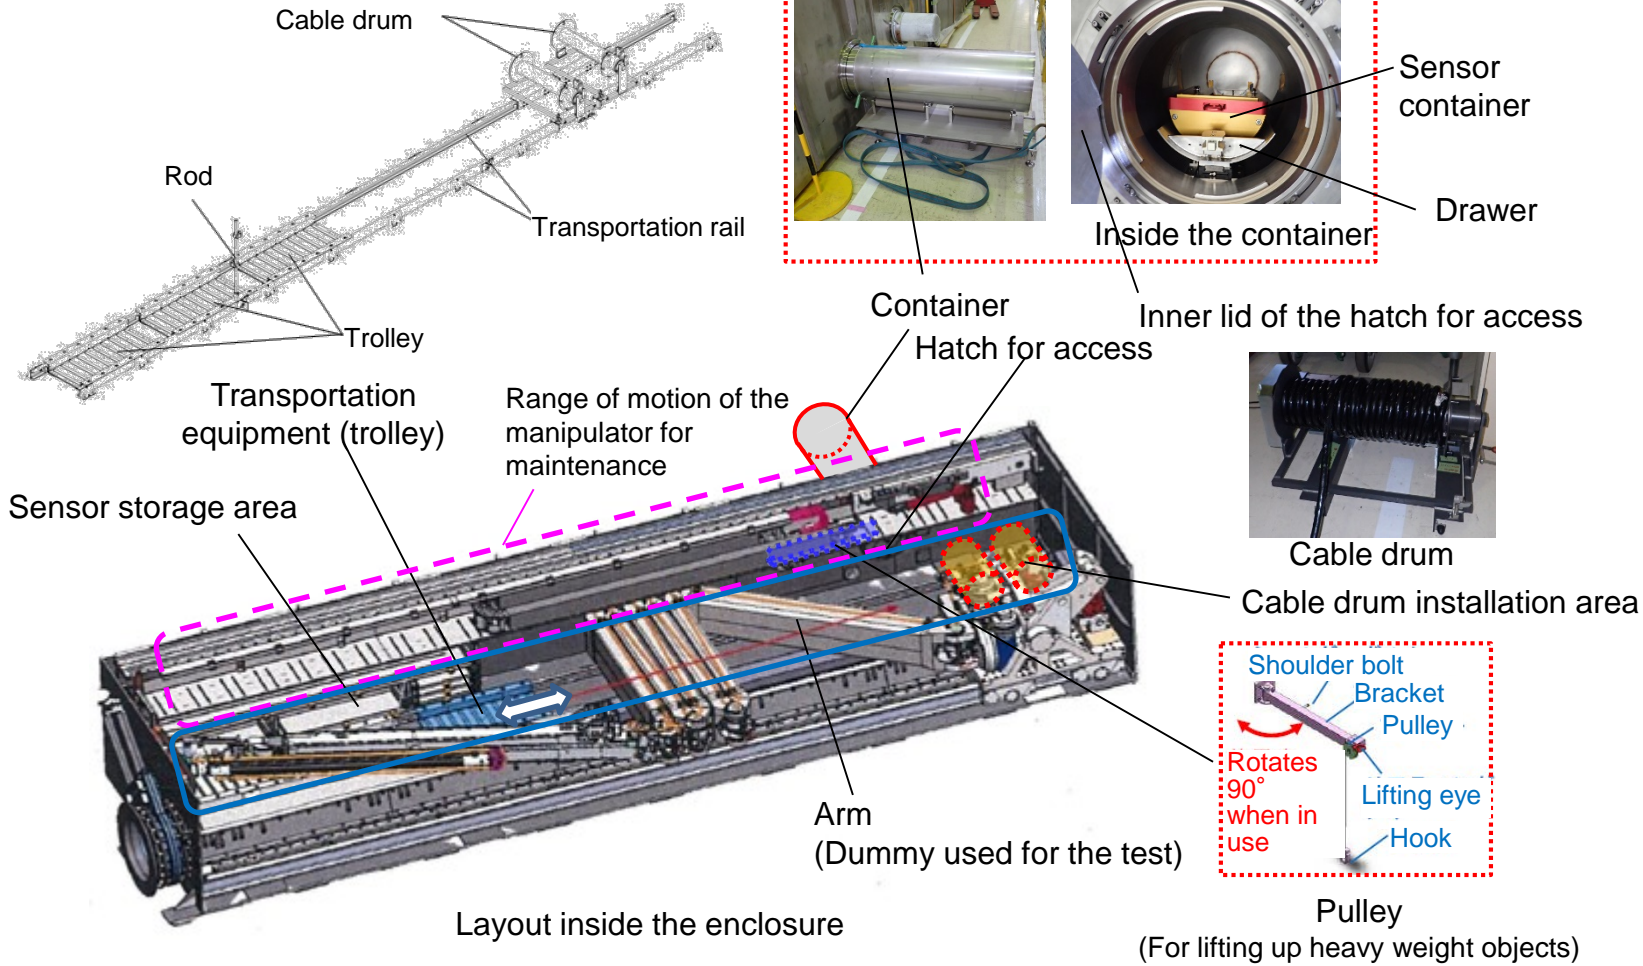
[Overview of carrying-in/out]

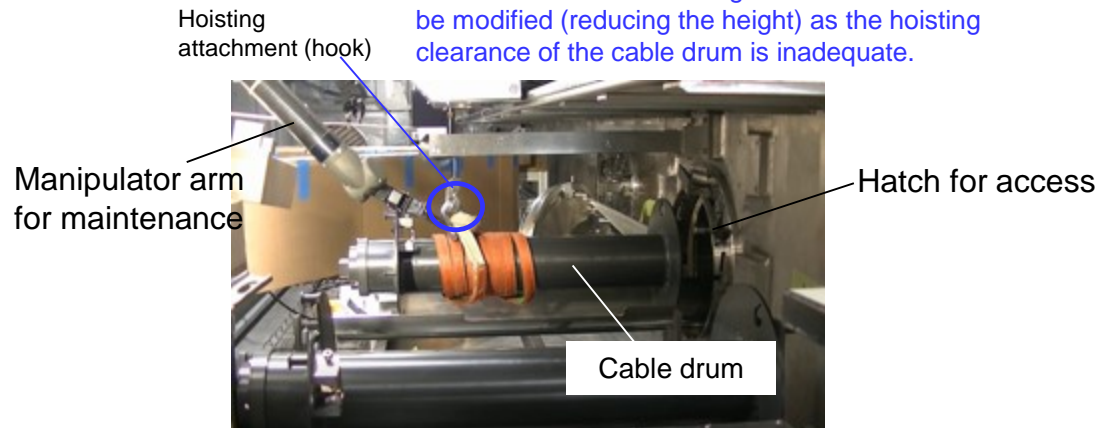
Since transportation by means of a trolley using a rod requires time due to limited space, the transportation jig needs to be improved.

Direction of the view from camera

Trolley for installing the cable drum

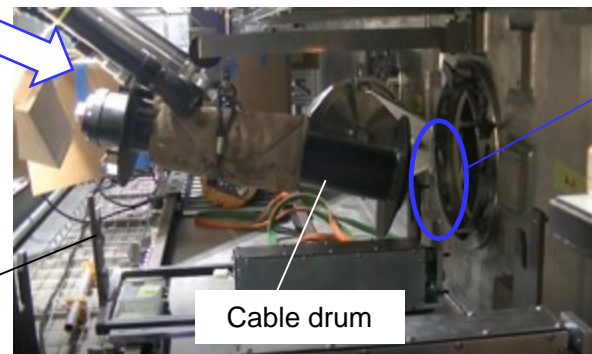
The rear side of the cable drum is at a blind spot which affects work. The field of vision needs to be improved (securing an opening towards the cable drum, etc.).

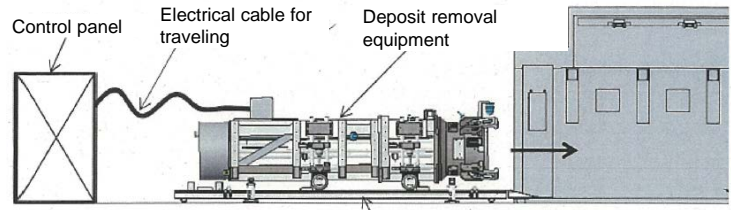
Layout plan for installing the deposit removal equipment

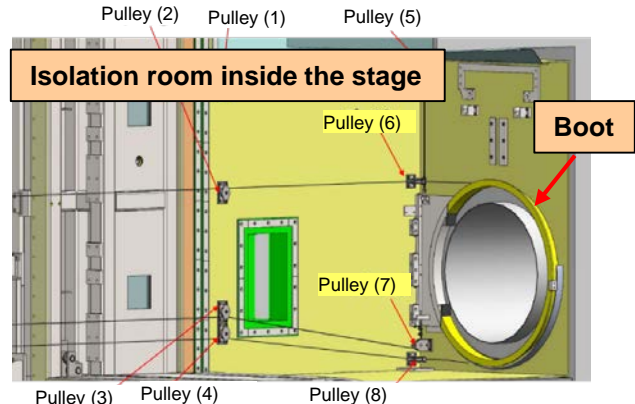
A method was developed in which a mechanism was provided for rotating the boot by means of wires and pulleys and installing it inside the isolation room, and in addition, a boot transportation equipment that can install the boot by means of remote operation was manufactured so that the isolation room can be removed from inside the stage in the remote chance that this needs to be done.

Layout of the wires and pulleys in the isolation room

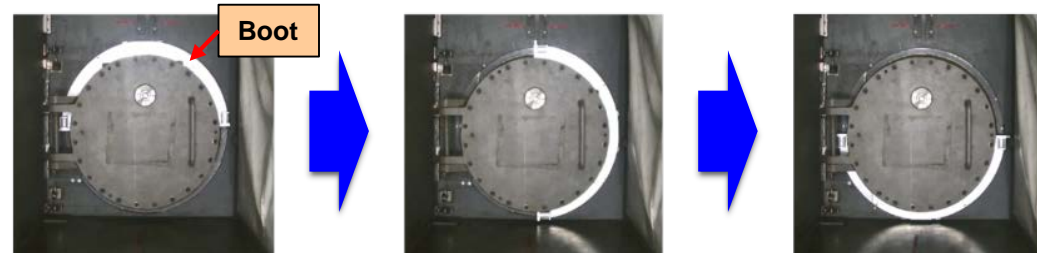
Installation of lower boot (Image captured without the boot transportation dolly)

Steps for installing the lower boot

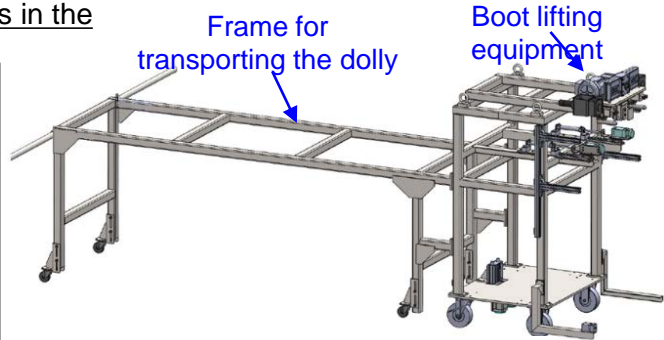
<Boot lifting equipment>
 Equipment for lifting and lowering the upper and lower boots over the penetration piping by means of remote operation

Boot transportation equipment

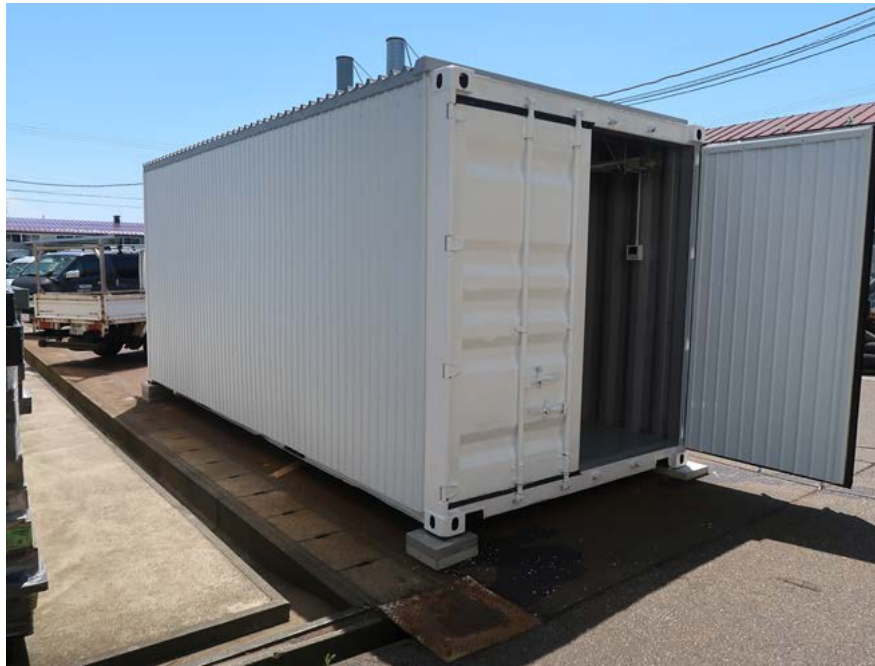
The layout of the boards and equipment inside the container was reviewed, and the specifications of the accessories such as lighting, etc. were finalized. Some of the plant rooms were manufactured.

[Plant room]

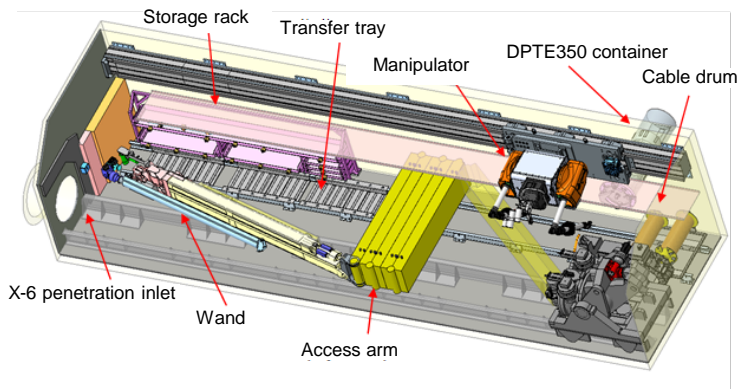
Arm enclosure and manipulator for maintenance
(3D-CAD model)

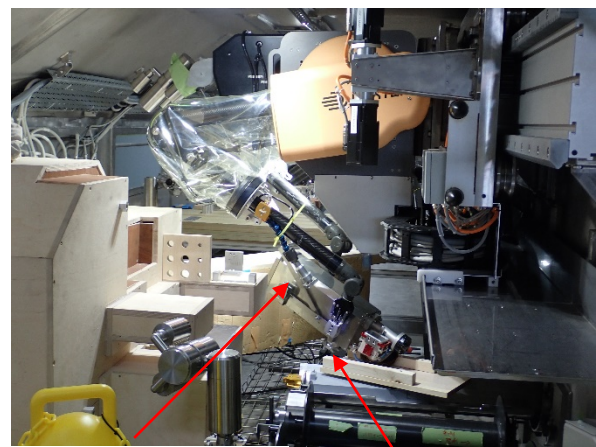
The rolling hanger to support the equipment Gripper added to the sides

Carrying-in from the DPTE350 port

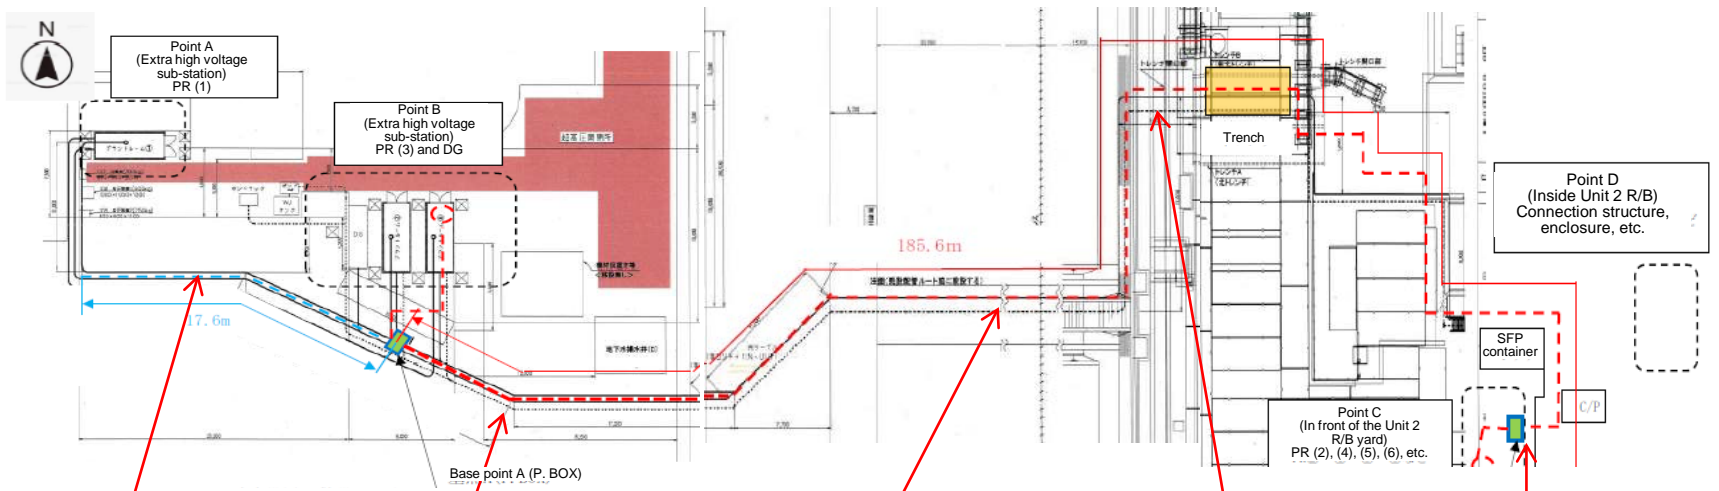
A cable run (trough and cable tray) was installed on the route for outdoor laying of cables and the power and control cables were placed in the cable run, following TEPCO's guidelines related to laying of cables.

a. Trough installation [1]

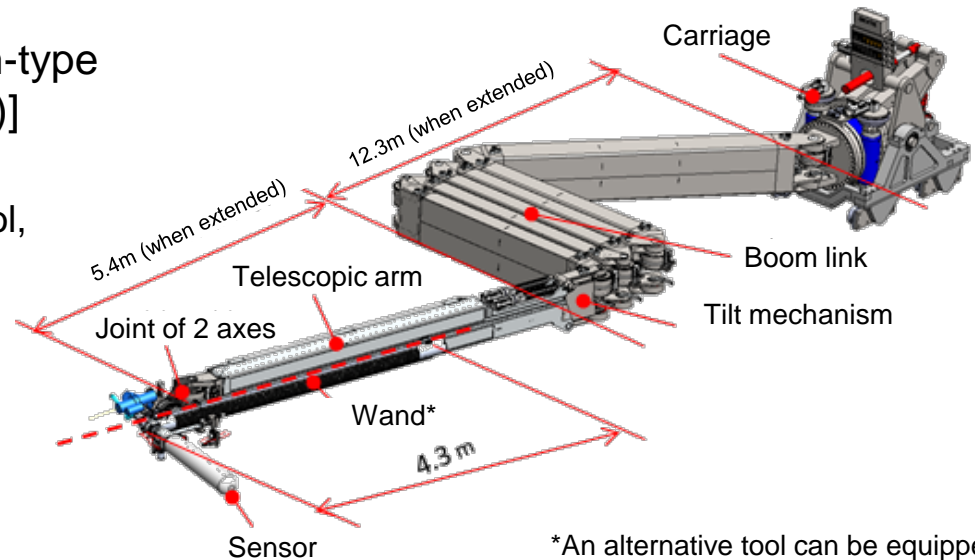
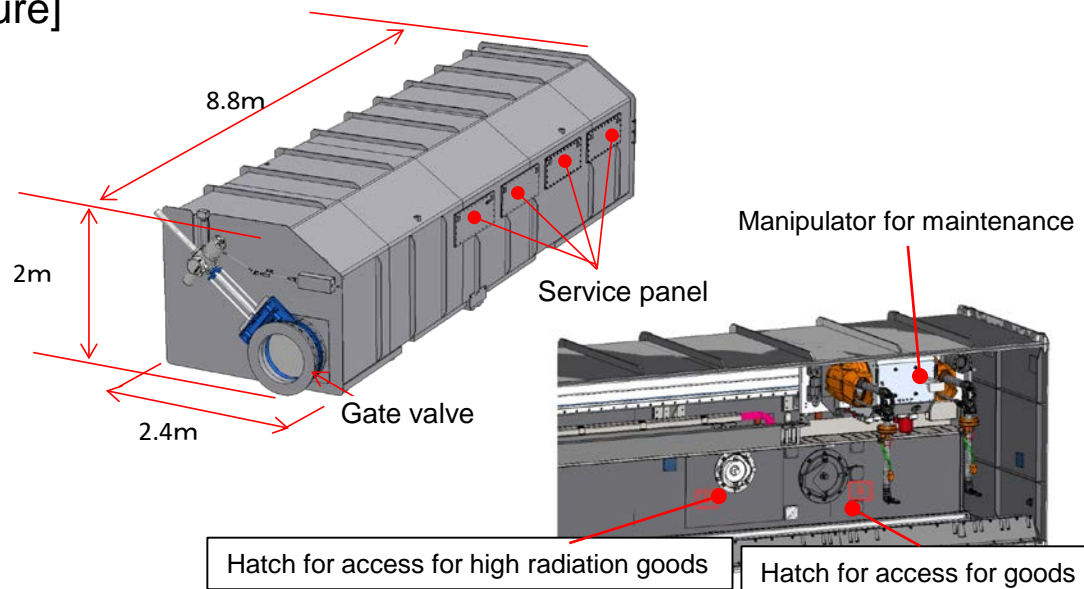
- ✓ Mass: approx. 30t
- ✓ Main material: Stainless steel
- ✓ Design pressure: -5 to +10kPaG
- ✓ Leakage rate: 0.05 vol%/h
- ✓ Accessories

Manipulator for maintenance, sluice valve, camera, lighting and etc.
