# Investigation results of the Unit 1 pedestal floor

Tokyo Electric Power Company (TEPCO) Holdings, Inc. investigated the pedestal opening. The first-half investigation on March 2022 confirmed that the pedestal wall of the opening part was damaged. The second-half investigation on March 2023 confirmed that the entire circumference of the pedestal interior was also damaged.

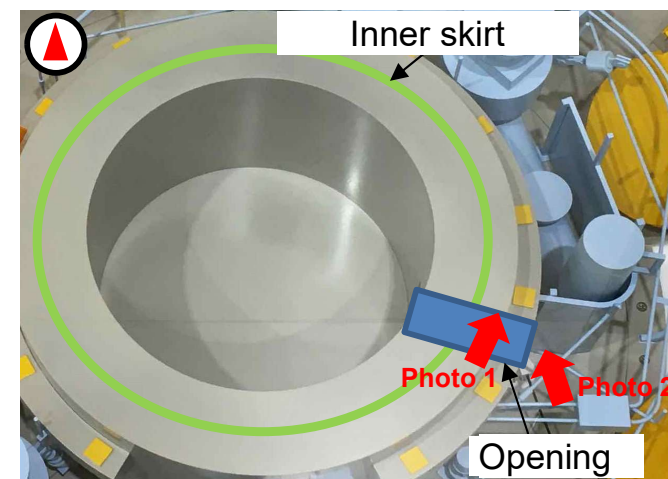
Photo 1: Concrete remains seen from the pedestal opening

- TEPCO assumes that the lost concrete area of the pedestal inner wall (only concrete remains) is approximately 1 meter in height and 50cm in depth.
- The lost of the pedestal outer wall opening would be limited.

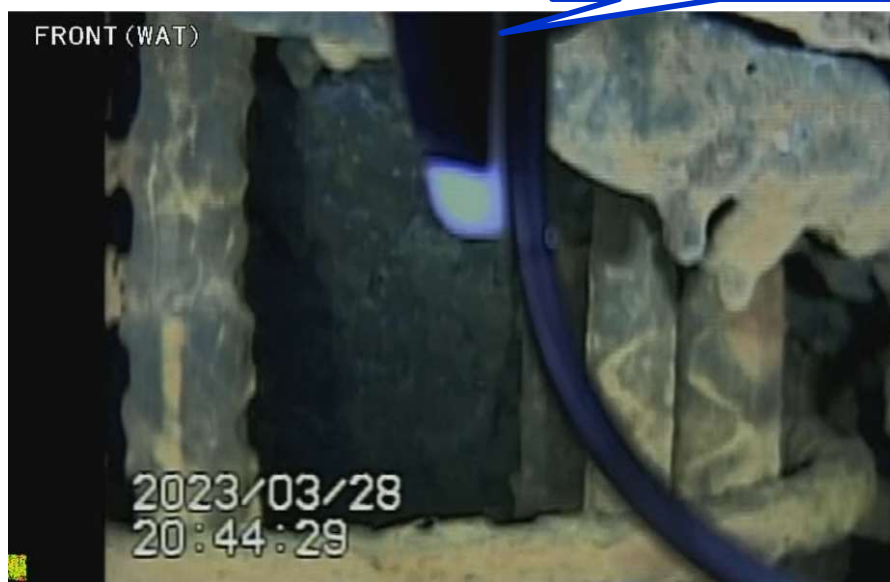
Photo 2: Concrete remains seen from the pedestal opening

A ROV frame can be seen,
