Subsidy Project of Decommissioning and Contaminated Water Management
in the FY2015 Supplementary Budgets

Development of Technology for Detailed Investigation inside PCV

Accomplishment Report for FY2017

International Research Institute for Nuclear Decommissioning (IRID)

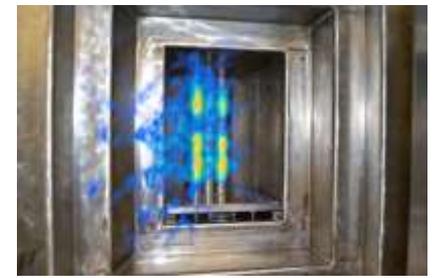
Results of the dynamic range confirmation

Based on the test measurement data at 1000 Gy/h, the image was converted to the dose data distinguished by irradiation direction. By overlapping it with the image of the actual environment, it was confirmed that the source locations could be identified. (The same test was also performed at 1 Gy/h.)
