**Subsidy Project of Decommissioning and Contaminated Water Management  
in the FY2016 Supplementary Budgets**

**Development of Technology for Detailed Investigation  
Inside PCV**

**FY2018 Accomplishment Report**

International Research Institute for Nuclear Decommissioning

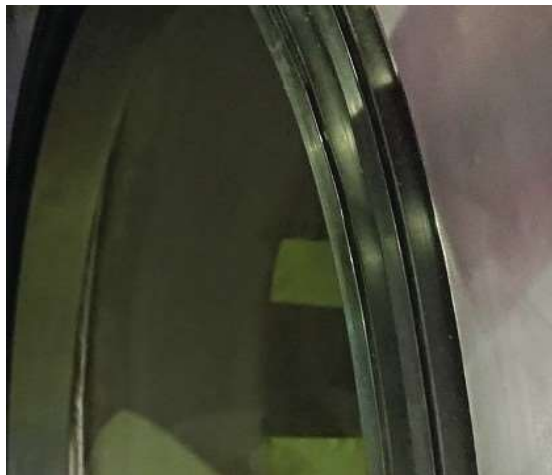
Lip seal (EPDM)

- A lip seal is used due to its ability to fit with a given shape, taking into consideration that the surface condition (flatness) of the flange of the X-6 penetration is not known.

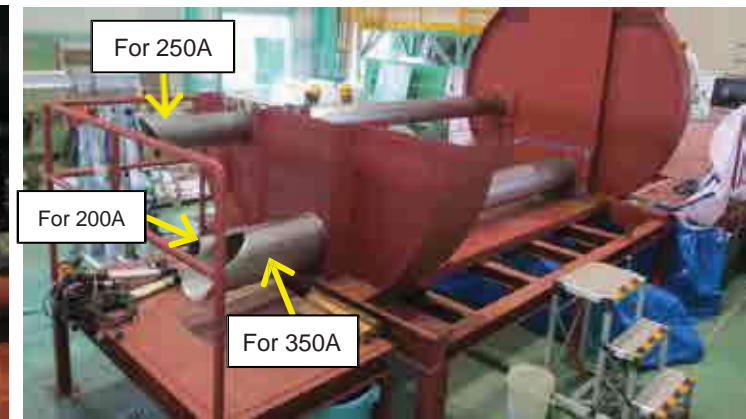
Figure 4.3-7. During Insertion of Guide Pipe for 350A

- It was demonstrated that the guide pipe can be inserted without impairing the isolated condition of the work area.
- Although there was no problem, the outer diameter of the 350A guide pipe for the AWJ head was changed according to a request from the investigation device team.

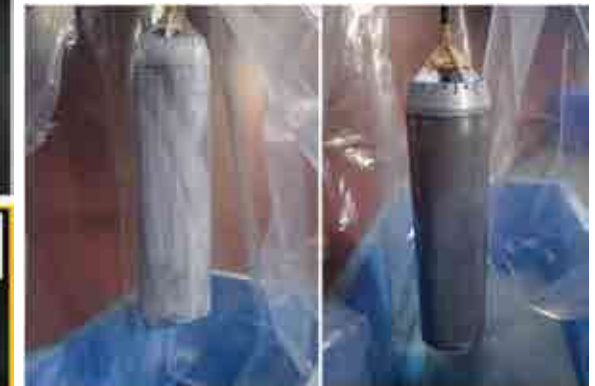
Before cleaning

Test the performance of the cleaning device by applying chalk powder on the surface of the ROV mockup. No cleaning residue was found even in concave portion. The cleaning performance was confirmed satisfactorily.

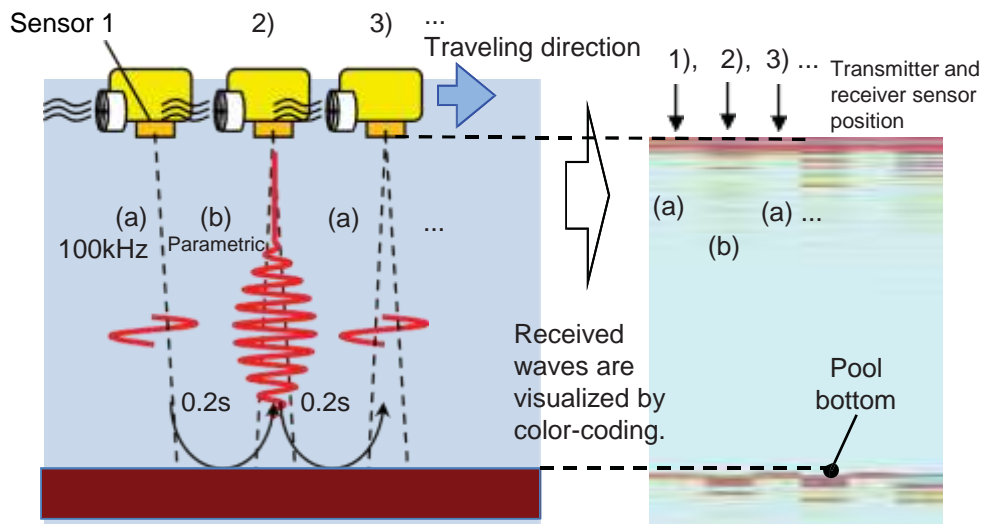
Figure 4.5 (1) (iv)-4 Ultrasonic image scanning method used in combination test

- A deposit thickness measurement test was performed with 100 mm and 300 mm thick deposit simulants placed on the bottom of 2.1 m deep water pool. In this test, the high-power ultrasonic sensor was loaded on the ROV, and ultrasonic waves were irradiated in a manner where (a) 100 kHz basic measurement method and (b) parametric method were switched alternately at a high frequency while having the ROV keep on traveling (See Figure 4.5 (1) (iv)-4)
- It was demonstrated that the measurement method is less susceptible to the posture of the ROV and disturbing noise and can capture the image of the surface and bottom face of deposit as well as objects buried in deposit and also can measure deposit thickness (Figure 4.5 (1) (iv)-6))
