# Request for Information (RFI) of Innovative Approach for Fuel Debris Retrieval

Items for “Request for Information”

International Research Institute for Nuclear Decommissioning

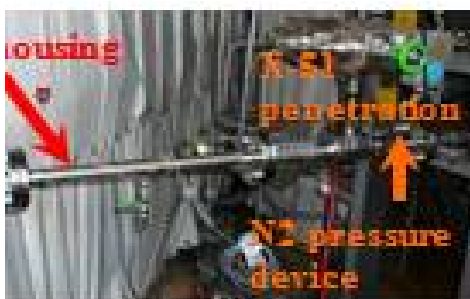
Installation of temperature gauges

- Core is cooled continuously by water injection and the temperature is low. (around 40 °C)
- No criticality is confirmed by monitoring temperature and noble gas.

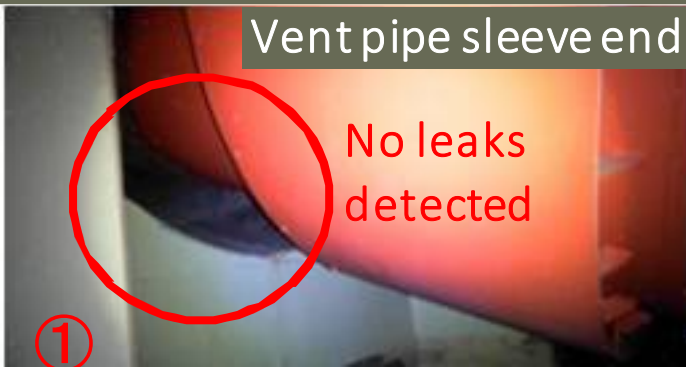
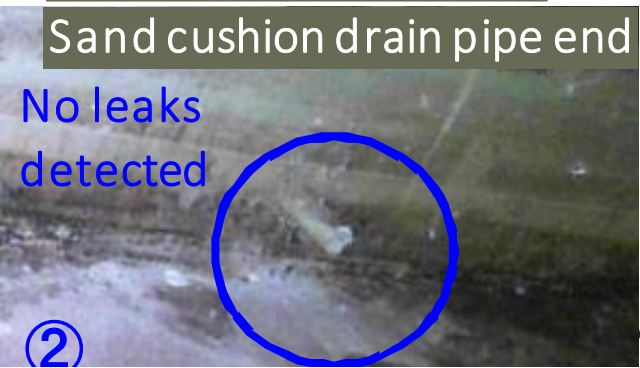
[Current status confirmed]  
 ➤ Injected water has been accumulated into the bottom of torus room as a result of possible leakage in somewhere.

[Information not yet obtained]  
 ➤ Leakage point is not found at Unit 2.

Implementation Date: December 11, 2012  
 Survey Target: Refer to left diagram

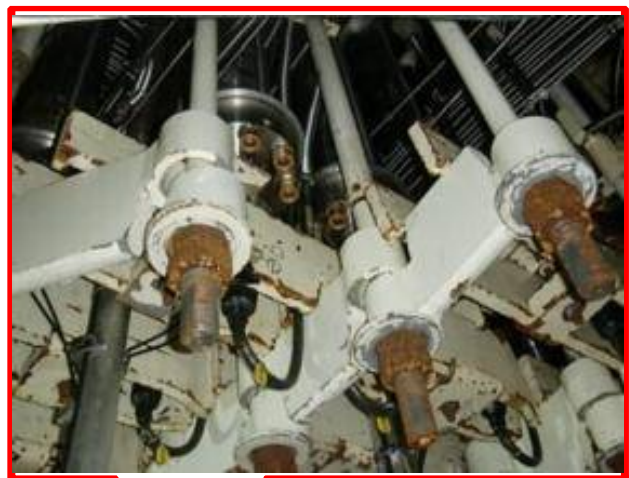
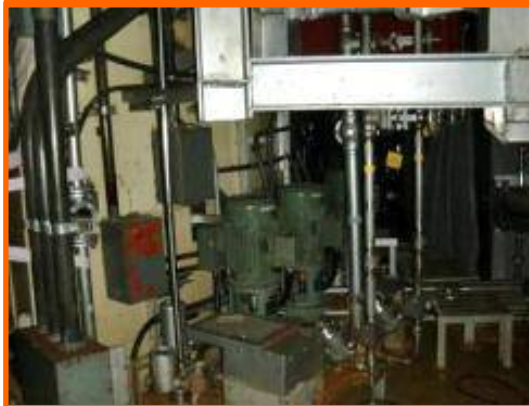
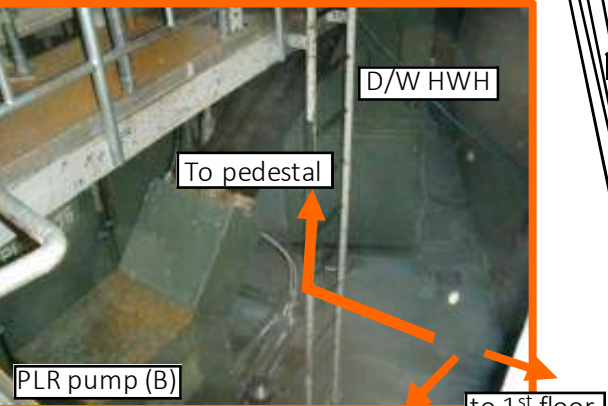
Internal Structure of RPV

Internal structure is so complicated that access of observation equipment to inner PCV is not easy.

\* Photos are taken at Unit 5 (Just for reference)
