Development of technology for detailed investigation inside the primary containment vessel (on-site demonstration for detailed investigation inside PCV through X-6 penetration)

Final report for FY2020

**International Research Institute for Nuclear Decommissioning
(IRID)**

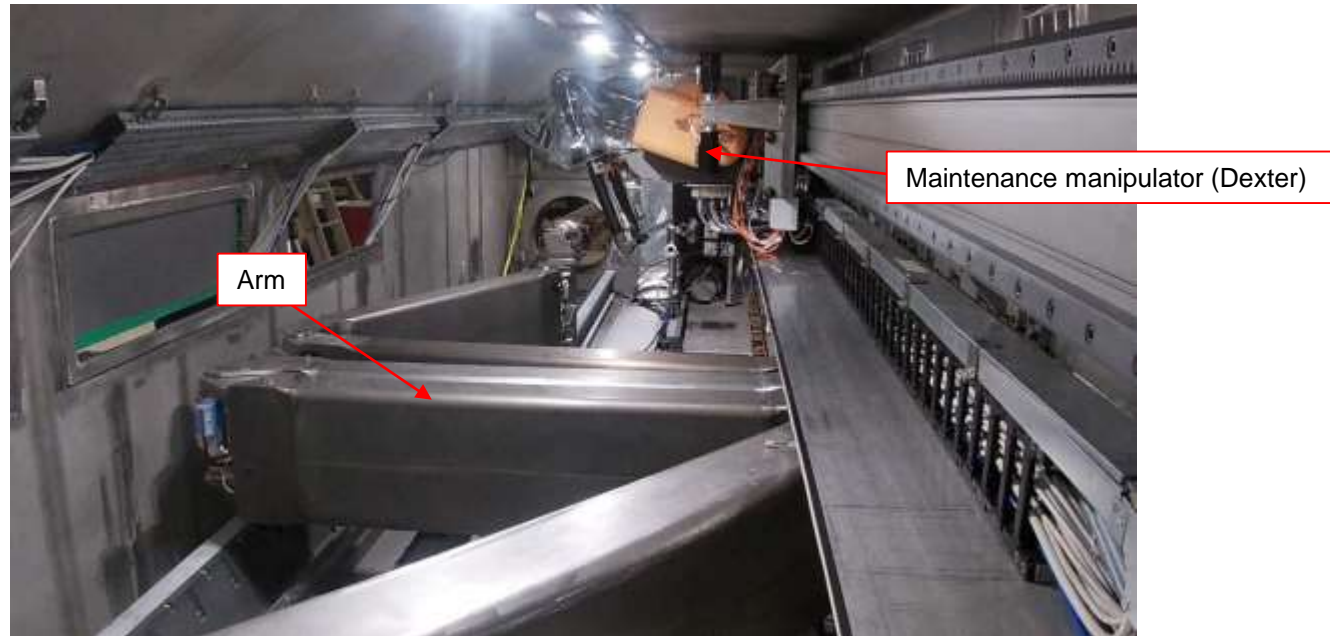
Installing equipment in the enclosure

The test results confirmed that the arm and the maintenance manipulator can be moved without mechanical interference, and electric functions (control and image signals) are at satisfactory levels.

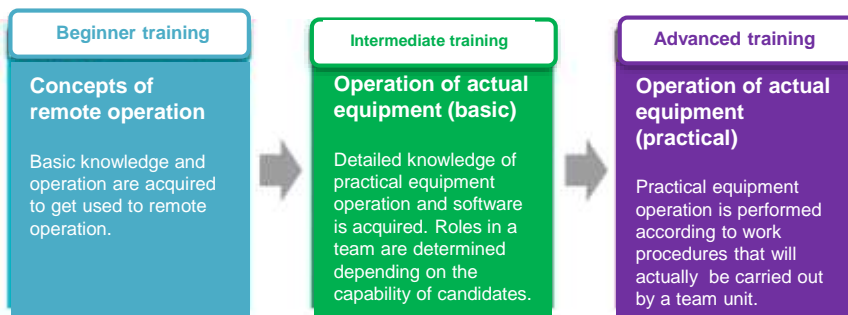
Training steps

Steps	Summary of training
Beginner training	<ul style="list-style-type: none"> • Remote operation method and operation precautions • Basic operation of Dexter • Basic operation of control and VR systems
Intermediate training	<ul style="list-style-type: none"> • Overview of the arm-type access and investigation equipment • Work with the arm-type access and investigation equipment (theory and practice) • Intensive training for an arm operator (learning of equipment operation) • Skill evaluation (by testing)
Advanced training	Operation of the entire work procedure for investigation plan (including emergency operation)

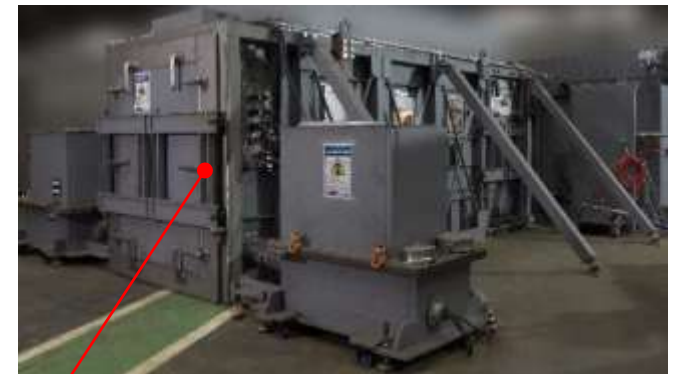
- **Functions:**
 - Serves as a boundary covering the interior of the concrete stage in the area from the X-6 penetration sleeve to the hatch isolation room.
- **Specifications:** Approx. 1ton/W1.2 × L1.7 × H1.8m

- **Functions:**
 - Serves as a boundary while the hatch is being opened.
 - Serves as a boundary/shielding by means of an air-tight door after the hatch has been opened.
- **Specifications:** Approx. 5.5ton/W1.7 × L5.3 × H2.5m

Isolation room (full view from behind)

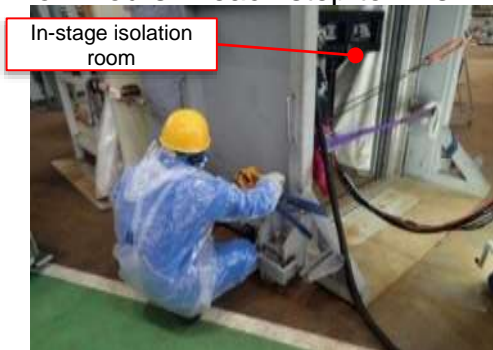
In-stage isolation room installation work

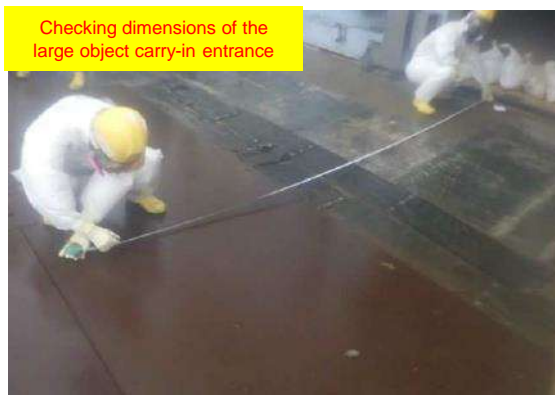
Measuring the west yard

- Site investigation of the inside of the reactor building and the west yard was undertaken to verify hatch opening at the site. The information obtained in this investigation will be utilized for the site verification.

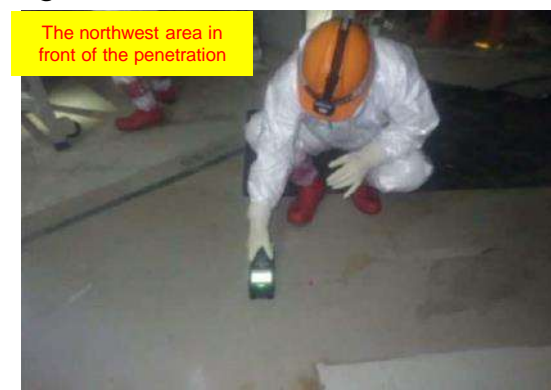
Detecting buried metal in the reactor building

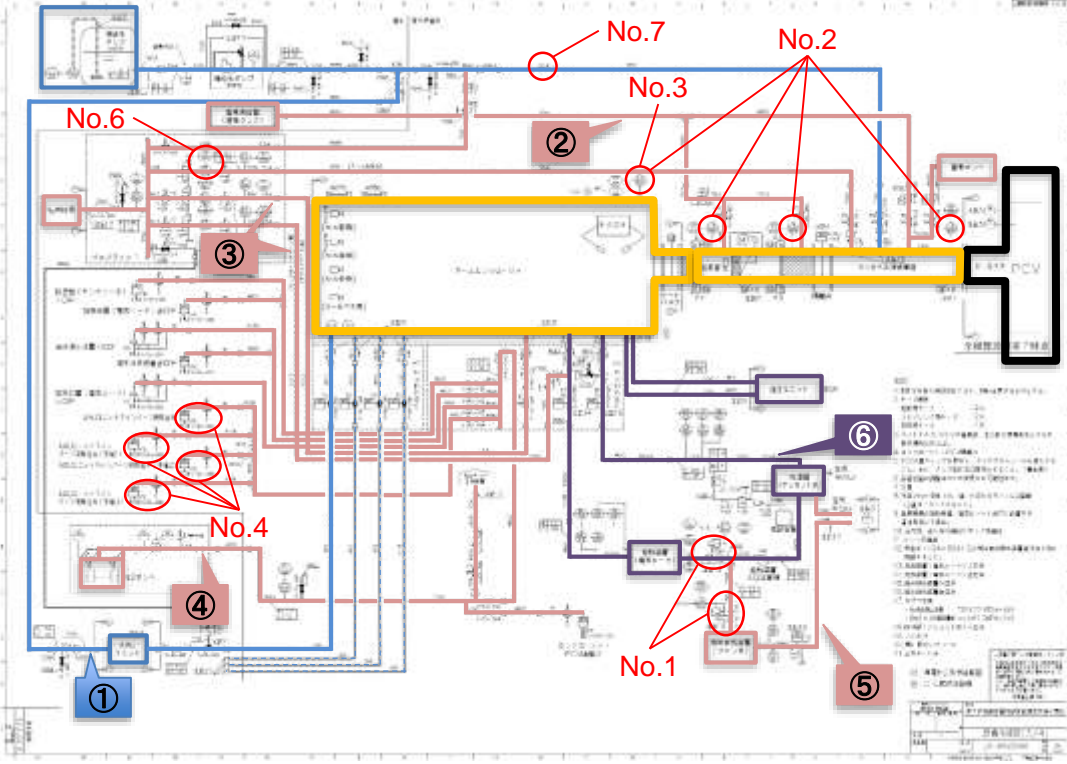
- ① Water supply line for abrasive water jet (AWJ) unit
- ② Nitrogen supply line to check sealing of the X-6 penetration connection structure flange
- ③ Nitrogen purge line connecting to a maintenance manipulator in the enclosure
- ④ Nitrogen supply line for air actuating valve
- ⑤ Nitrogen (air) exhaust line
- ⑥ Dehumidifying circulation line of the enclosure

No	Revisions since FY 2020	Reasons for revision
1	The valve of a dehumidifying circulation line(V-VS-003,010) was replaced with an opening control valve.	Improvement of operation performance by adding a flow regulation function.
2	A pressure gauge (PT-001,002,003,004) was displayed in the operation room.	Improvement of monitoring for the access and investigation equipment main unit, the X-6 penetration connection structure, etc.
3	A pressure gauge (PT-001) function was added to activate an alarm when the pressure is high or low.	Improvement of enclosure protection function.
4	A valve of a water supply line for AWJ unit (V-WJ-002,004,006,008) was replaced with an air controlled valve.	Improvement of operation performance.
5	A strain measuring instrument of the X-6 penetration was removed.	Reflecting elimination of requirements from the connecting structure side.
6	Nitrogen flow measurement (FT/FI-020) for arm cleaning was added.	Improvement of management functions for amount of consumption of nitrogen.

➔The system plan was partly revised and refined to improve the operation performance.

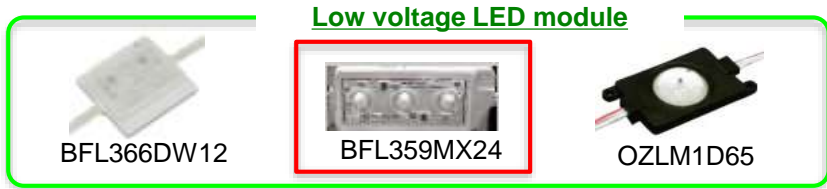
Results of radiation-resistance test

Candidate light	Temperature in equipment	Radiation resistance *1)	Camera image	Voltage decrease (calculated value)	Evaluation
Current light (10W)	x	--	--	--	X
LED module BFL366DW12x2(1.0Wx2)	○ Less than temperature used in equipment	○ (underway) Small change in illumination before/after irradiation(rate of change:-1.5-1.4%)	○ Clear image Camera diaphragm:F5.6	5.6V(140m, 0.16A, 0.13sq)	○
LED module BFL359MX24x1 (1.6W)	○ Less than temperature used in equipment	○ (underway) Small change in illumination before/after irradiation (rate of change:-2.9-1.5%)	○ Clear image Camera diaphragm:F4	2.3V (140m, 0.066A, 0.14sq) Small voltage drop	◎
LED module OZLM1D65x2(1.4Wx2)	○ Less than temperature used in equipment	○ (underway) illumination before/after irradiation (rate of change:-2.5-2.3%)	△ Darker than others Clear image Camera diaphragm:F5.6	8.3V (140m, 0.24A, 0.14sq)	△

*1) LED module power off, gamma ray irradiation (dose rate: More than 100Gyh, accumulated dose rate: 80Gy)
The LED module will be power-on, gamma ray irradiation test (dose rate: More than 10Gyh, accumulated dose: 20Gy) will be conducted.

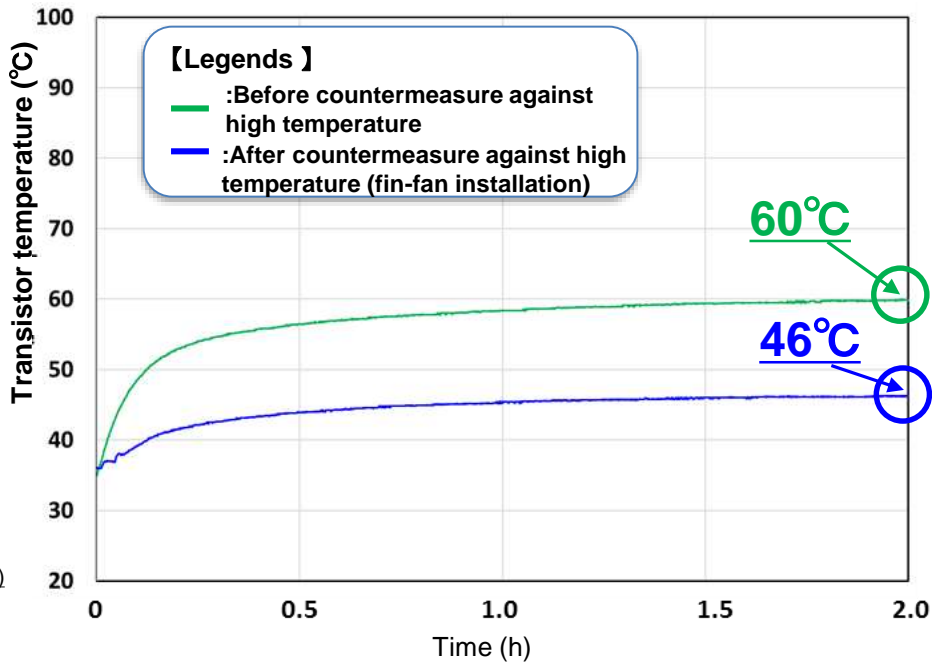
Fig. Temperature changes of the transistor before/after countermeasure against high temperatures (2-hour operation, outside temperature:: 35°C.)

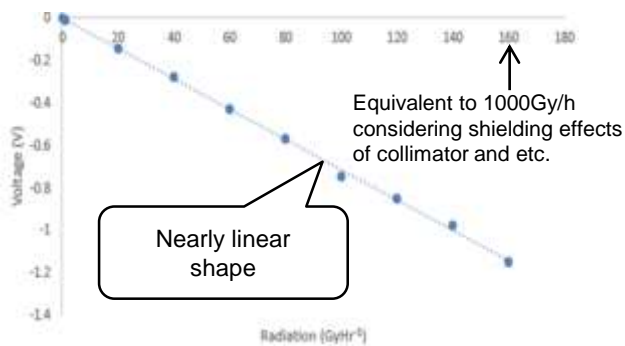
Relationship with spatial dose rate and output voltage

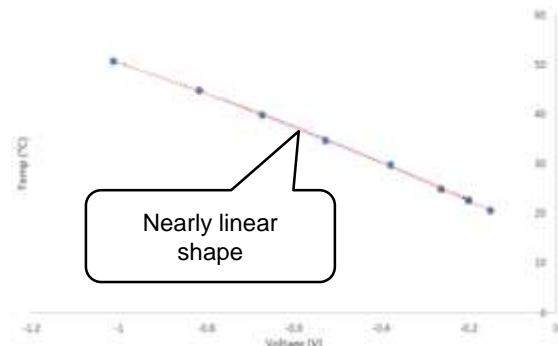
Relationship with output voltage and temperatures of detector

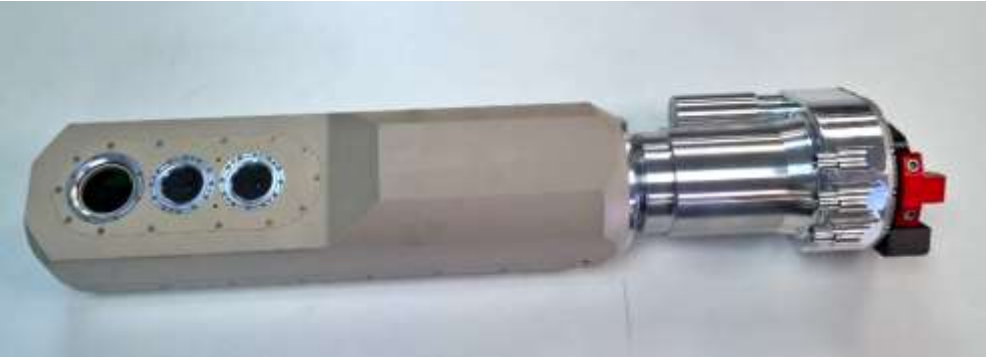
- Manufacturing of maintenance gamma sensor, basic performance inspection and calibration were carried out.

Maintenance gamma sensor

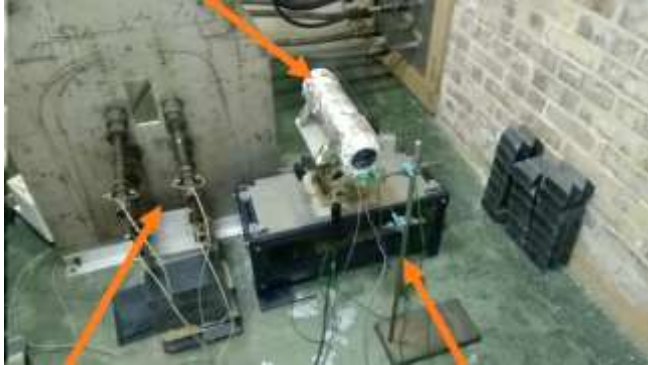
Radiation Sources
Appearance of calibration facility
Ambient Temperature Thermocouple (near)

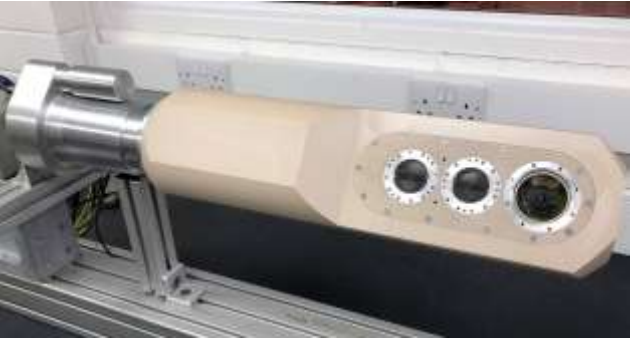
Appearance of basic performance inspection

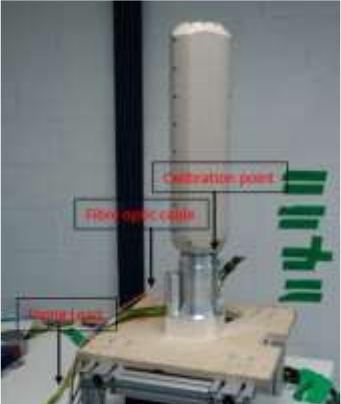
Relationship between output voltage of detector and spatial dose rate
Maintenance gamma sensor: Test Use FF-A (red)
Gamma sensor: FF-A (blue)

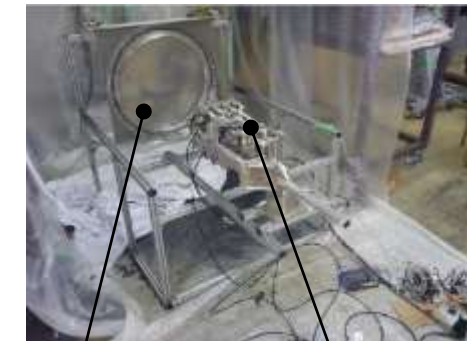
Items	Test results
① Coating test	A coating test of a mock-up (simulated touch plate) was carried out. ⇒Possible to coat more than the area of φ600mm by remote operation.
② Pressure resistance, air-tightness and leakage tests in the coating area	Caulking coating parts of a mock-up was pressurized up to 11kPaG (maximum value of differential pressure in the PCV and the enclosure) to confirm pressure resistance and air-tightness, and measure leakage amount ⇒No deformation was confirmed by visual observation. ⇒Leakage rate was confirmed to be less than 0.05vol%/h.

Simulated touch plate Caulking coating tool

Coating test facility

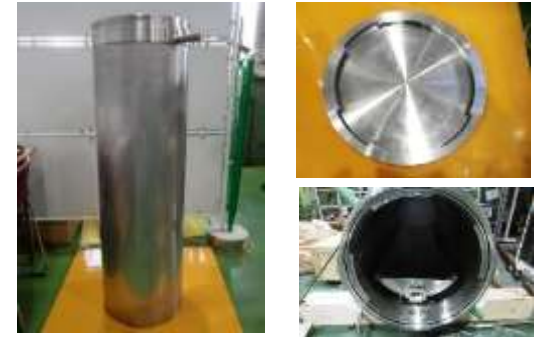
Items	Test results
① Appearance /welding inspections	Visual observation confirmed that there <u>are no signs of significant damage, scratches or dirt.</u> Non-destructive inspection (PT testing) for the welding part was carried out. The test result confirmed that there is no harmful defect.
② Operation check	Drawing and pressing force in the drawing part were measured. ⇒ <u>The test result confirmed that it can be operated at less than the specification value (10kg) of the maintenance manipulator.</u>
③ Pressure resistance/ leakage tests	(a) Applied and reduced pressure up to -5~10kPaG (design specification pressure of the enclosure) in the container. ⇒ <u>Visual observation confirmed that there is no deformation.</u>

Appearance inspection

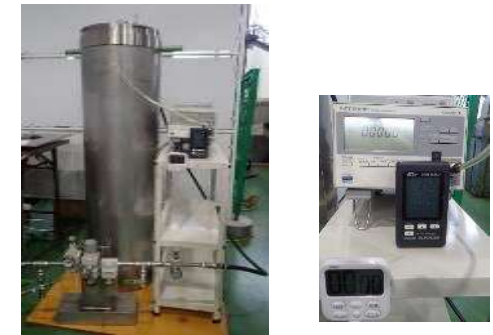
(b) Leakage amount of a sealing part of the container main body was measured when 10kPaG pressure is applied. ⇒ <u>Test results confirmed that the design specifications (less than $4 \times 10^{-2} \text{Pa} \cdot \text{m}^3/\text{s}$) were satisfied.</u>

(c) Leakage amount of a sealing part of the connection with the container and port (interface) was measured when 10kPaG pressure is applied. ⇒ <u>Test results confirmed that the design specifications (less than $4 \times 10^{-2} \text{Pa} \cdot \text{m}^3/\text{s}$) were satisfied.</u>

Pressure resistance and leakage test

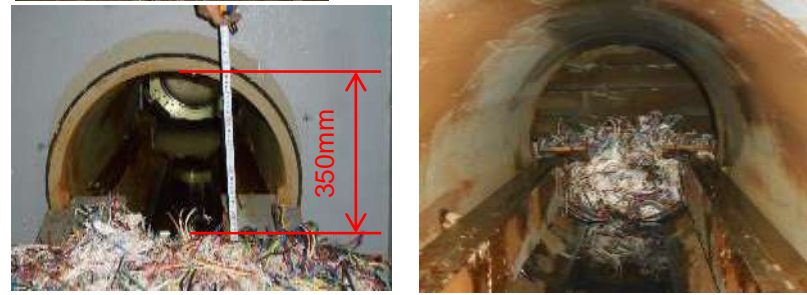
The test results confirmed that the range of cable removal was extended (a cable remaining at the upper half of a route that the arm-type access equipment will pass through was almost totally removed).

Confirmation results (FY2020)

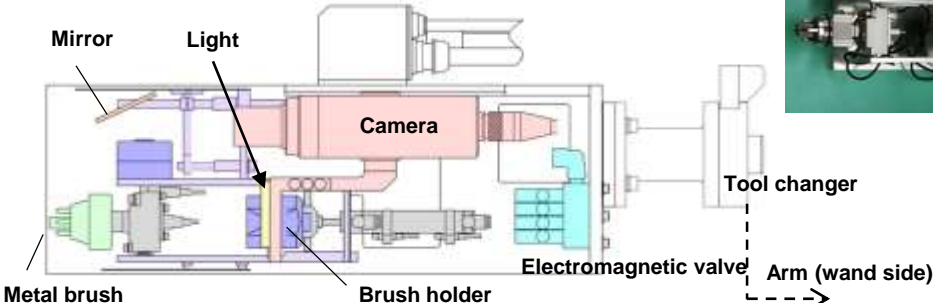
Method	Overview
<p>Ultrafine metal-brush method</p> <p>Collecting of powdery deposition in the air (approximately $\Phi 2\text{mm}$)</p>	<p>The deposition in the PCV is collected by using a metal brush on the tip.</p> <p>Mass 7.6 kg</p> <p>Dimension Length 542mm×Width 211mm×Height 204mm</p>

<p>Vacuum tube method</p> <p>Collecting powdery deposition together with water (less than $\Phi 2\text{mm}$)</p>	<p>Collecting of deposition by sucking into vacuum tube.</p> <p>Mass 8.2kg</p> <p>Dimension Length 550mm×Width 211mm×Height 204mm</p>
