Subsidy Project of Decommissioning and Contaminated Water
Management
Development of Technology for Investigation inside
Reactor Pressure Vessel (RPV)

Interim Report for FY2020

International Research Institute for Nuclear Decommissioning
(IRID)

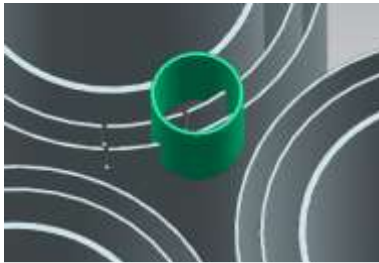
- ① The amount of hole saw feeding in the vertical direction was approximately 1 mm and it suspended due to overload (cutting speed: 0.5mm/min).
- ② Increasing the rotational torque of the hole saw can be considered for improving cutting performance, but with the current tool configuration and restrictions on dimensions, major increase in torque seems unlikely and hence hole saw is not applicable.

Hole saw
Cutting in the
vertical direction
(Cutting of outer
casing + middle
casing)

Conceptual image of cutting the steam separator
(Hole saw)

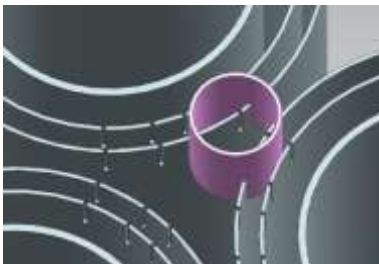
Hole saw
Cutting in the
vertical
direction
(Cutting of
outer casing)

Conceptual image of cutting the steam separator
(Hole saw)

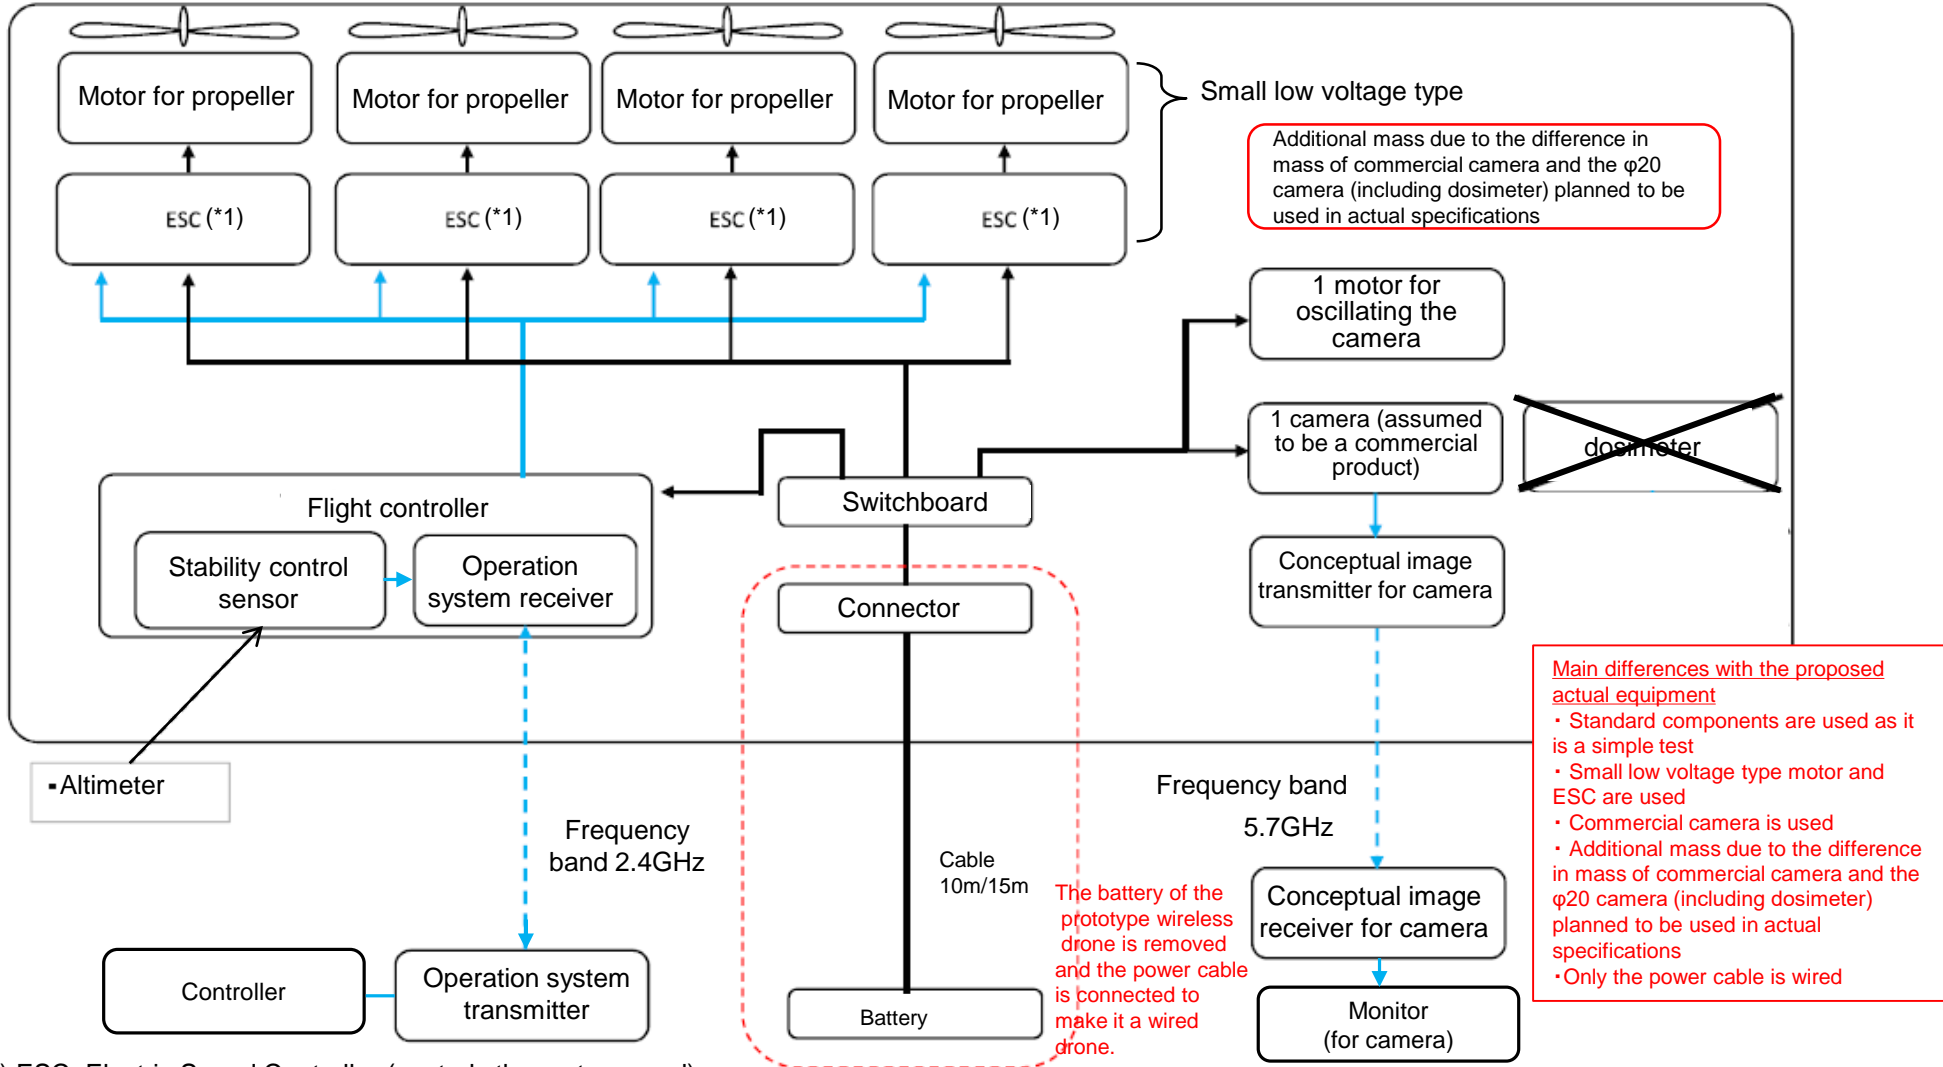
← : Flow of electric current
 ← : Flow of signal (solid line: wired, dotted line: wireless)

(*1) ESC: Electric Speed Controller (controls the motor speed)

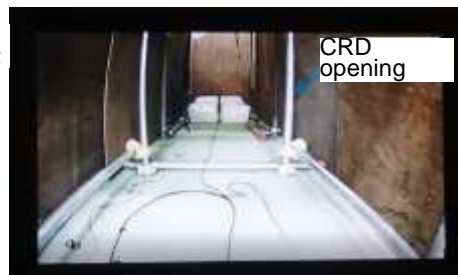
[Camera image]

Test condition (while passing through the CRD opening part)

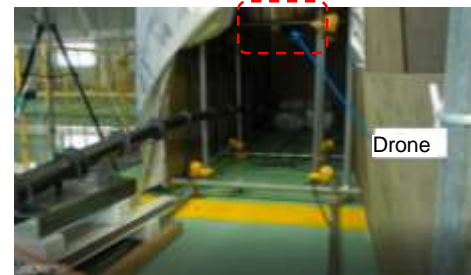
[Flying state]

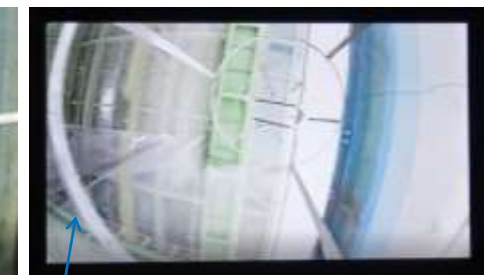
RPV opening [Camera image]

Test condition (while passing through the RPV opening part)

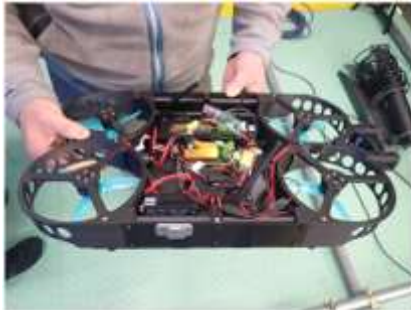
[External appearance of the drone: top surface]

When 1200g of weight was mounted on the drone, upward flight was possible but wobbling of the drone increased and as the current value of the propeller motor exceeded 80A as against the battery current (3.5A), due to which the battery could get damaged, the upper limit of payload for this drone was considered to be 1100g.

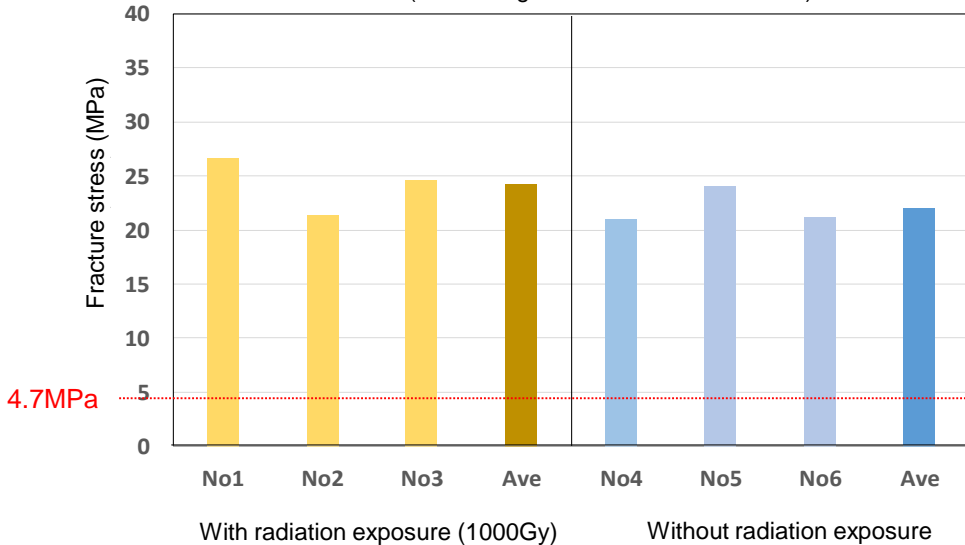
The shear failure stress after radiation exposure was 21.4 to 26.7 [MPa], that is on an average: 24.2 [MPa], as against 21.0 to 24.0 [MPa], that is on an average: 22.1 [MPa] for the unirradiated sample. Thus there was no major difference in the bonding strength. And, in case of both, the irradiated test piece and the unirradiated test piece, there was a cohesion failure wherein a fracture occurred inside the adhesive layers and hence it is believed that the adhesive did not degrade due to radiation exposure.

Fracture stress at the CFRP bonded part (after being left in indoor environment)

Based on the above results it was evaluated that there is no degradation of the CFRP bonded part due to shear failure stress if it is left for less than 24 hours (*1) under an environment with temperature: 50[°C], humidity: 90%, dose rate: 100[Gy/h] assumed while investigating inside RPV.

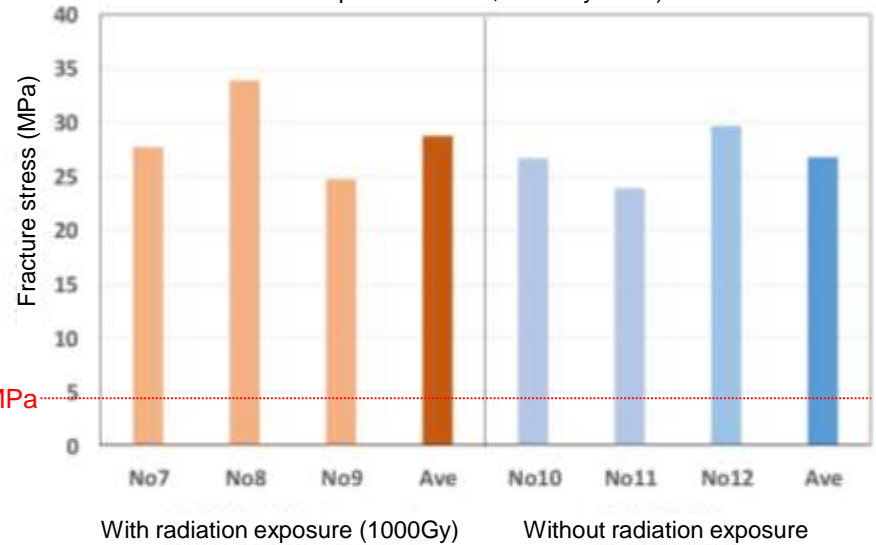
The shear failure stress after radiation exposure was 24.7 to 33.9 [MPa], that is on an average: 28.8 [MPa], as against 23.9 to 29.7 [MPa], that is on an average: 26.8 [MPa] for the unirradiated sample. Thus there was no major difference in the bonding strength. And, in case of both, the irradiated test piece and the unirradiated test piece, there was a cohesion failure wherein a fracture occurred inside the adhesive layers and hence it is believed that the adhesive did not degrade due to radiation exposure.

Fracture stress at the CFRP bonded part (after leaving for 24 hours under temperature: 50°C, humidity: 90%)

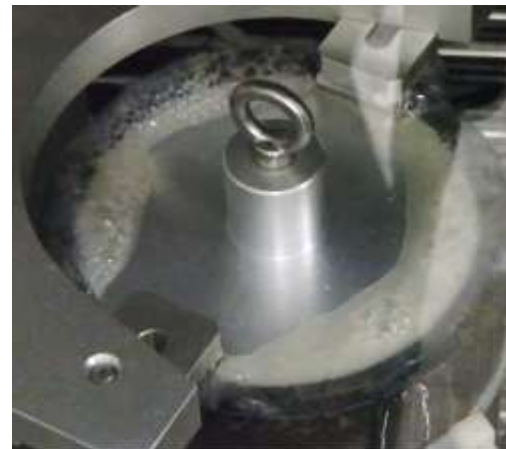
Verification of leakage in the regular seal under 0Gy (unirradiated) and 50°C conditions

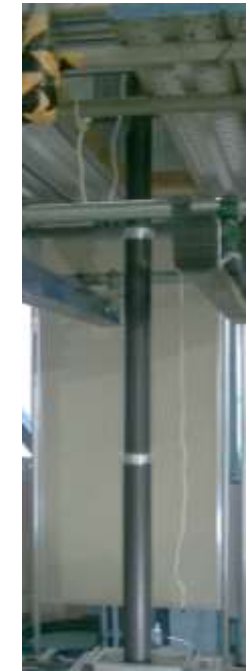
3 stage telescopic pipe (when completed retracted) 3 stage telescopic pipe (when completed extended)

The basic performance (stretching movement, extension) of the 14 stage telescopic access equipment, the design of which is being studied, was verified through simple tests using a three-stage telescopic pipe. Issues such as high sliding resistance or leakage from the sealed portion came forth, however, it was evaluated that the mechanism itself was feasible.

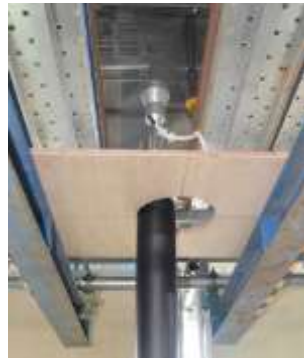
Simulated opening created

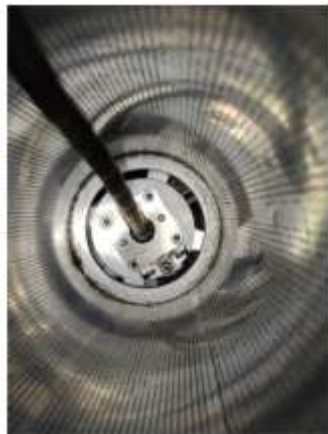
Inside the 1st stage of the pipe after the test

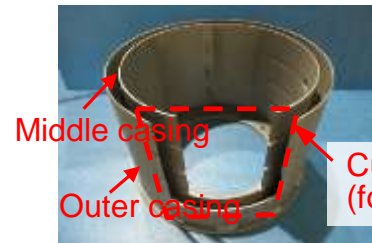
Results of the simple tests (AWJ)

- Alternative machining technologies were investigated and evaluated, and machining technology in which hole saw cutting, circular saw cutting and laser cutting are added to the AWJ cutting technology was selected as machining technology that reduces the generation of secondary waste.
- Reducing the size of the nozzle used in AWJ, optimizing machining parameters such as the jet spray angle, the cutting location, etc., were studied. In addition, equipment and tools required if hole saw cutting, circular saw cutting and laser cutting were to be used, were studied as well.
- Simple tests for verifying the cutting performance of the machining technologies were conducted and it was determined that there are prospects of AWJ cutting and laser cutting being applied (Refer to the table on the right for the combinations of cutting direction and method).
