Subsidy Project of Decommissioning and Contaminated Water
Management

Development of Technology for Investigation inside
the Reactor Pressure Vessel (RPV)

Final Report

International Research Institute for Nuclear Decommissioning
(IRID)

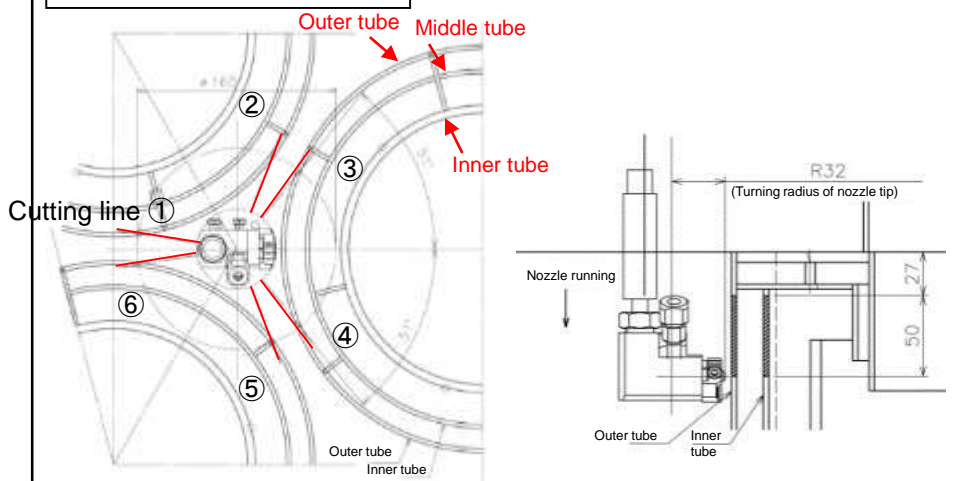
Drawing of cutting conditions

② Vertical cutting (exterior)

Items	Conditions
AWJ nozzle	Angle nozzle
Injection pressure	343 MPa
Injection flow rate	3.3 liter/min
Abrasive feed rate	100 g/min
Standoff	41.9 mm
Cutting speed	10 mm/min

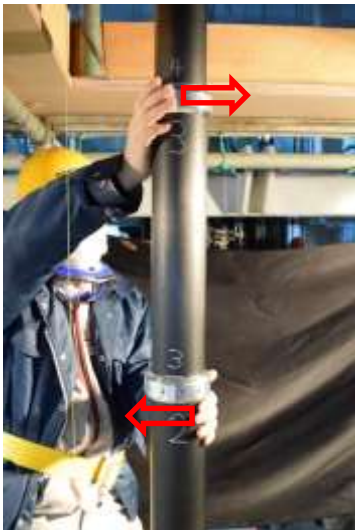
When a horizontal load was applied to the pipe tip, it applied a large bending moment on the base, and since sufficient force could not be applied to the tip to counteract the looseness, bending force was manually applied to each stage pipe starting from the tip. After that, the amount of the tip misalignment of the 14th stage pipe due to looseness in a state of no load was checked, and it was verified that there was a looseness of +144.7 to -218.3 mm. (The direction in which the anti-rotation rail of the telescopic guide pipe is attached is negative)

The bending direction force is being applied to the pipe so that the third stage pipe is inclined

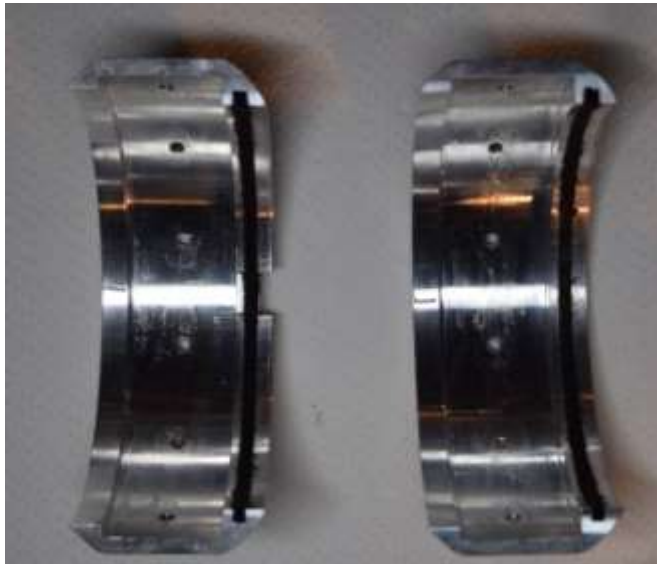
Appearance of scraper at the tip of the 1st stage pipe after pressure resistance test (disassembled state)

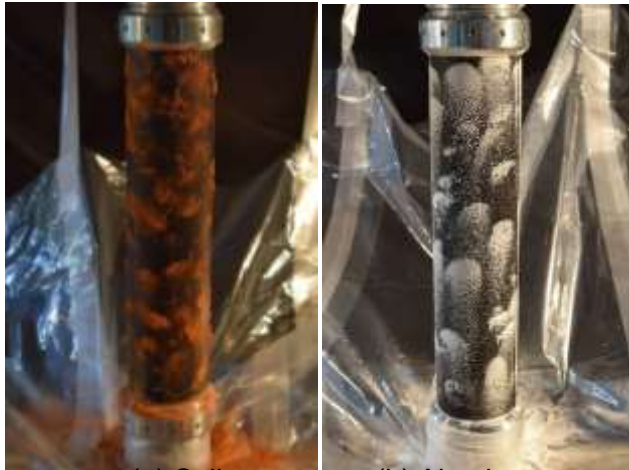
(a) Soil
Powder adhered to the entire outer surface of the pipe

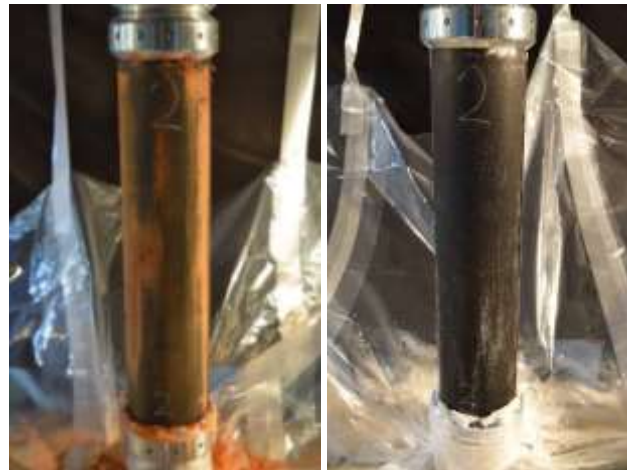
(a) Soil There are wiping streaks
Condition of pipe outer surface after retraction and re-extension
