# Current Status and Challenges of R&D for Decommissioning of Fukushima Daiichi Nuclear Power Station

November 14, 2023

International Research Institute for Nuclear Decommissioning (IRID)

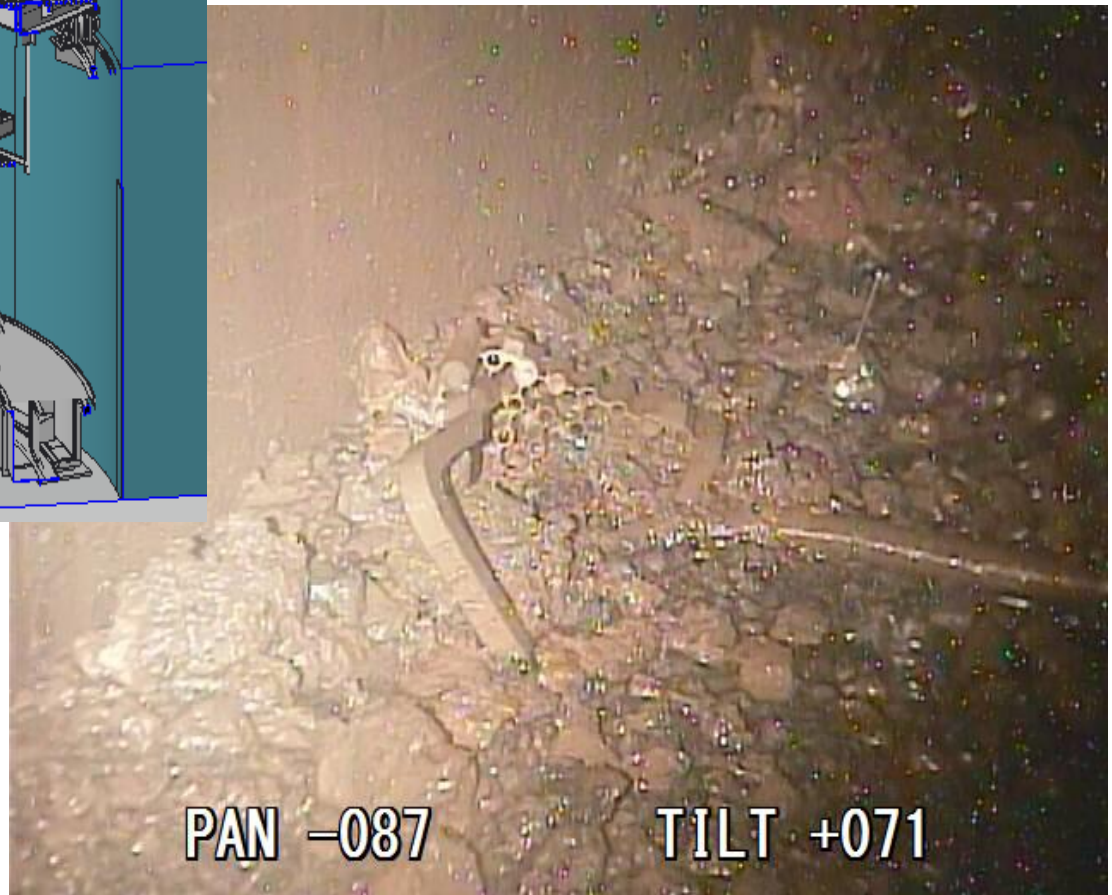
Bottom of the Unit 2 PCV  
(An overhead image)

Pedestal floor and wall  
Fuel debris? and a fuel assembly handle

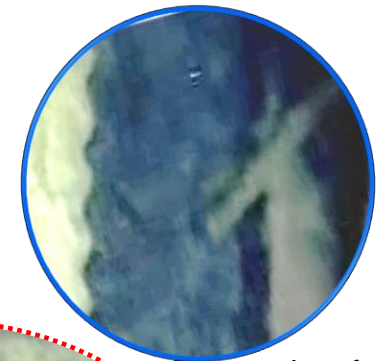
Photo taken from different angle

Photo of left red-circled part taken from different angle

Figure 1: Remains of the pedestal outer wall of the right opening

Figure 2: Visual image taken from different angle of the remains

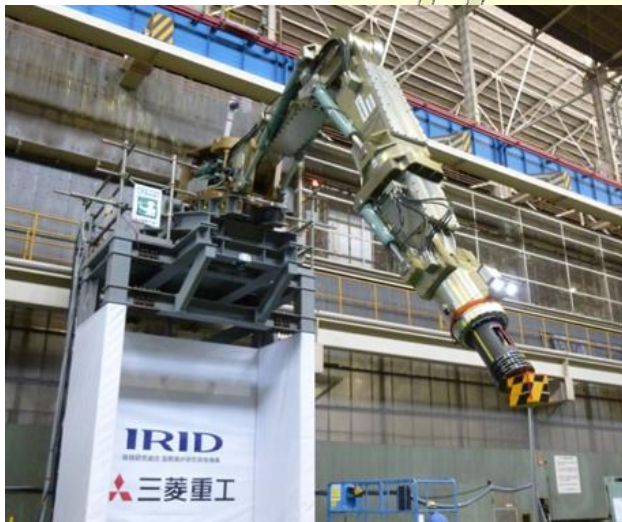
Example of cutting technology (Chisel)
