福島第一の廃炉研究開発の現状と課題

Current Status and Challenges of R&D for Decommissioning of Fukushima Daiichi Nuclear Power Station

International Research Institute for Nuclear Decommissioning (IRID)

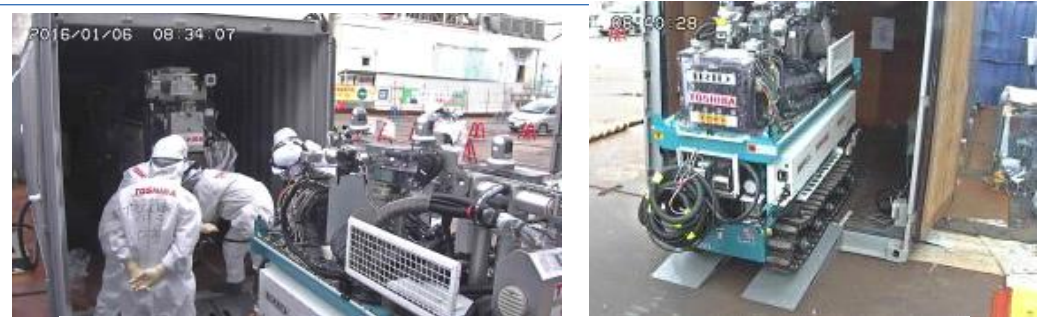
Suction and dry ice blast decontamination was performed on 1st floor of the **Unit 3 R/B** from January 2016 to February 2016.

: Suction

: Dry ice blast

Photos of transporting decontamination equipment from a container

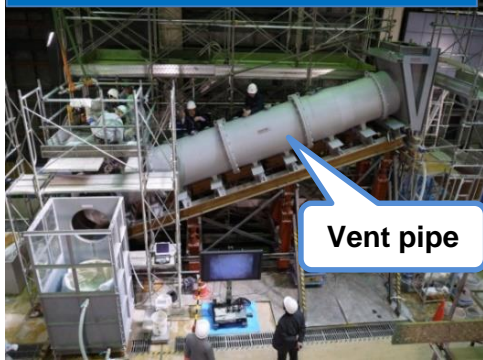
Test for stopping water leaks from vent pipe

Water stop performance was verified by using the 1/2 scale test facility (in factory).

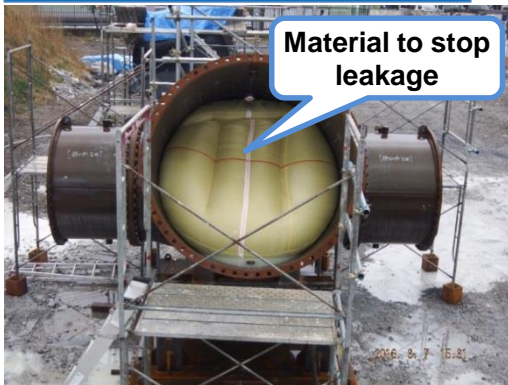
Test for stopping water leaks

Water stop performance of the material was verified by using the full-scale test facility (outdoor).

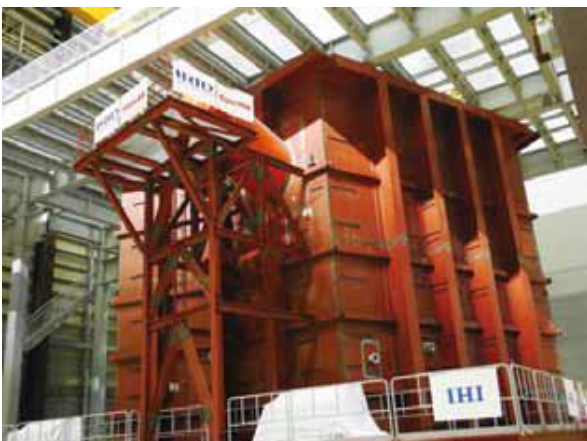
Appearance of test facility

- The procedures of the following three methods for water stops are tested to verify workability and performance of concrete placing.
 - ① Stop water leaks from vent pipes
 - ② Stop water leaks in the S/C by injecting filling
 - ③ Strengthen the S/C support column

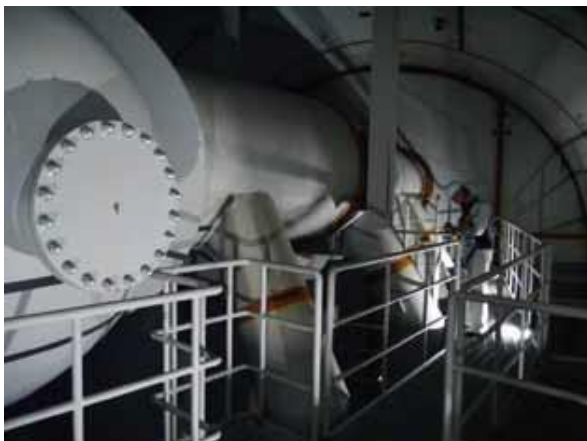
Inside of the test facility (in the S/C)

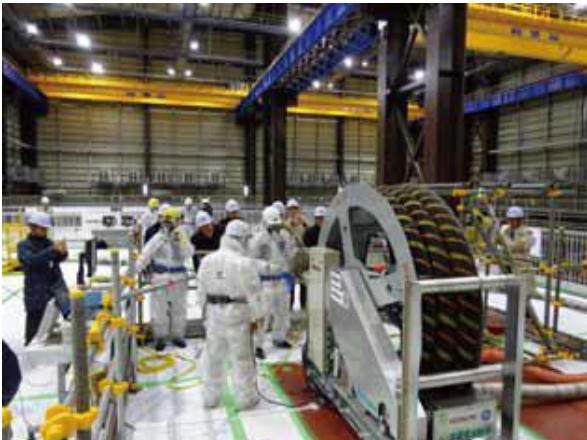
Verification test of workability to strengthen the S/C support column

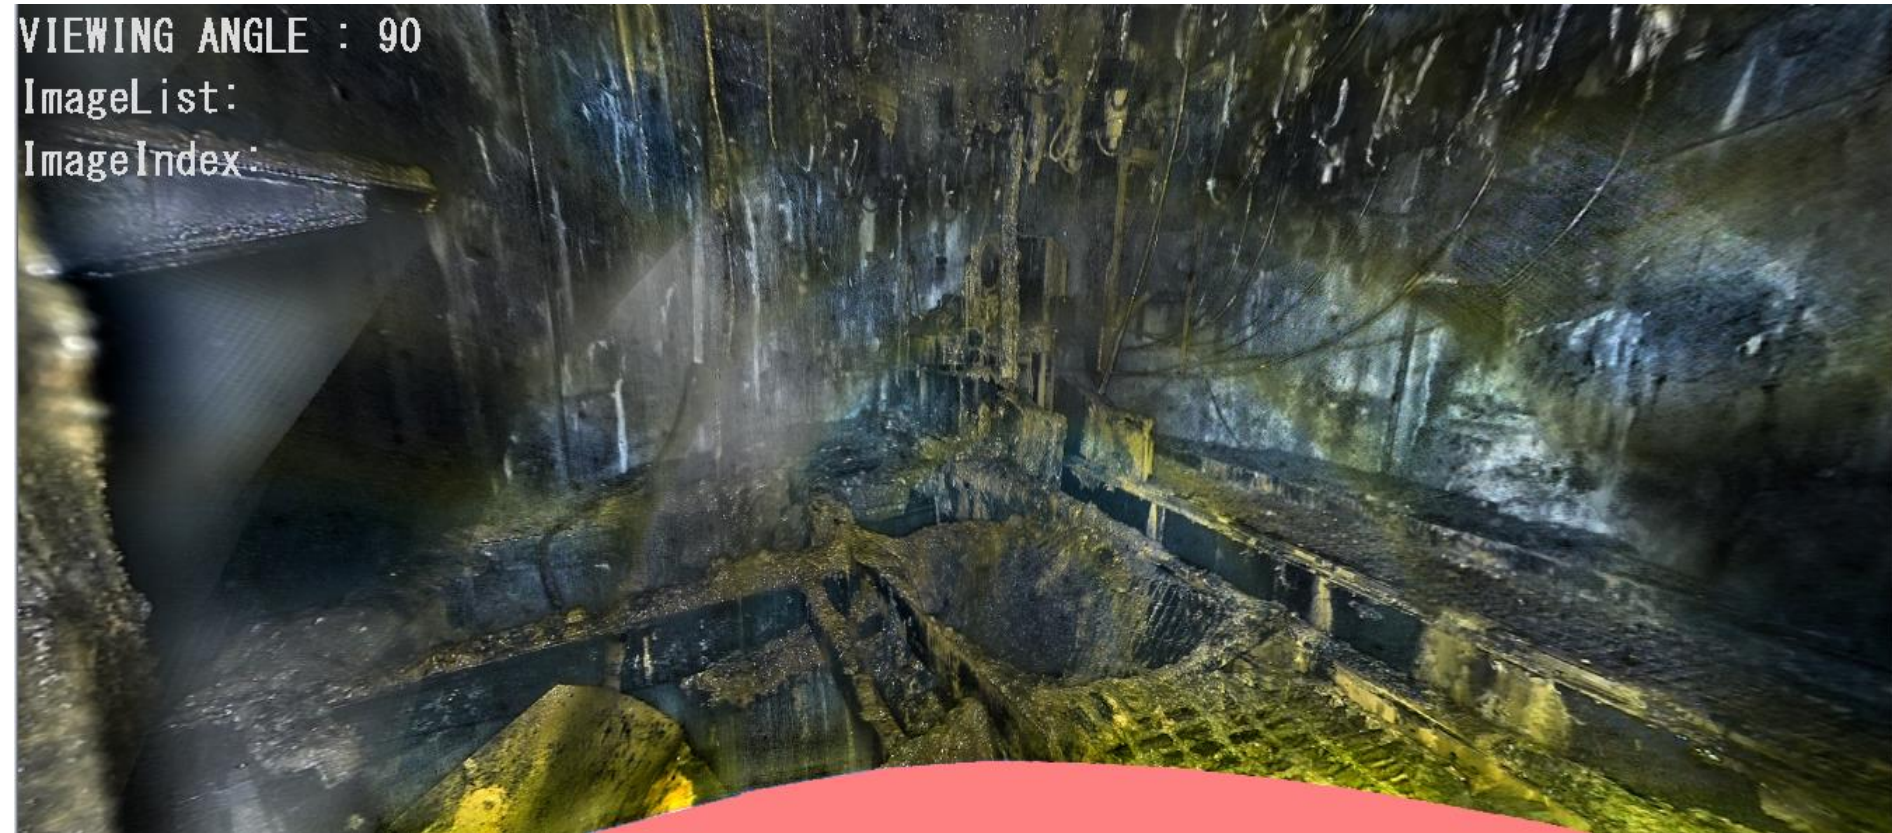
Upper pedestal interior (after image processing)

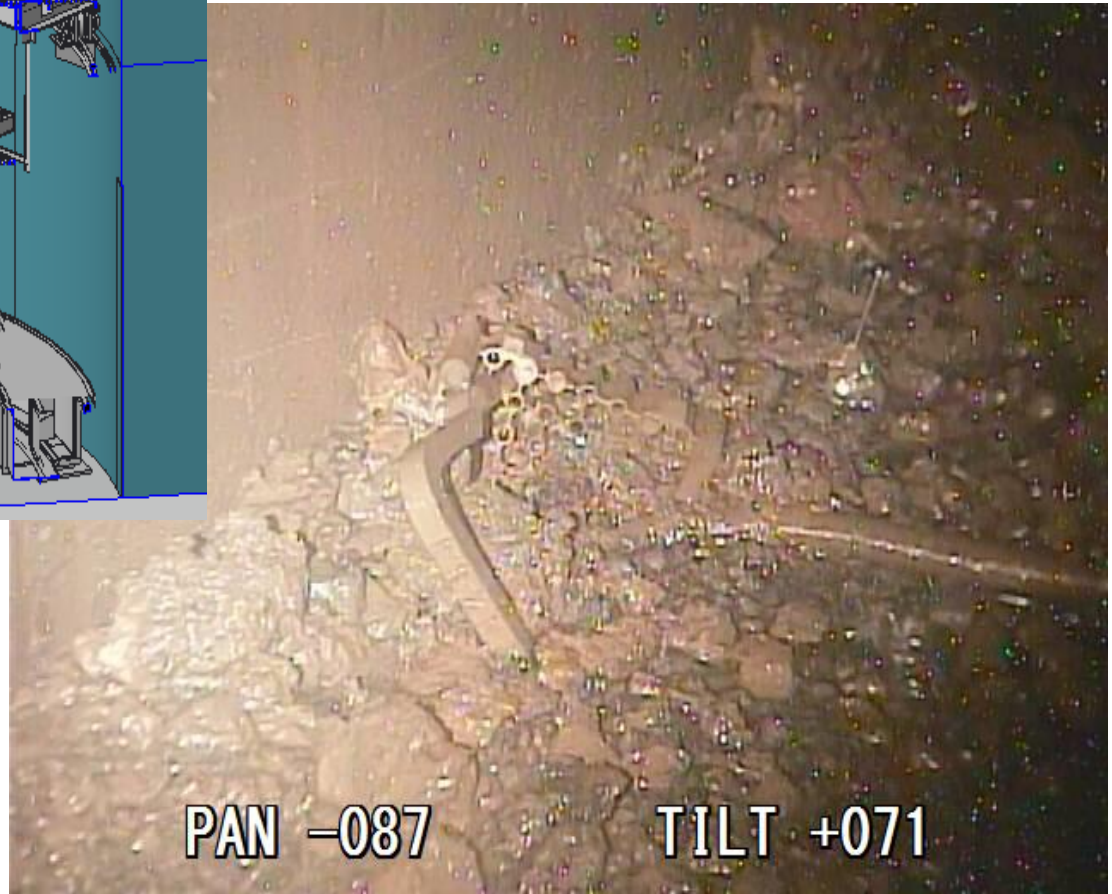
Unit 2 investigation: Pedestal Floor

Bottom of the Unit 2 PCV
(An overhead image)

Pedestal floor and wall
Fuel debris? and a fuel assembly handle

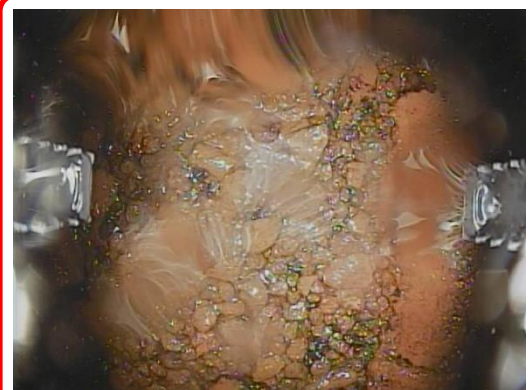
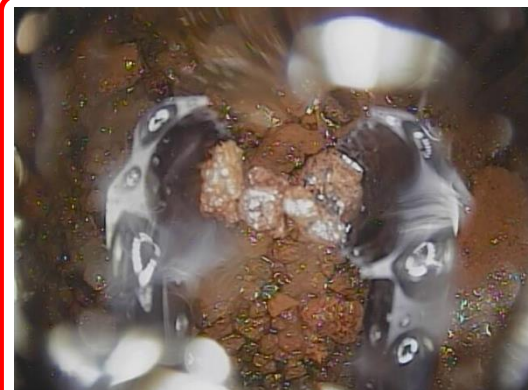
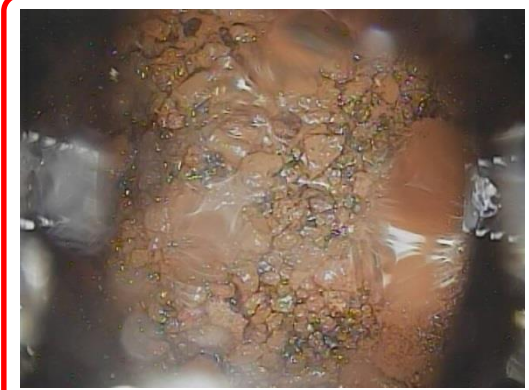
Before touching deposition

Touching deposition

After touching deposition

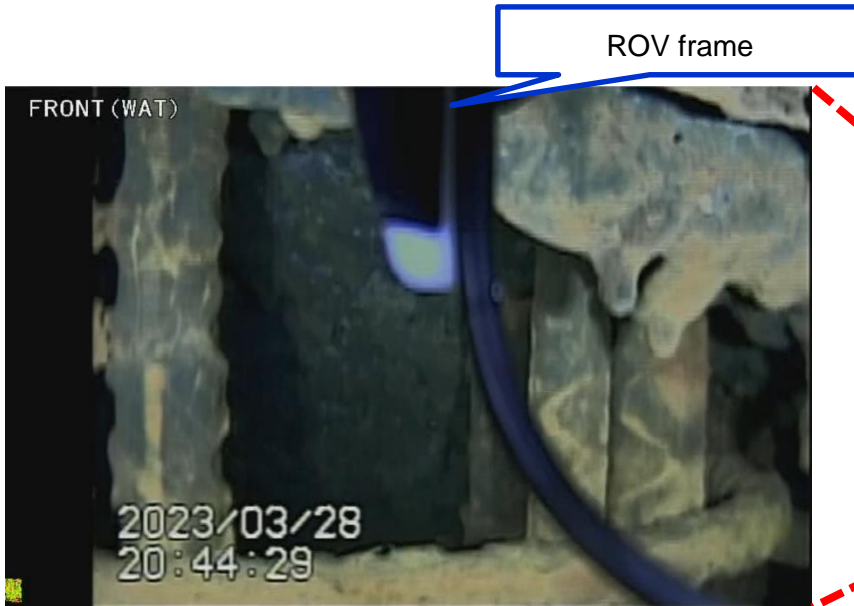
- Tokyo Electric Power Company (TEPCO) Holdings, Inc. investigated the Unit 1 pedestal to confirm the concrete that likely remain outside the pedestal (Bolts that were installed before the accident were confirmed to be fixed). The investigation on March 2023 confirmed the inside of the pedestal wall.
- TEPCO assumes that the lost concrete of the pedestal outer wall opening in right side would be limited.
- The investigation found that reinforcing steels of the outside pedestal have remained 7 pieces in the right opening part and 11 pieces in the left side. The earthquake resistance should be evaluated based on 64° that is equivalent to the angle in accordance with the opening angle.

Photo 1: Concrete remains can be seen from the pedestal opening

Photo 2: Concrete remains can be seen from the pedestal opening

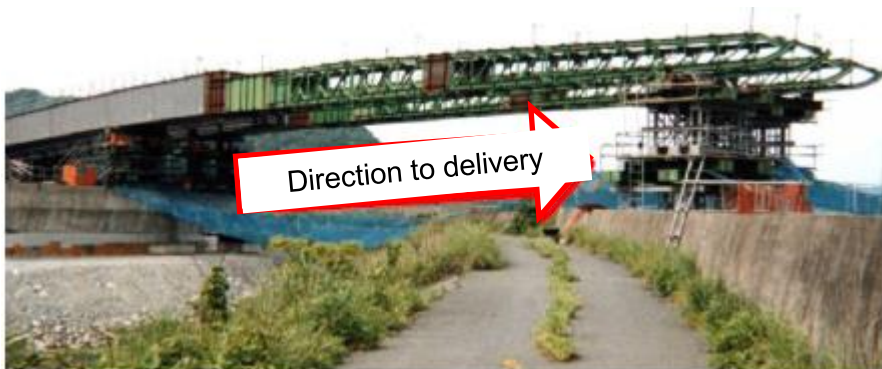
Example of the delivery method
