IRID's R&D Results for Fukushima Daiichi Decommissioning and Future Challenges and Expectations

5 Dec 2023

Toyoaki Yamauchi
President of International Research Institute for Nuclear Decommissioning (IRID)

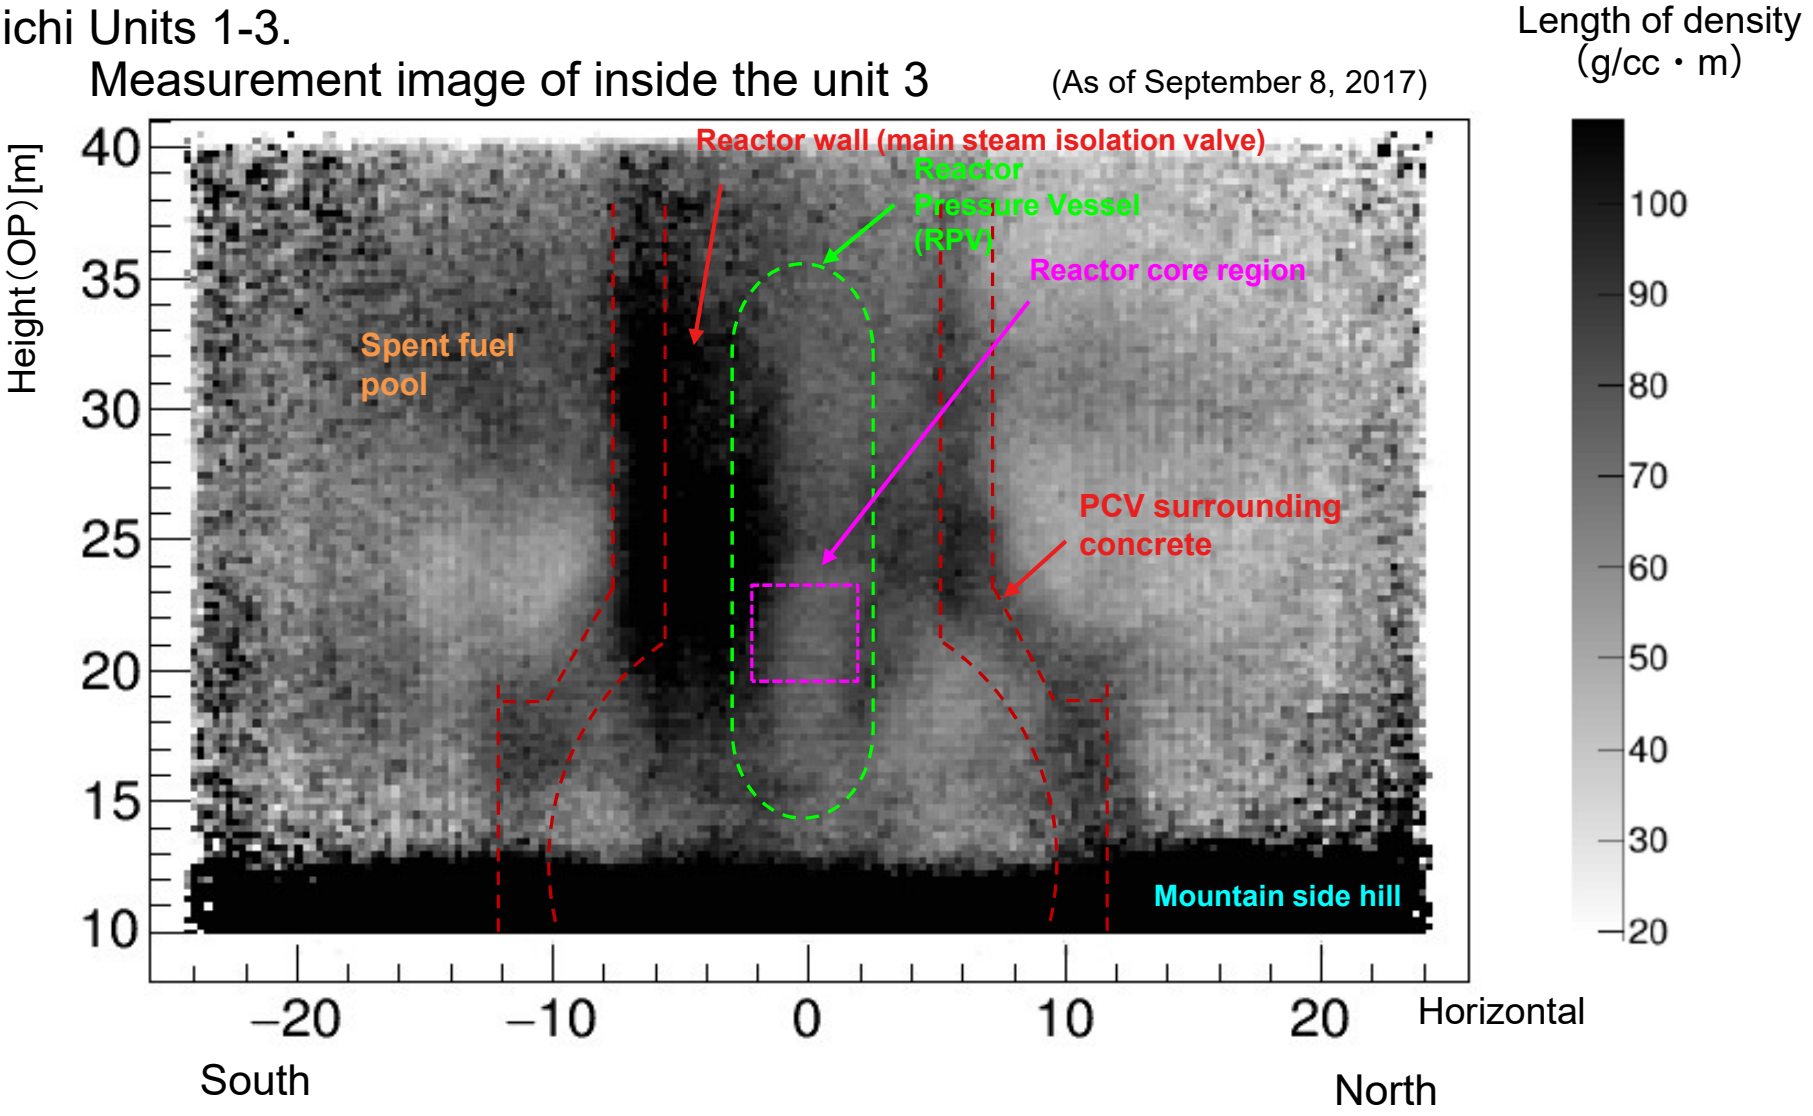
Measurement image of inside the unit 3 (As of September 8, 2017)

No high-density substances were confirmed in the core region of the Fukushima Daiichi Units 1-3.

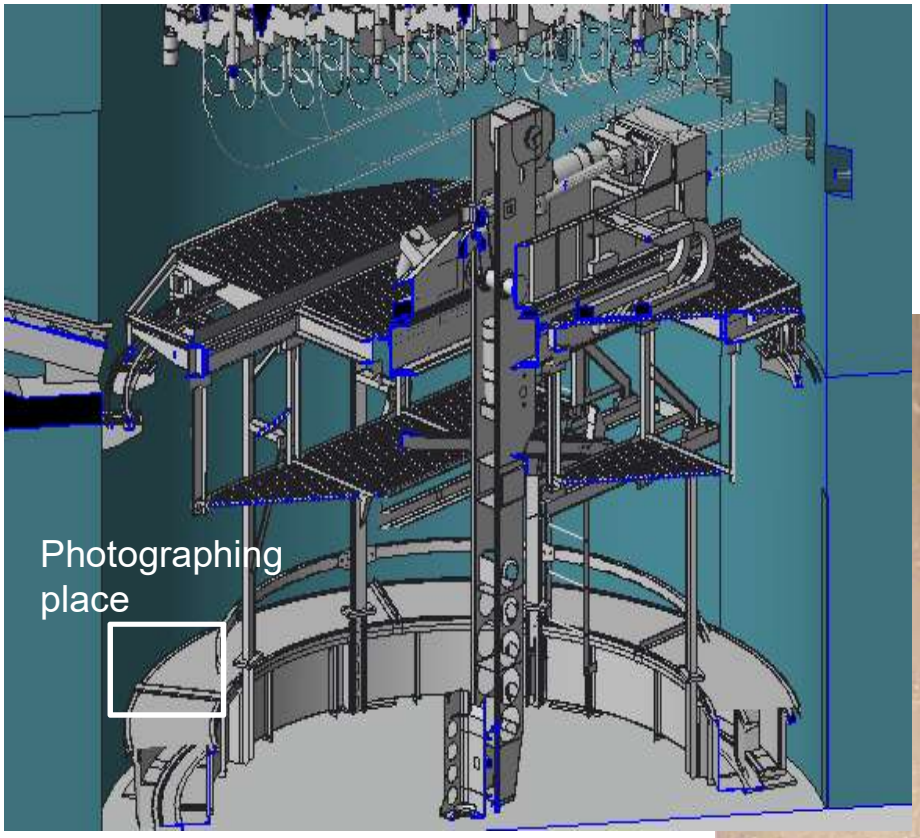
The Unit 2 PCV bottom
(An overhead view)

Photo: Near the pedestal inner wall
at the Unit 2 PCV bottom

(A fuel assembly handle was found.)

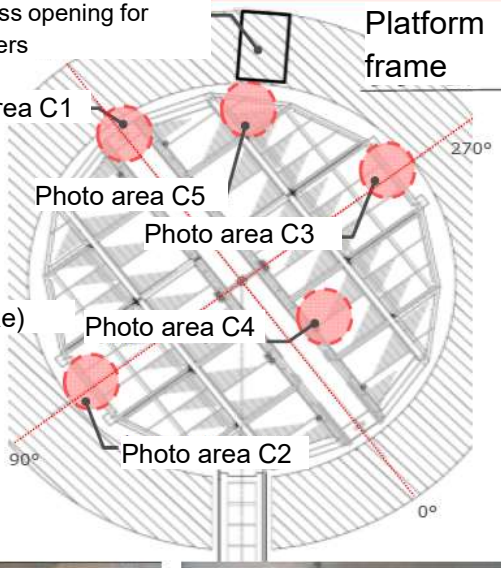
Area C1 where a photo was taken
<Camera position: Lower>

Deposit (pebble-like)

- The investigation has revealed that deposits in sandy, pebble-like and massive form has accumulated.
- The access opening for workers was not confirmed visually (Deposits were found nearby the pedestal).

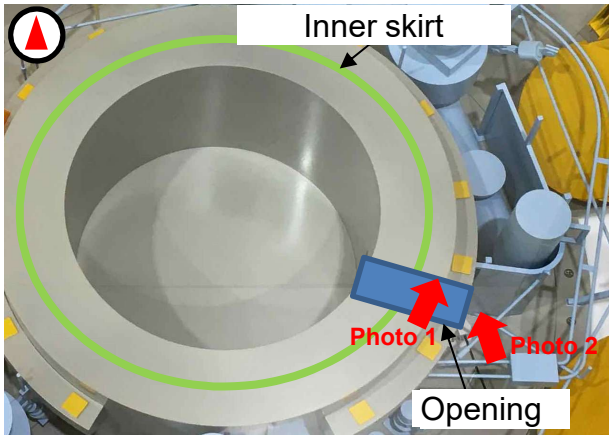
Tokyo Electric Power Company (TEPCO) Holdings, Inc. investigated the pedestal opening. The first-half investigation on March 2022 confirmed that the pedestal wall of the opening part was damaged. The second-half investigation on March 2023 confirmed that the entire circumference of the pedestal interior was also damaged.

- TEPCO assumes that the lost concrete area of the pedestal inner wall (only concrete remains) is approximately 1meter in height and 50cm in depth.
- The lost of the pedestal outer wall opening would be limited.

Photo 1: Concrete remains seen from the pedestal opening

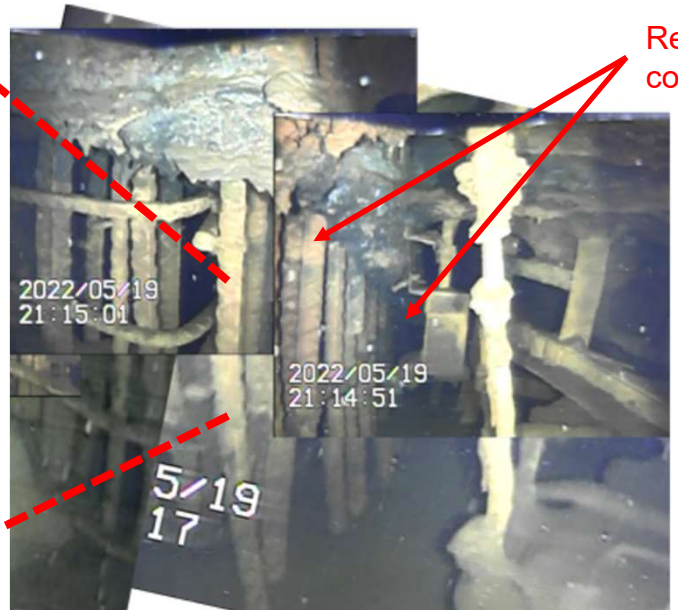
Photo 2: Concrete remains seen from the pedestal opening

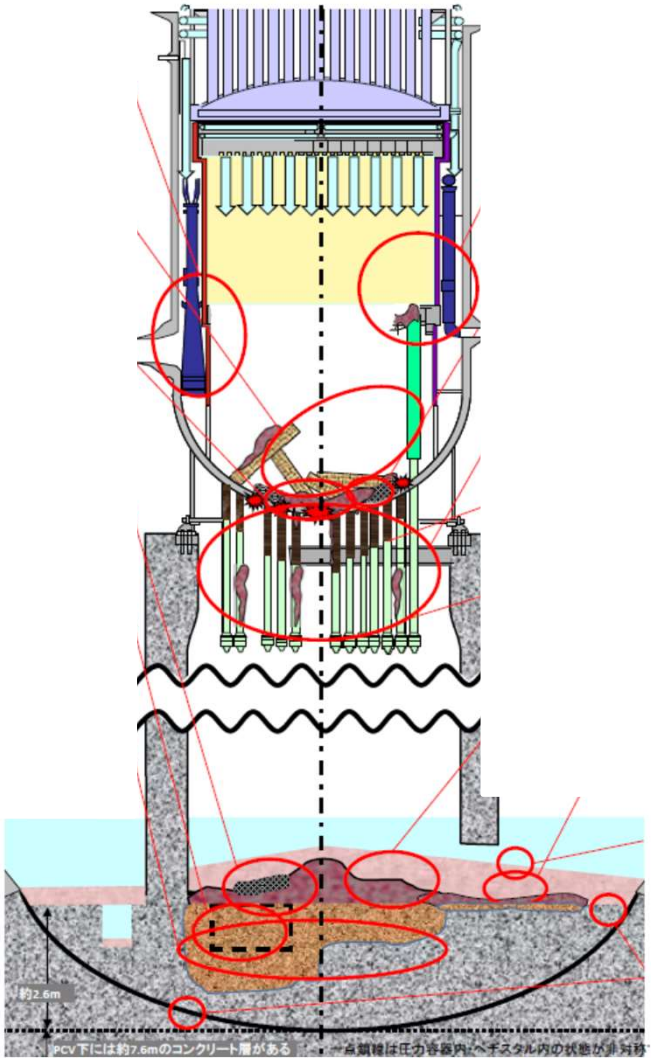
・Unit 1 has almost no fuel in the RPV, and deposits have spread outside the pedestal. The inner walls of the pedestal were also damaged.
(The Unit 1 reactor core was damaged about eight hours after the loss of power.)

Damage estimation of the Unit 1 RPV/PCV
(From TEPCO website)

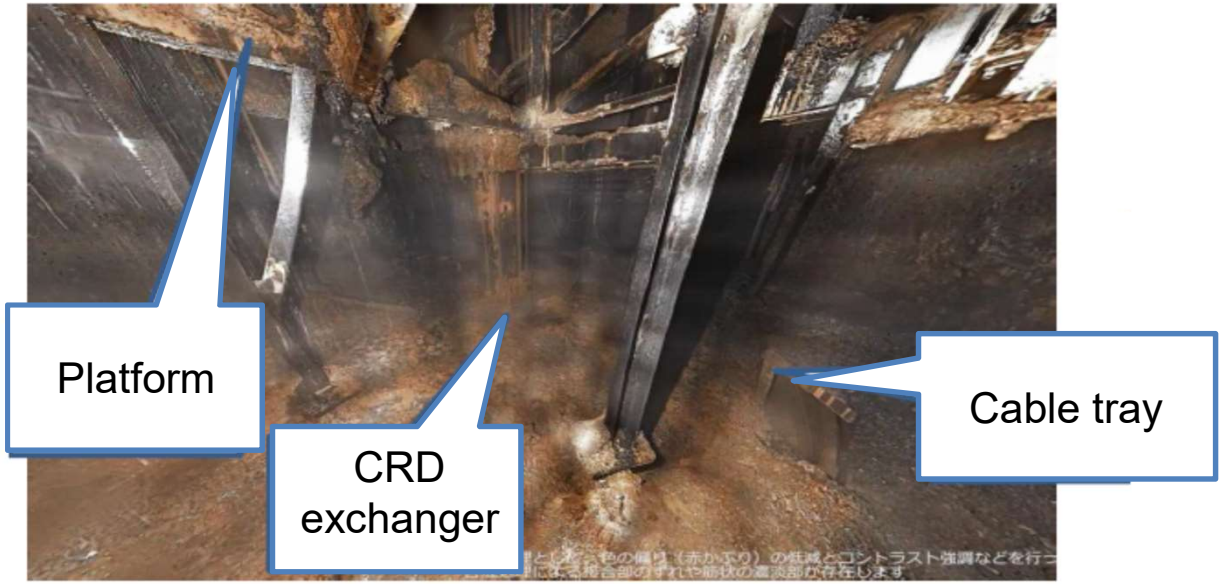
・Unit 2 has a lot of fuel left in the reactor pressure vessel (RPV). Although there is 1 meter-deposit on the pedestal floor. The RPV substructure retains its original form.
(The Unit 2 reactor core was damaged about 3 days after the loss of power.)

Wide angle photo of the Unit 2 entire pedestal floor
(Reference: the TEPCO Holdings website)

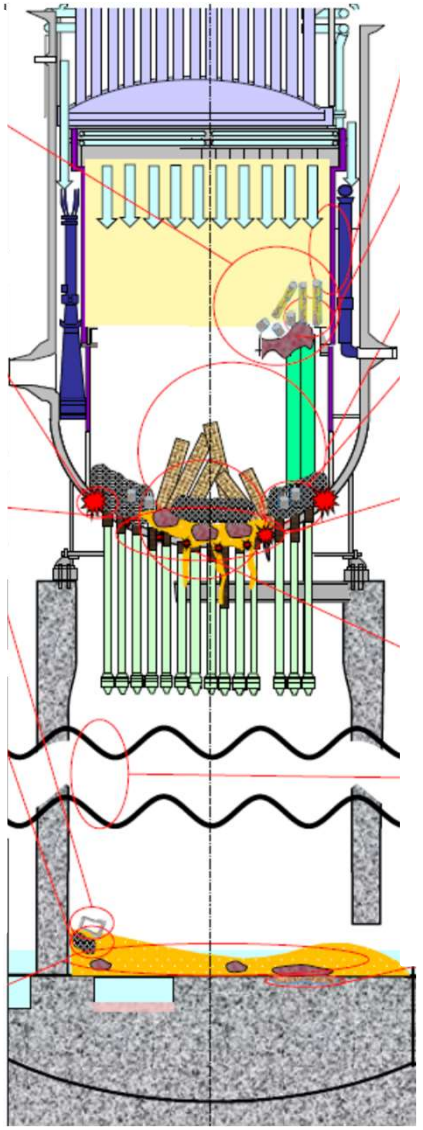
Damage estimation of the Unit 2 RPV/PCV
(From TEPCO HP)

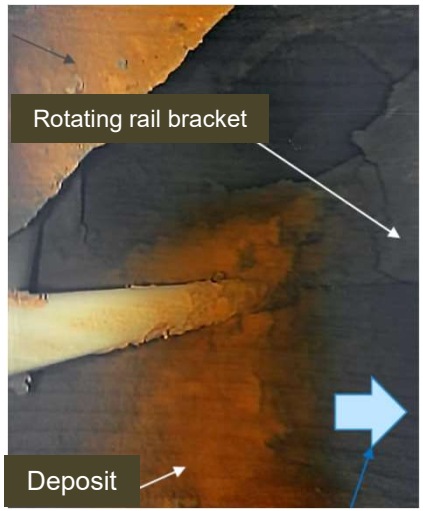
・Unit 3 have some fuel left in the RPV. There is 2-3 meters of deposits on the pedestal floor.
(The Unit 3 reactor core was damaged about one and half day after the loss of power.)

Photos taken from investigation inside the Unit 3 pedestal

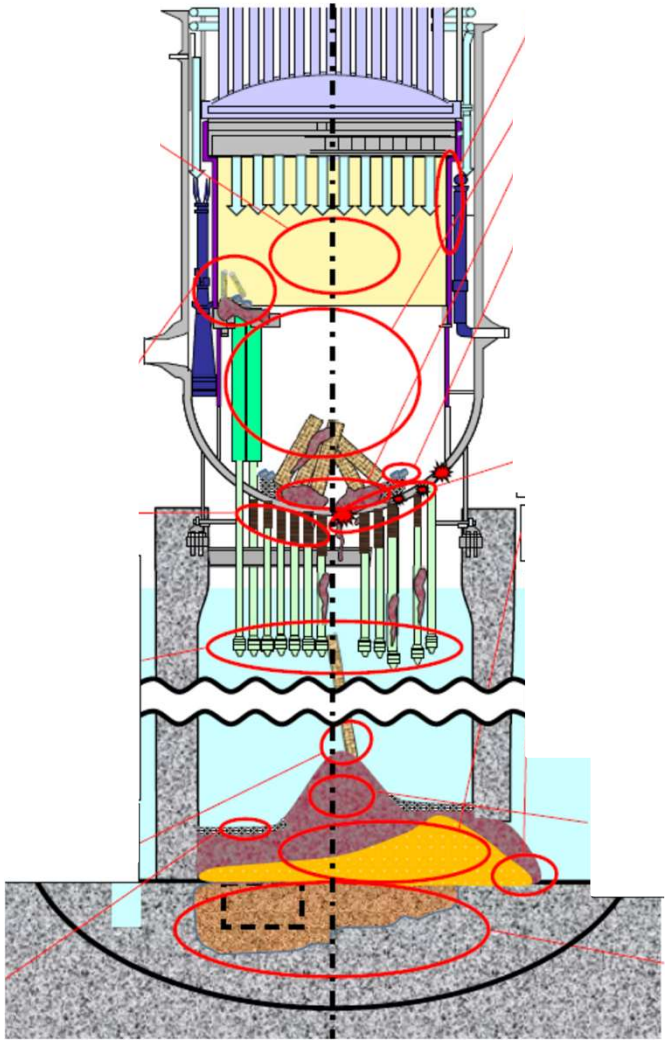
Damage estimation of the Unit 3 RPV/PCV
(From TEPCO HP)
