“Development of a technology to investigate inside the Reactor Primary Containment Vessel (PCV)”

- Results of follow up check after the site test -

[For April 18 and 19, 2015]

Tokyo Electric Power Company

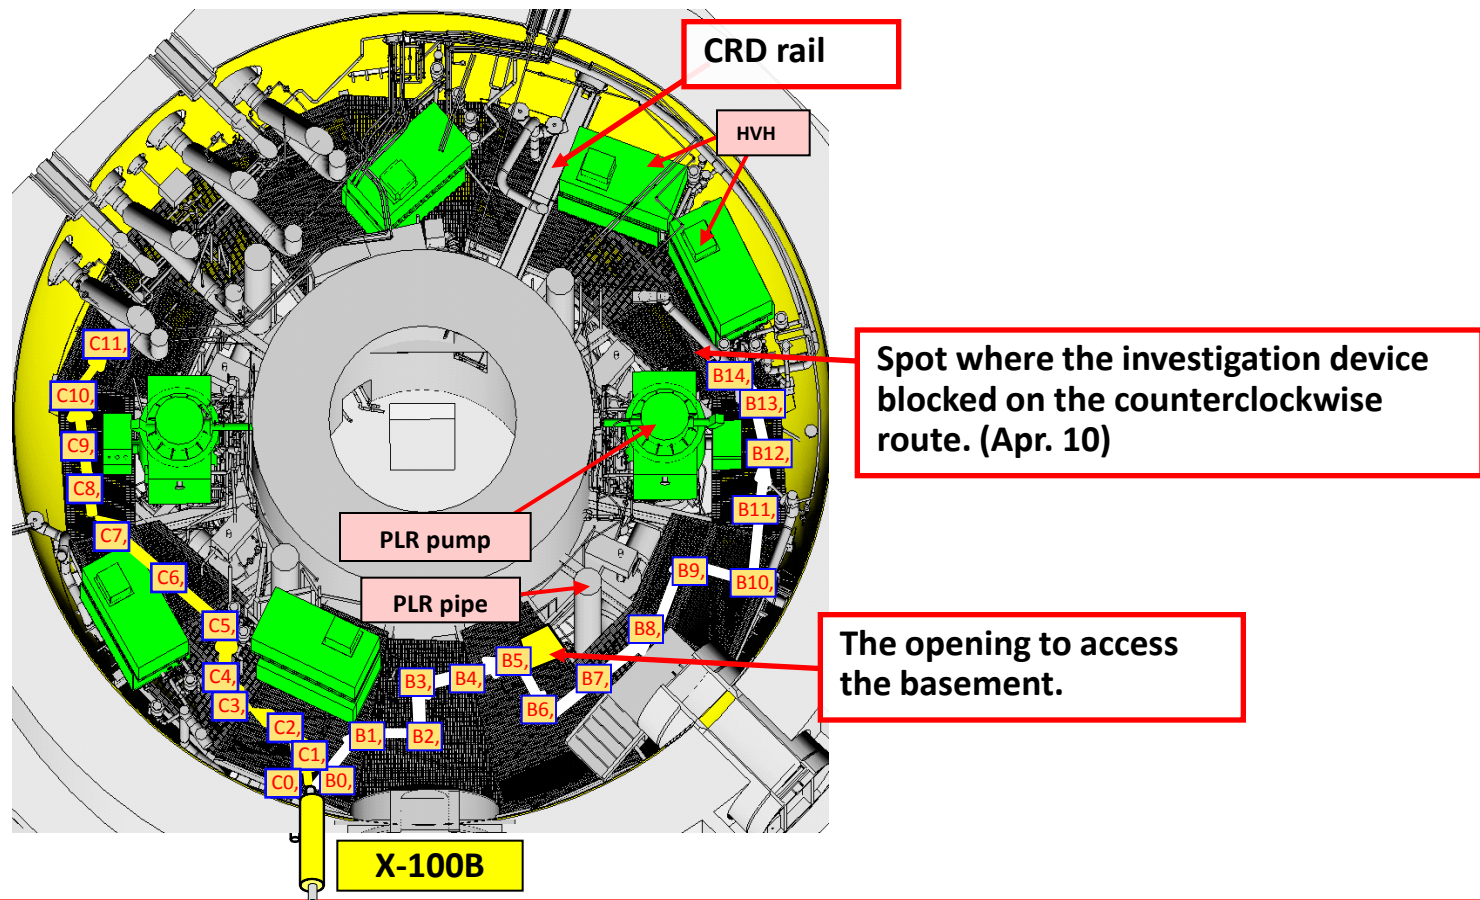
The following items were checked on the counterclockwise route.

- Route of remaining cable,
- Degree of interference of remained cables at the opening to access the basement,
- Status of the investigation device blocked in the vessel, and
- Access route to the CRD rail.
