IRID In-house Project

Development of Technology for Detailed Investigation inside Primary Containment Vessel (PCV) (On-site Demonstration of Technology for Detailed Investigation Considering Deposit Measures)

FY2021 Accomplishment Report

International Research Institute for Nuclear Decommissioning
(IRID)

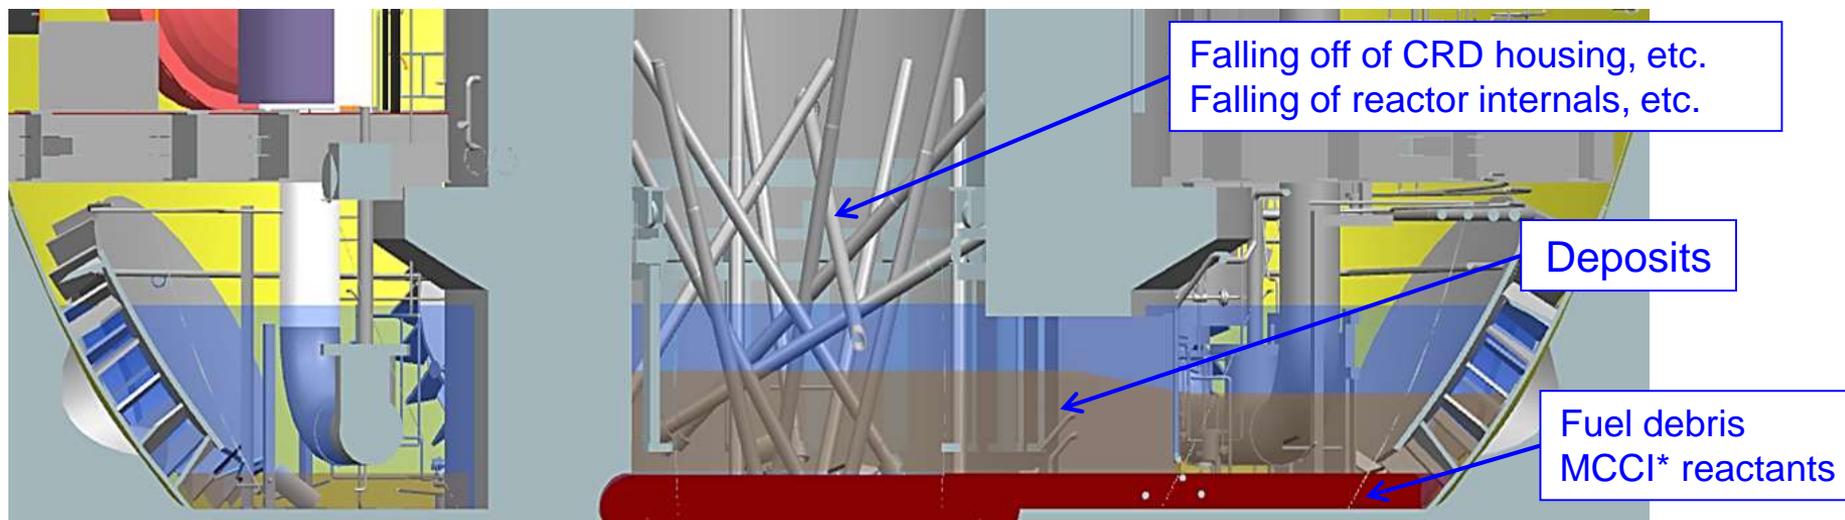
Figure 1.1-1 Estimated status of inside Unit 1 PCV

There are large amount of deposits in Unit 1 and since the Control Rod Drive (CRD) housing or the reactor internals are assumed to have fallen off (refer to Figure 1.1-1), the deposits need to be retrieved and the fallen objects need to be removed during fuel debris retrieval (or before then). The purpose of this project is to enter inside the PCV by creating an opening (approximately 350mm) larger than those created for internal investigations in the past and ascertaining the situation of inside the PCV such as the distribution of deposits, distribution of fuel debris in the deposits, situation of the reactor internals, etc.

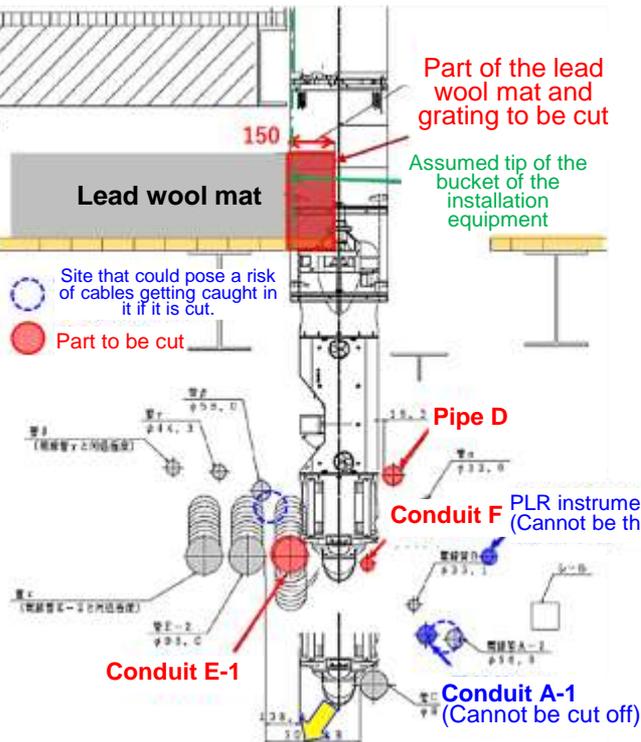
Plan 1

- If conduit E-1 or A-1 is cut, there will be a risk of ROV cables getting caught in it, therefore, Plan 1, Plan 2-1 and Plan 3 were selected as prospective ROV insertion routes based on the results of the interfering objects investigation.
- The ROV insertion route was narrowed down based on the concept of making sure to avoid impact of cutting on the PLR instrumentation piping, that the conduit A-1 is not cut off (thinning or partial cutting is permitted), and that conduit E-1 is not cut, if it has remained while cutting the lead wool mat and the grating.

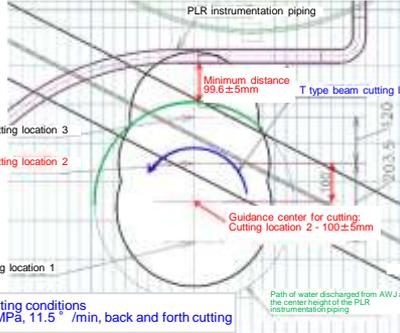
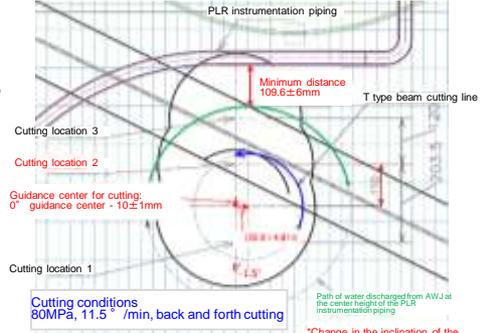
While cutting T type beam

- It was verified that the water discharged from AWJ while cutting the T type beam is likely to pass through the PLR instrumentation piping.
- The impact can be reduced (minor thinning) by using a discharge pressure of 80MPa.

- The situation of Conduit E-1 was confirmed after cutting the lead wool mat and grating and the T type beam.
- It was found that the flexible side conduit had been cut and was hanging down.

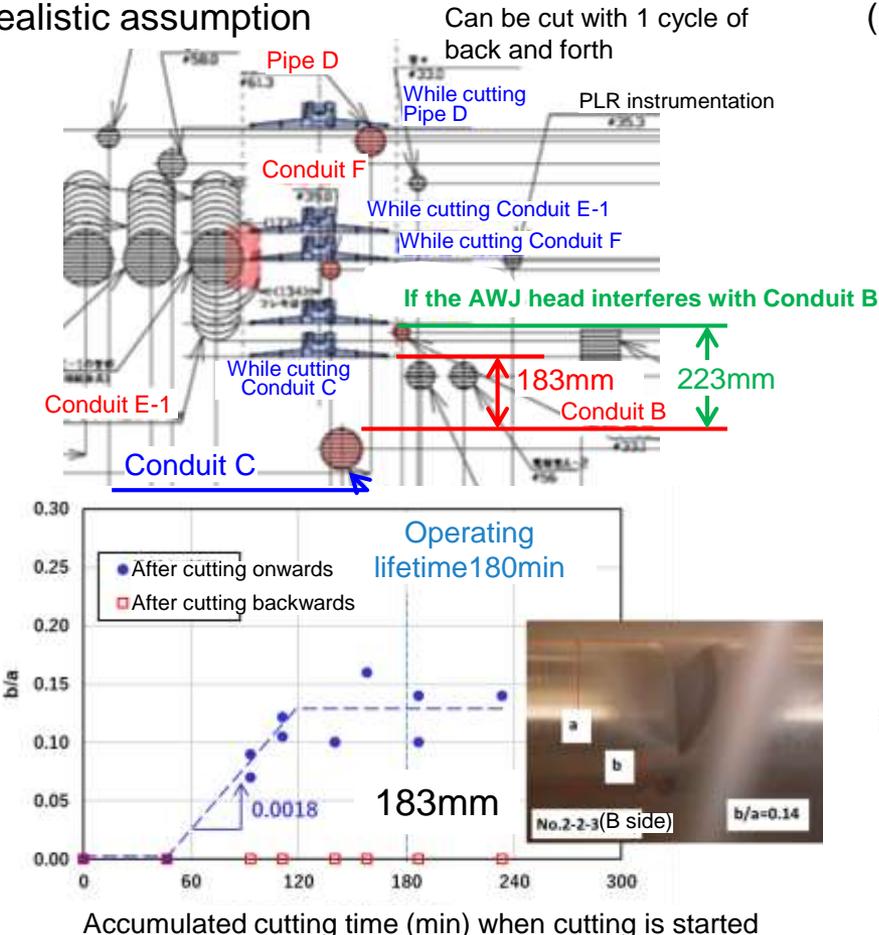
(a) Realistic assumption

- Cutting would be difficult within the lifetime of the nozzle from a distance of 452mm. However, it was possible from a distance of 183mm as well as 223mm.
- In case that Conduit E-1 remained and is interfered with the AWJ head during cutting, it was decided that the conduit would be cut off.

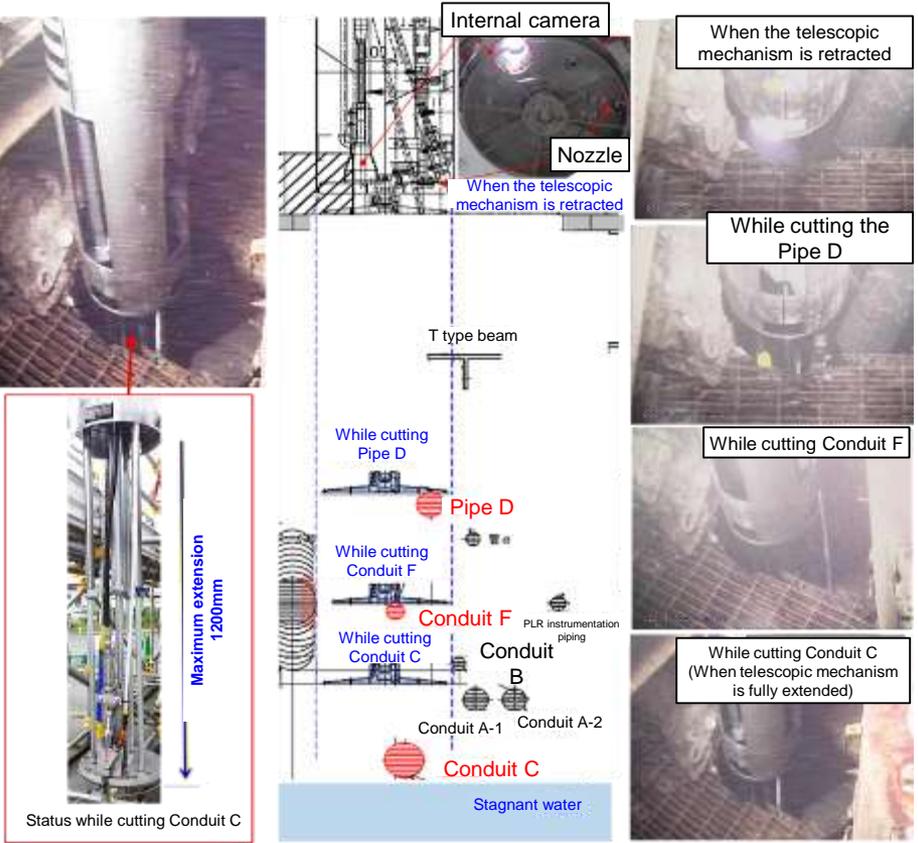
Figure 4.1.1 (v)-1 Equipment while cutting the conduits

- Cutting of Pipe D, Conduit F and Conduit C was completed as per the plan.
- The conduits were cut continuously for a maximum of approx. 60 minutes, but the dust level inside PCV was low on the whole.

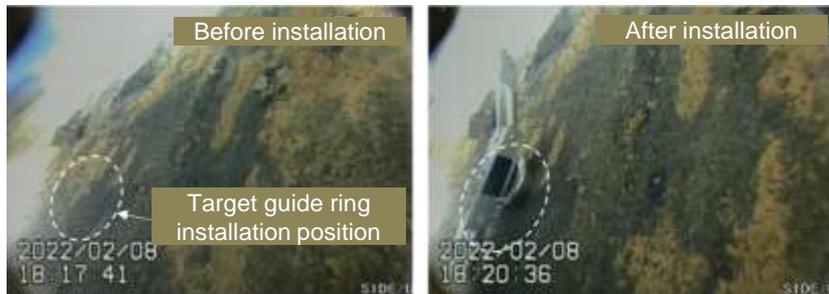
Jet deflector H

The work of installing guide rings for the four jet deflectors on the southern route was safely completed.
