“Development of a technology to investigate inside the Reactor Primary Containment Vessel (PCV)”

-- Site test “Investigation B1” on grating around the pedestal inside Unit 1 PCV -

April 13, 2015

Tokyo Electric Power Company

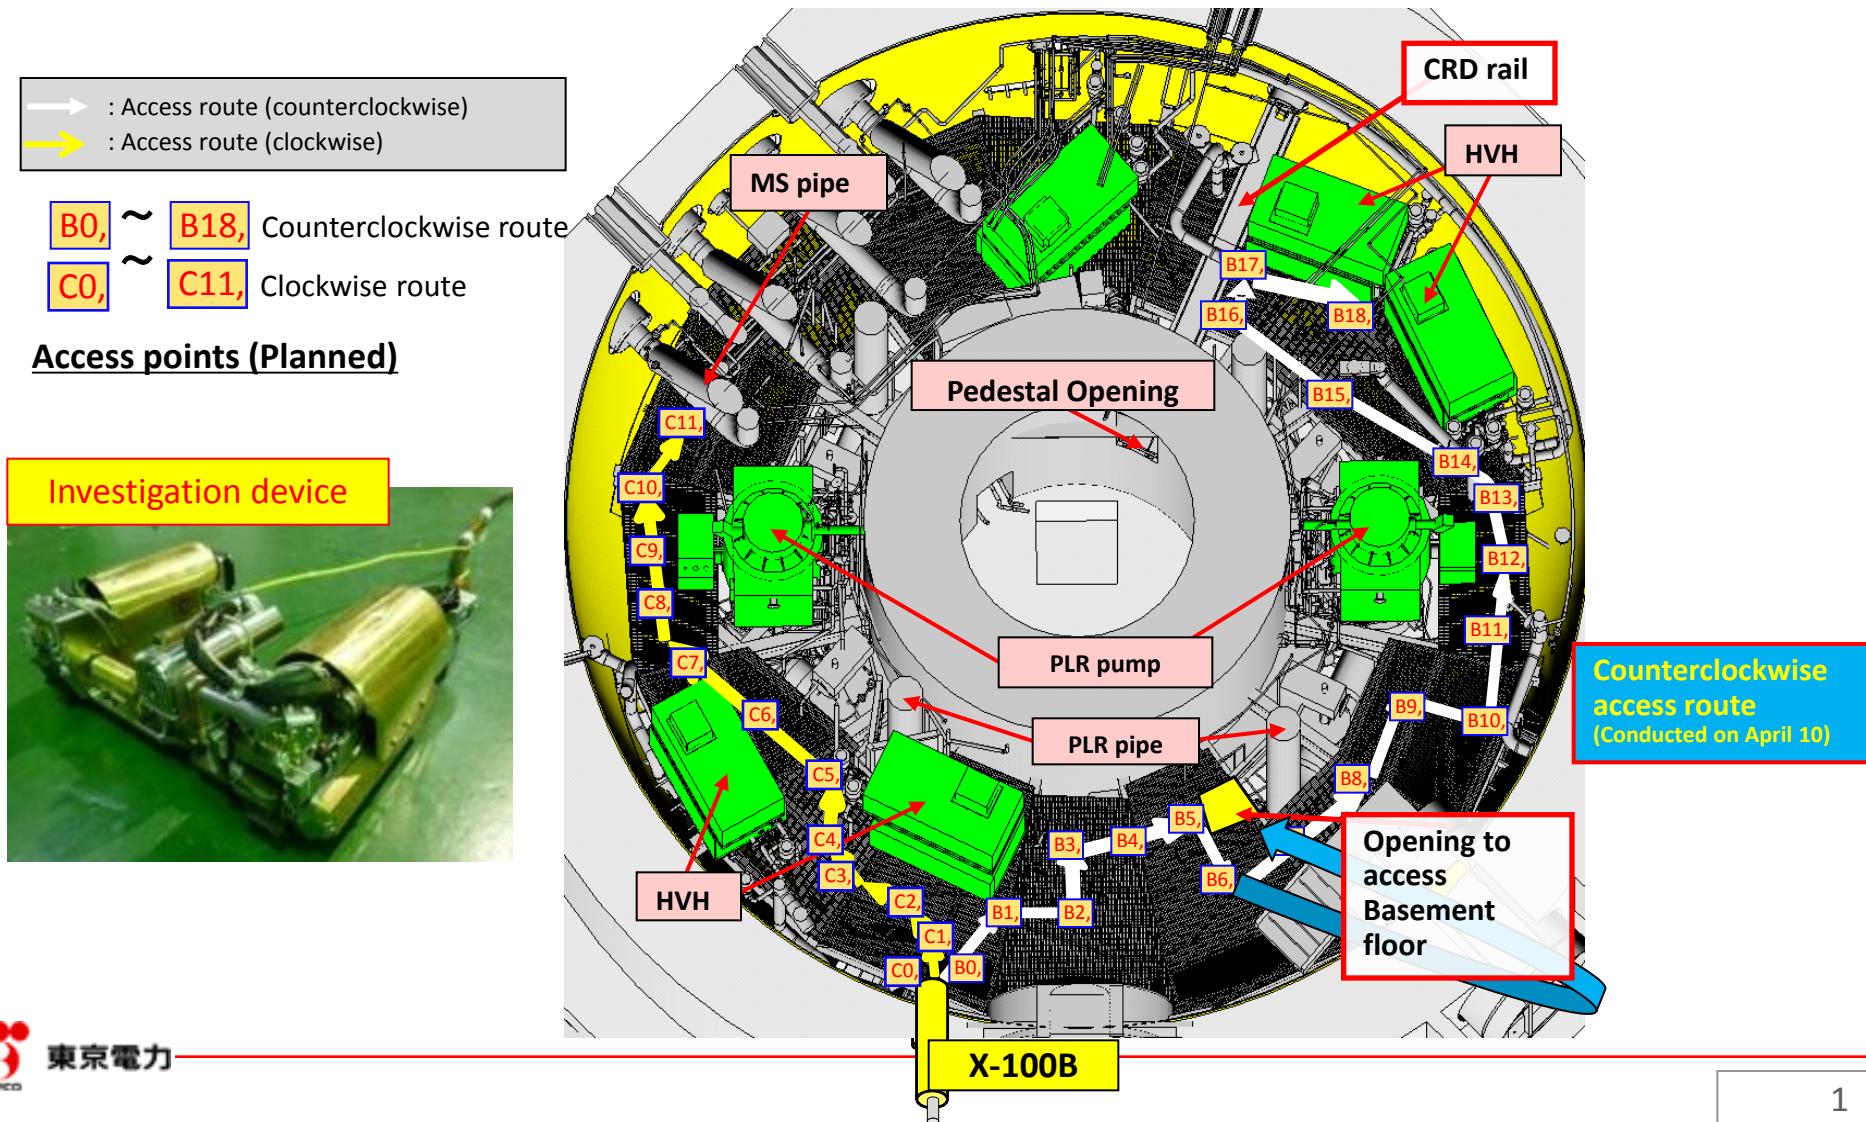
Purpose: For Unit 1, conducting an investigation in order to collect information on “the 1st floor grating inside the Primary Containment Vessel (PCV)” from the robot inserted through X-100B penetration pipe.

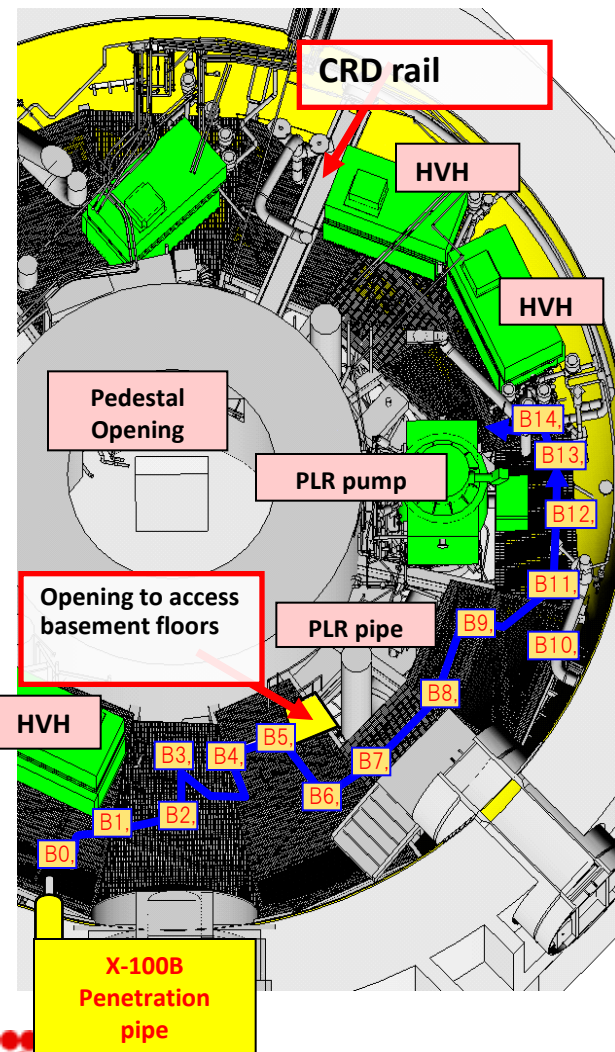
The following information were obtained for items ① to ③ of this investigation.

| No. | Location | Investigation results |
|---|---|---|
| ① | Opening to access basement floors | <ul style="list-style-type: none"> B2 investigation* will be conducted next time. <p>TEPCO confirmed there is an opening accessible to the basement as well as no obstacles around it.</p> |
| ② | CRD rail | <ul style="list-style-type: none"> Yet to be reached at CRD rail. Images have been taken with a camera facing towards CRD rail from the place where the robot reached at, which is now under evaluation. |
| ③ | On the access route | <ul style="list-style-type: none"> No significant damages were found on the existing facilities. (such as HVG, PLR pipe, the wall of Pedestal) Information on the temperature and radiation levels has been obtained at each investigation point. |

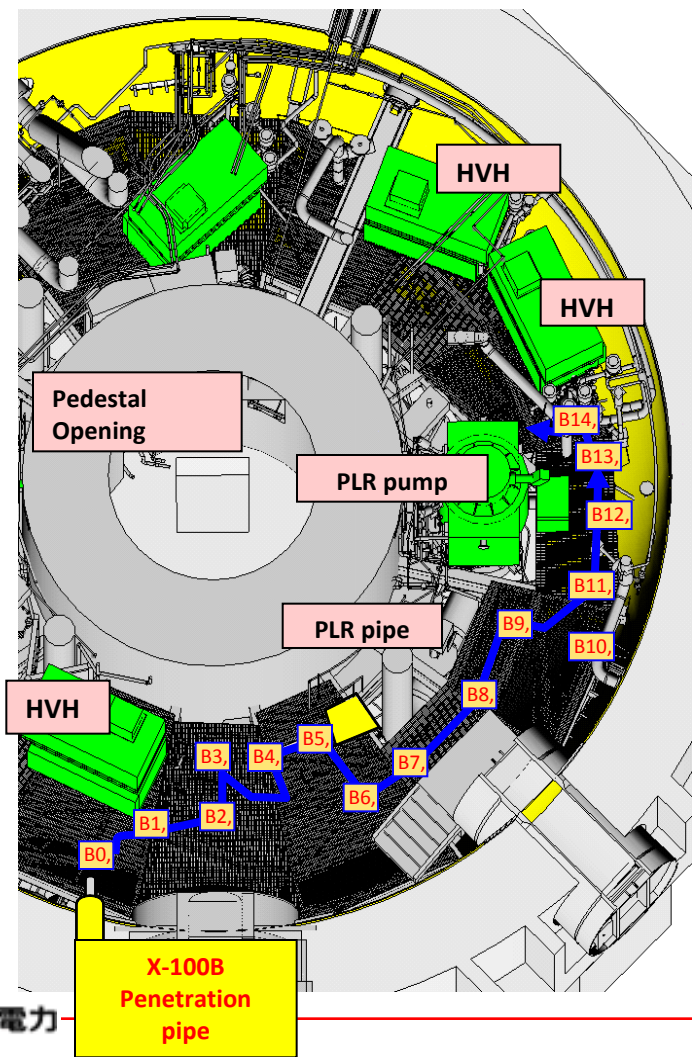
Temperature and dose rate were measured at the following points.

| | Dose rate (Sv/h) | Temperature (°C) |
| B3 | 7.4 | 17.8 |
| B4 | 7.5 | 19.2 |
| B5 | 8.7 | 19.4 |
| B7 | 7.4 | 19.5 |
| B11 | 9.7 | 19.2 |
| B14 | 7.0 | 20.2 |

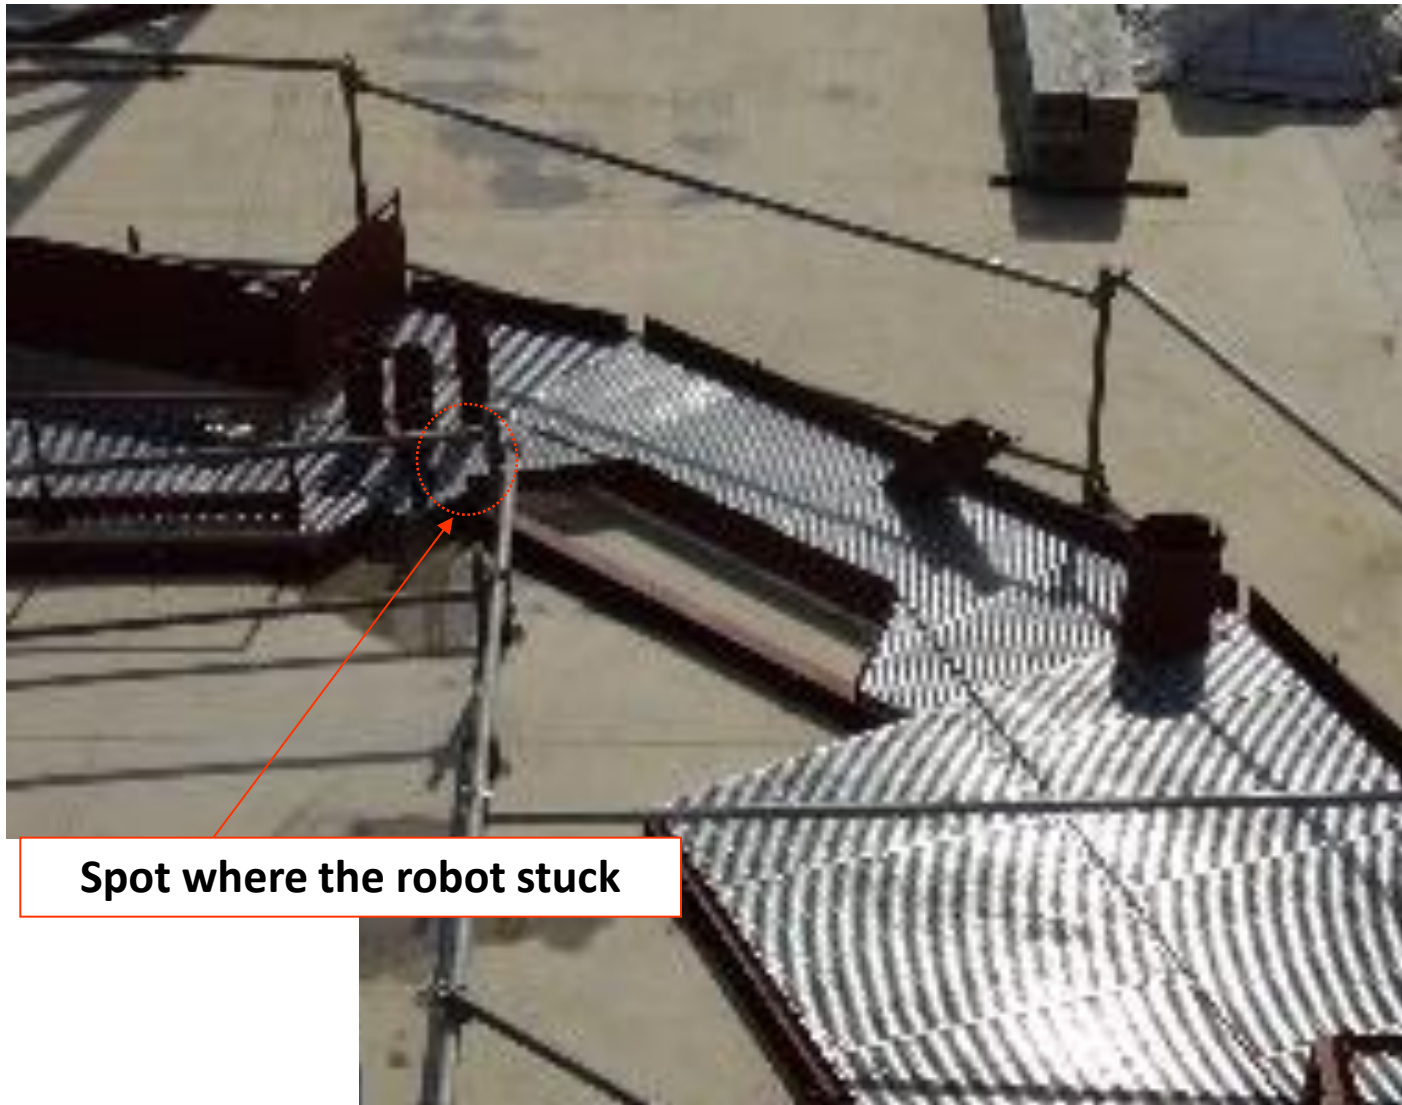
Spot where the robot stuck

The robot got stuck with an existing pipe and some shut parts of the grating or uneven part at the joint, which resulted in making the route hard to run on.

Measures to be taken are under study.
