“Development of a technology to investigate inside the Reactor Primary Containment Vessel (PCV)”

**- Results of site test “Investigation B1” on grating around the
pedestal inside Unit 1 PCV -**

April 30, 2015

Tokyo Electric Power Company

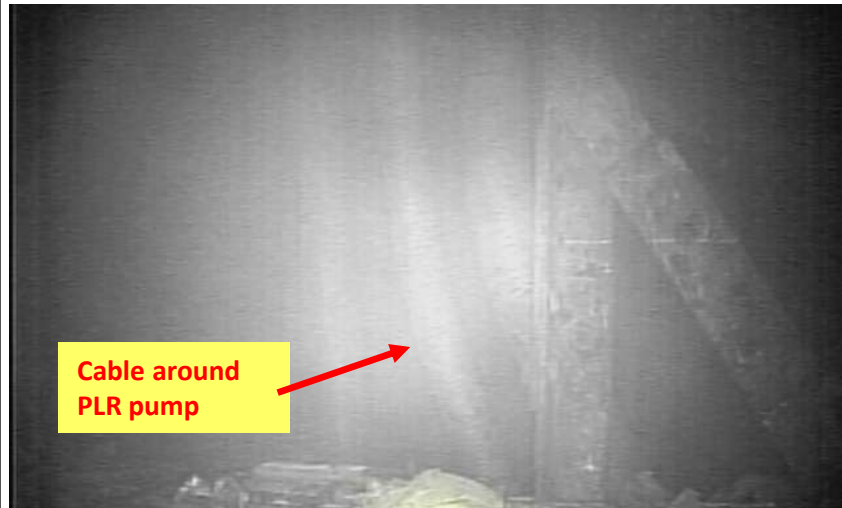
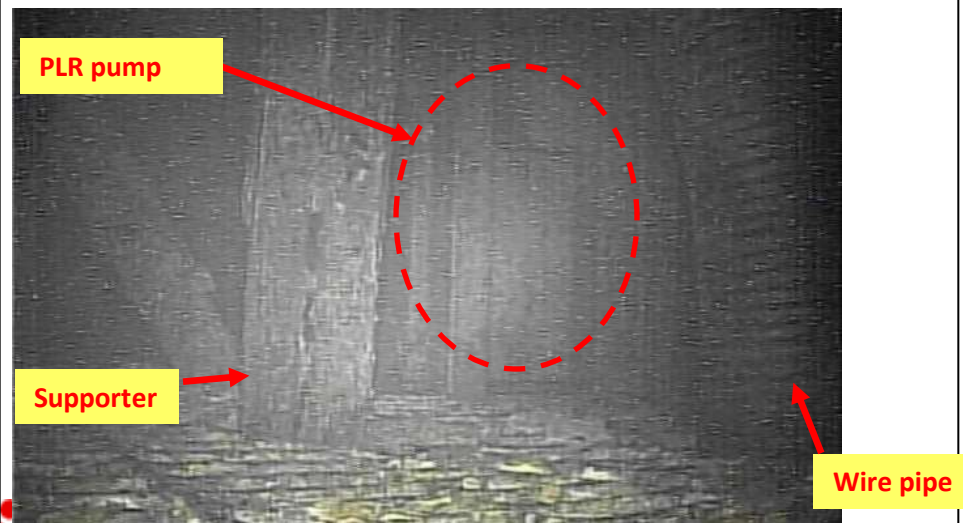
Taken from C2

No significant damages are found on PLR pump (A).

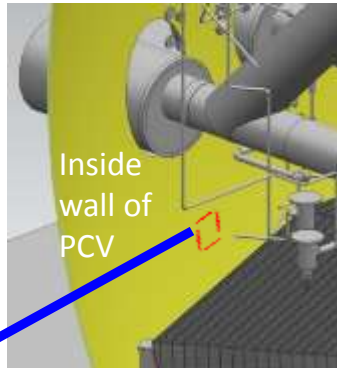
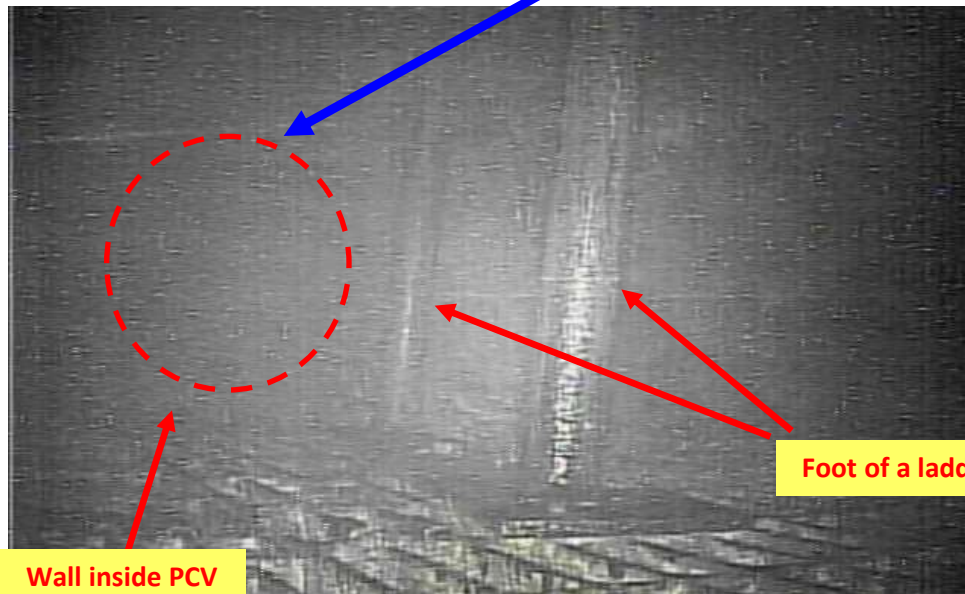
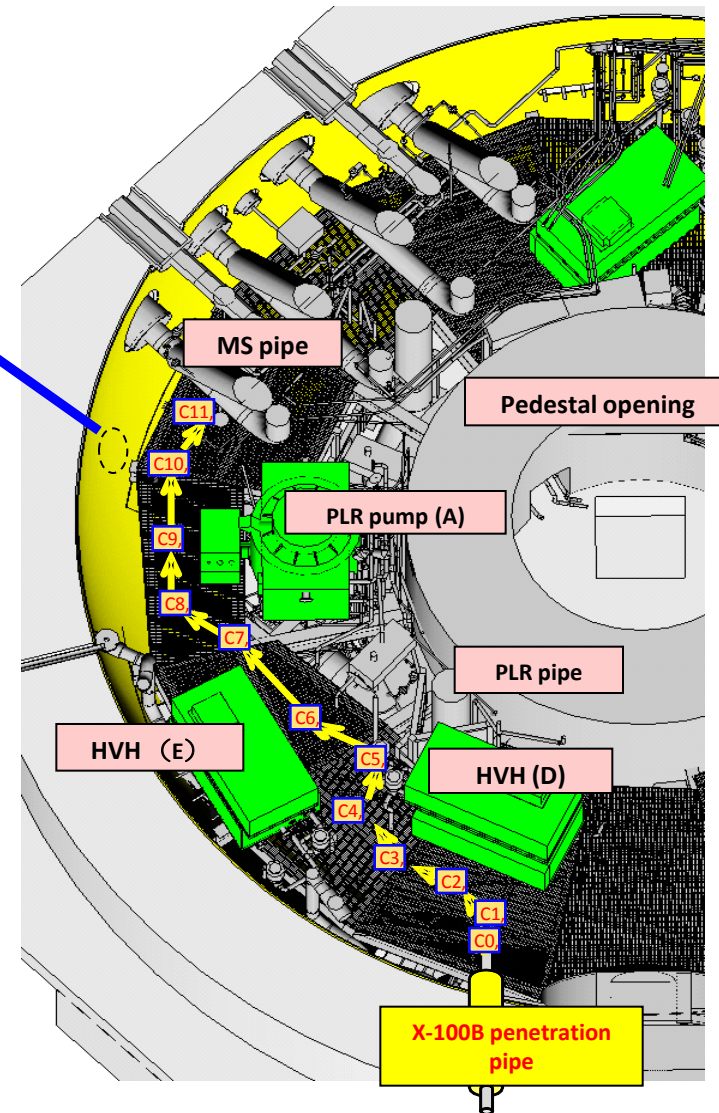
Taken from C10

No significant damages are found on the wall inside PCV.

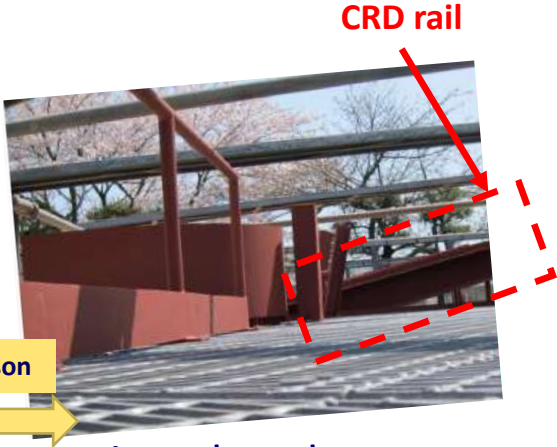
Images by mock-up test

■ Shooting was performed towards the direction of CRD rail at the end point where the device reached at (around B14) during the investigation along counterclockwise route. The images taken were processed but CRD rail could not be visually identified.

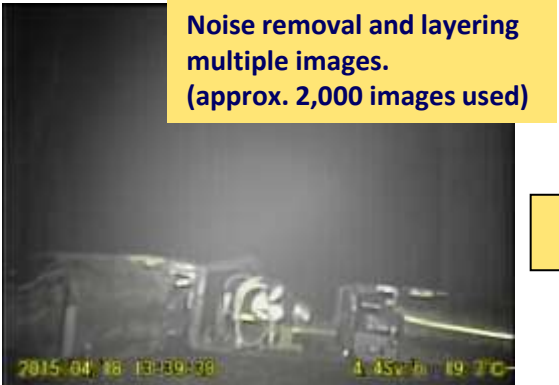
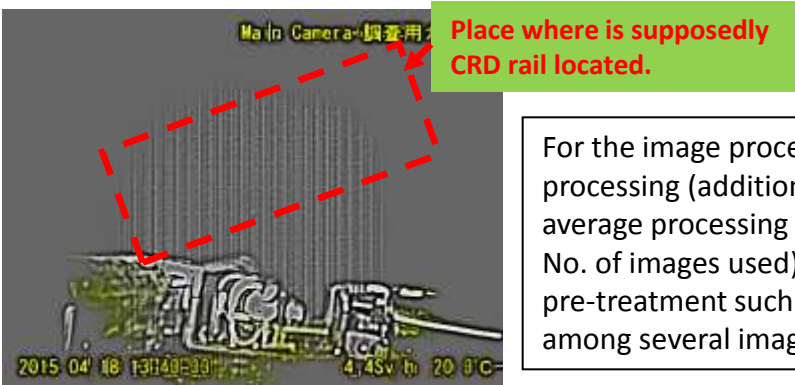
Image (taken at 2:00 PM, Apr. 18)

For the image processing methods, multiple processing (addition of images = layering) and average processing (No. of images added up / No. of images used) were applied after finishing pre-treatment such as emphasizing contrasts among several images.

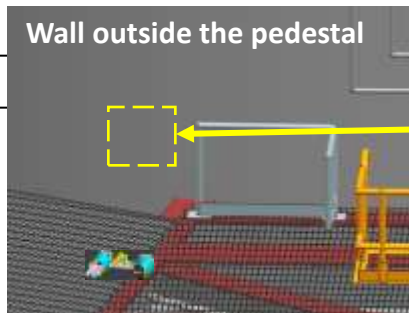
Taken from B3

Exterior status of the wall outside the pedestal

No significant damages were found on the wall outside the pedestal .

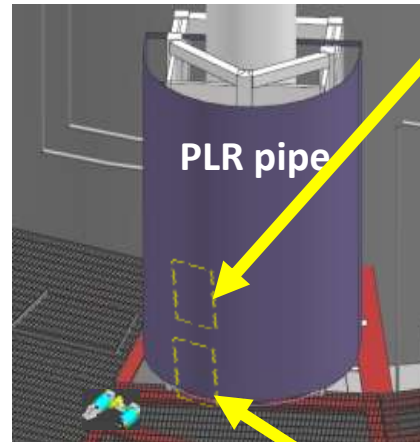
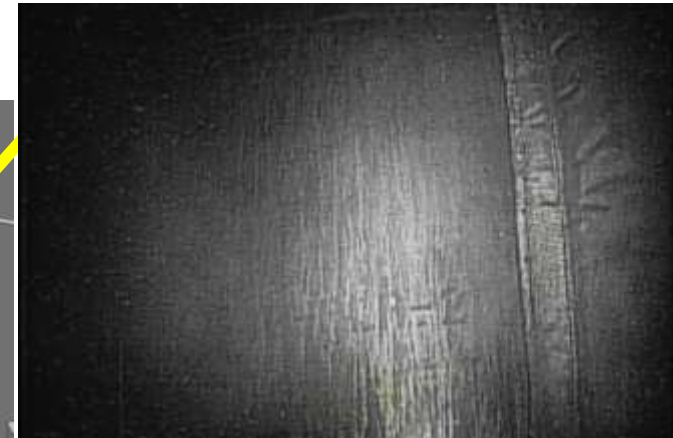
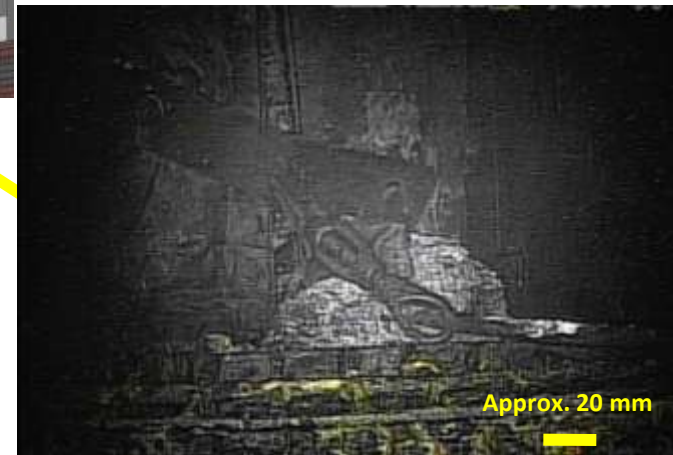
Taken from B7

- No significant damages were found on PLR pipe (heat insulation)
- Pieces of the shield of the pipe was found to be fallen off.
