Request for Information (RFI) of Innovative Approach for Fuel Debris Retrieval

Items for “Request for Information”

December 17th, 2013

International Research Institute for Nuclear Decommissioning

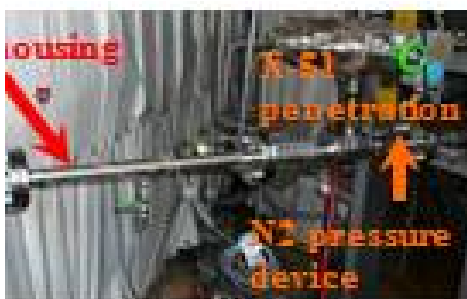
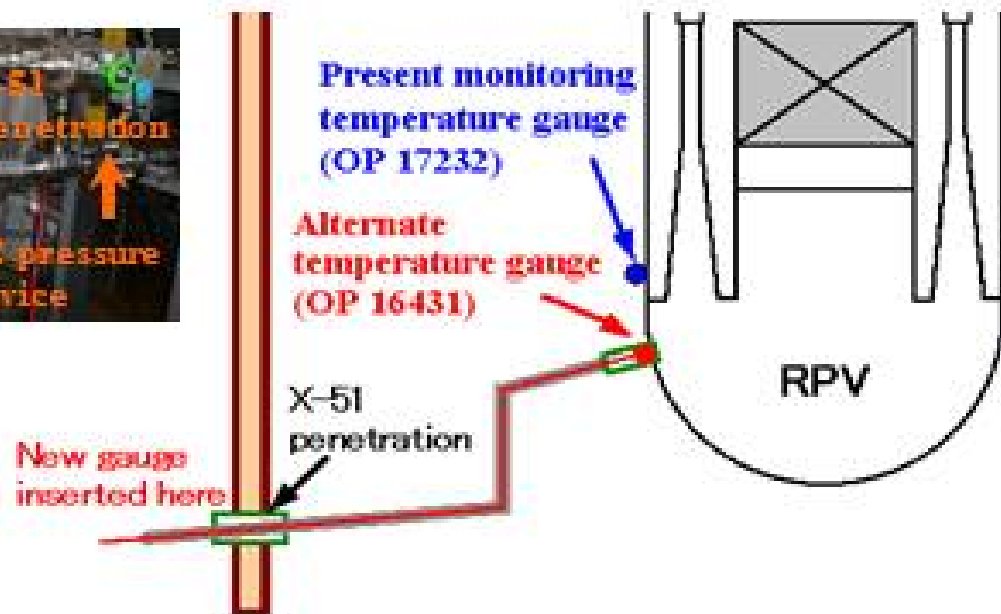
Installation of temperature gauges

- Core is cooled continuously by water injection and the temperature is low. (around 40 °C)
- No criticality is confirmed by monitoring temperature and noble gas.

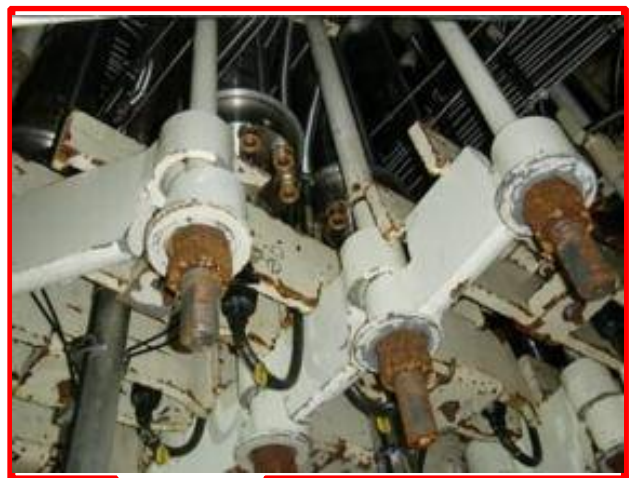
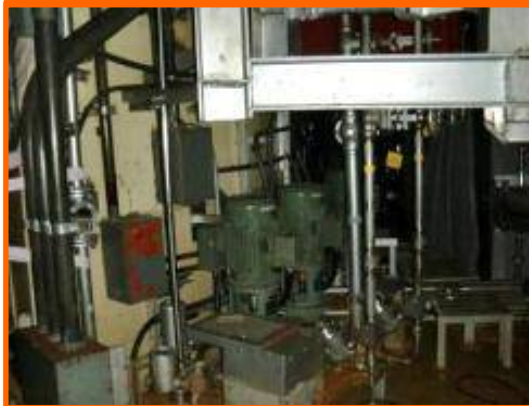
Internal structure is so complicated that access of observation equipment to inner PCV is not easy.

* Photos are taken at Unit 5 (Just for reference)
